AIRWORTHINESS DIRECTIVE

TYPES AFFECTED: Glasflugel - Club Libelle 205
Hornet
Mosquito
Mosquito B
Mosquito 304

SUBJECT: Elevator drive/tailplane mounting bracket

GFA AD 327	Issue 1
17.12.1987	Sheet 2 of 2

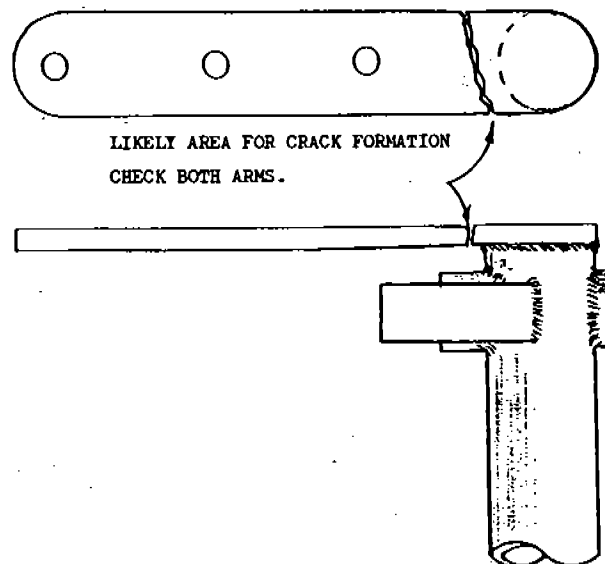
FIG. 1.

Visually inspect the elevator drive bracket for possible cracks (see Fig. 1) whilst twisting the two elevator halves against each other.

If the bracket is cracked or deformed the sailplane must not be flown.
