AIRWORTHINESS ADVICE NOTICE

GFA/AN 69

TYPE AFFECTED: All sailplanes and powered sailplanes originally externally finished in "Vorgelat" gel coat.

SUBJECT: Gel coat failure, its removal, replacement and care.

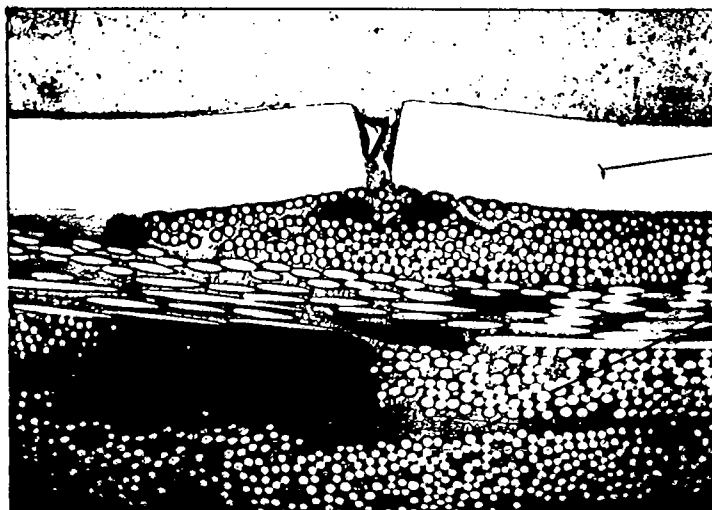
150 MAGNIFICATION.

Gel coat has lifted up due to the effect of SURFACE TENSION.

Fracture of the layer under the crack has occurred

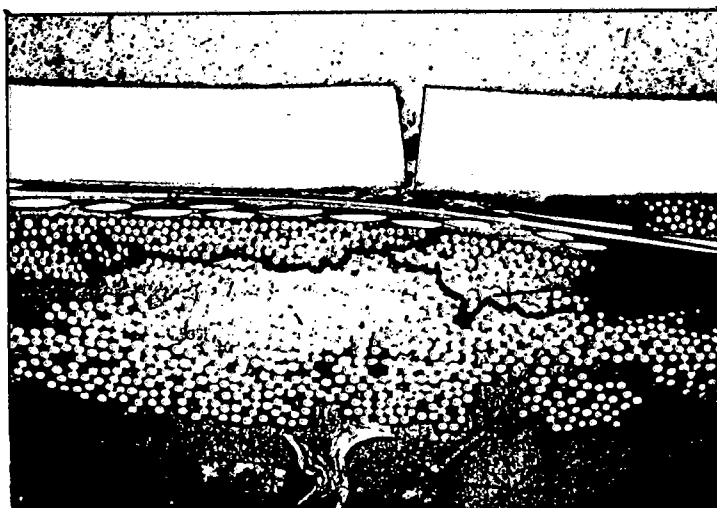
150 MAGNIFICATION
Gel Coat Cracking has penetrated the glass/epoxy layer creating a delamination.

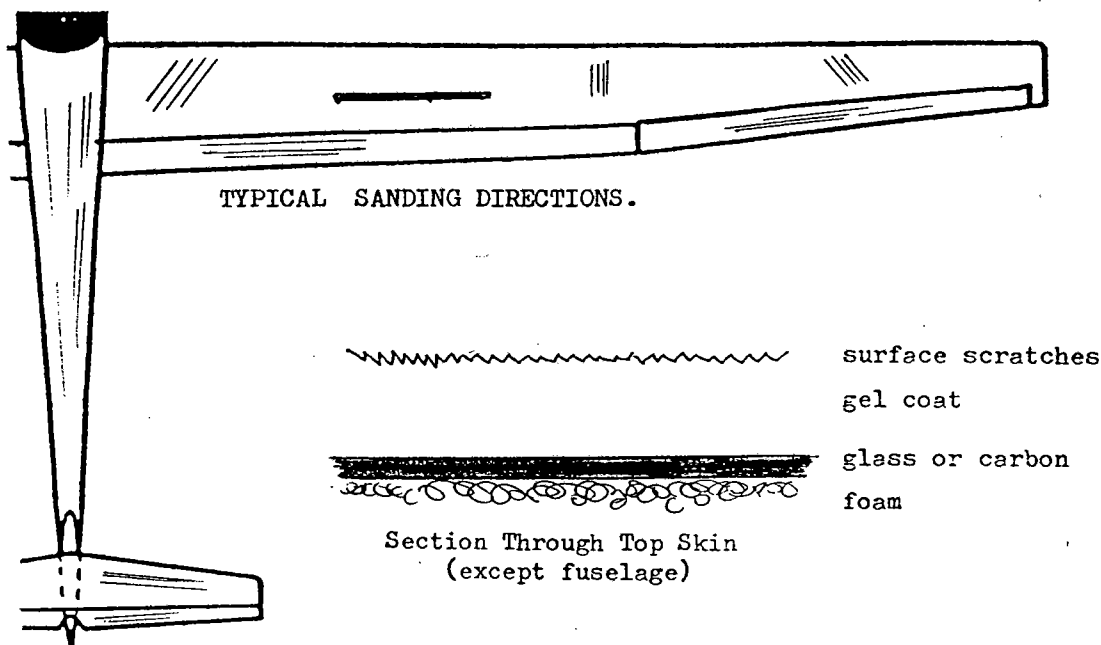
Sanding the gel coat creates a scratched or notched surface, the same as marking a sheet of glass with a diamond; those notches acting as trigger points for cracks to start from. On wings, these fine scratches are chordwise/diagonal at 45 degrees, on the control surfaces, usually spanwise.

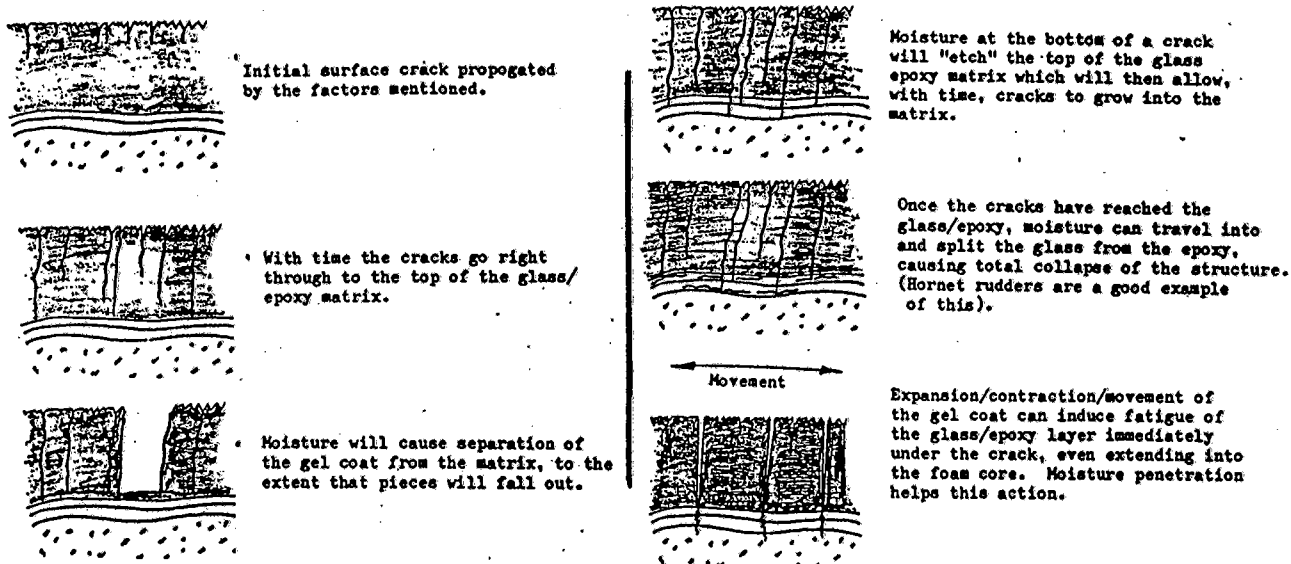
- (2) Transfer into the epoxy in the first layer of epoxy and glass or carbon under the gel coat;
- (3) Spread laterally, delaminating the skin layers.

- (4) Travel completely through the skin layers of wings, tailplanes, fins, rudders, elevators, flaps and ailerons.
- (5) Transfer into and through the foam layers of sandwich skins.
- (6) Transfer from skin layers into spar caps.
- (7) Cracks allow moisture penetration into structural material.

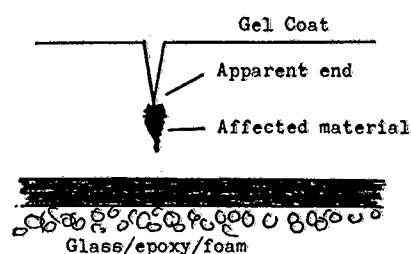
The sketch shows a crack part way through a gel coat layer. There will be a "Visual End" to the crack, but there will be "Crack Affected" material past the end of the crack. If that is left on the structure and surfaced over, there is every possibility that cracking will restart possibly spreading both ways.

This means that to give the best guarantee of producing a good long term result, ALL OF THE GEL COAT must be removed.

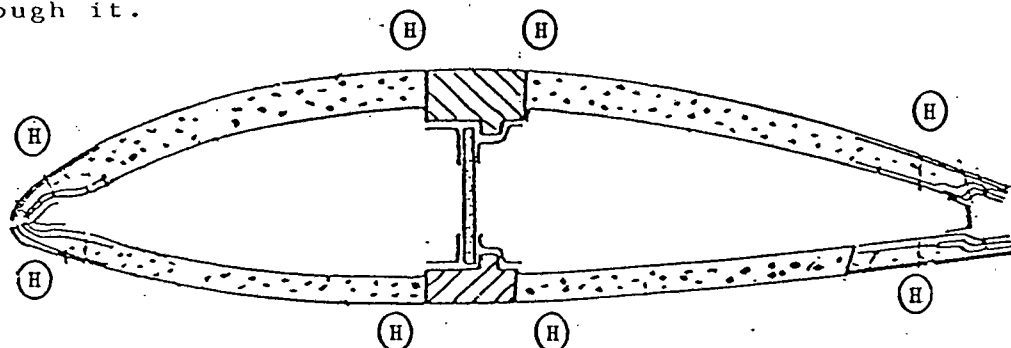
(H) Typical "hard" points which can be easily sanded through

Cutting through the glass/epoxy layer will weaken the structure by lowering its stiffness. The more damage created, the more the structure will be affected, Loss of stiffness will affect fatigue life and flutter.
