AIRWORTHINESS ADVICE NOTICE

TYPE AFFECTED: Janus, Janus B and Janus C

SUBJECT: Miscellaneous airworthiness information.

GFA AN 37	ISSUE: 5	24 August 2001	Page 2 of 3
-----------	----------	----------------	-------------

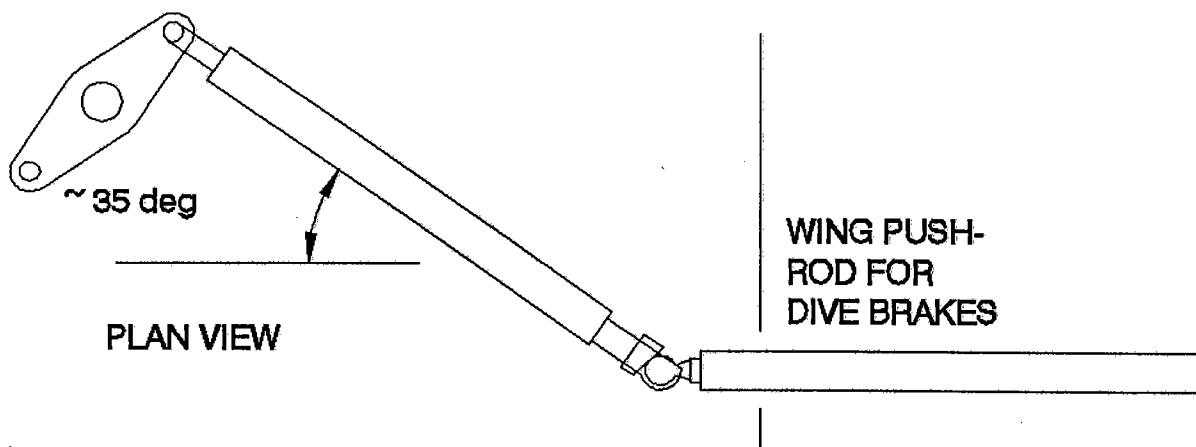
L'Hotellier coupling set up

1. During an annual inspection of a Janus B the L'Hotellier balls and couplings were found to be galled after only 150 hours in service. It was found that the balls were binding when the dive brakes were actuated because the coupling had been rotated during maintenance to couple from the top rather than the side.

To provide sufficient angular movement the couplings in the dive brake circuit should be installed on their sides as shown below. Note: the diagram in the Maintenance Manual would indicate that the couplings should all connect from the top, which is not correct.
