AIRWORTHINESS ADVICE NOTICE

TYPE AFFECTED: Blantik L13 all variants.

SUBJECT: Miscellaneous reported defects and airworthiness information.

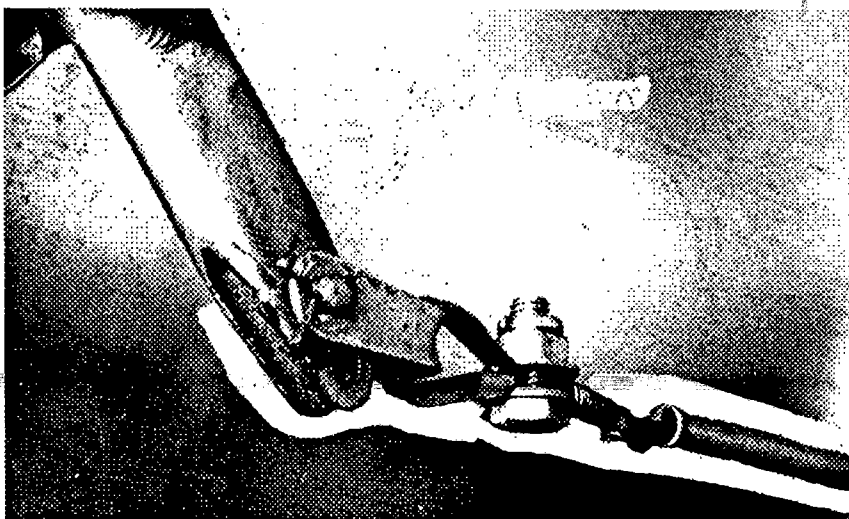
Figure 1. Correct Cable Position

The belly release in a Blantik was not lubricated at each Form 2 as the glider was only subject to aero tow. The release subsequently jammed in the full open position which allowed the cable connecting the nose and belly releases to become slack.

Correct maintenance of the Belly Release at each annual inspection (see AD 277) will eliminate the possibility of the release seizing and thereby prevent the cable from becoming slack. The other option is to remove the belly release and its actuating mechanism and clearly placarding the glider:

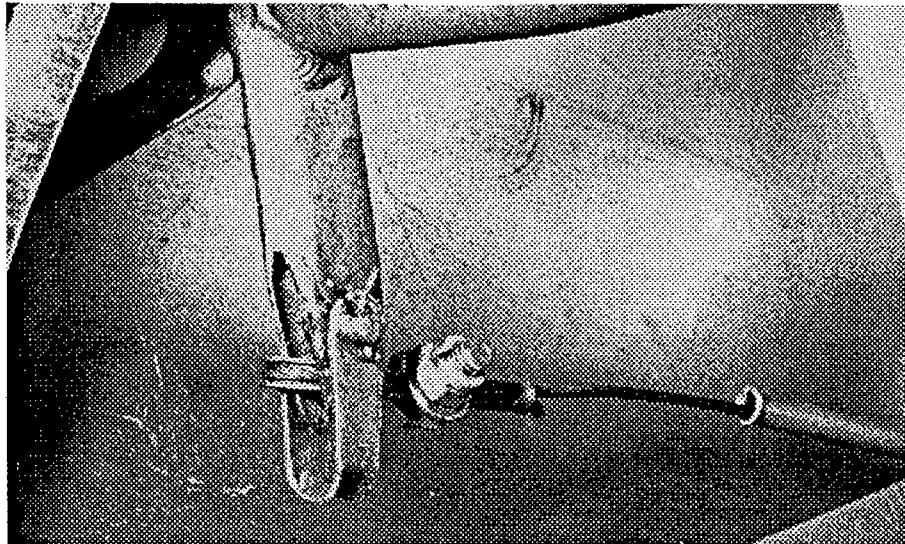
Figure 2 Incorrect Cable Position

The excess slack allowed the cable to loop around the actuating

lever (see Figure 2) which effectively shortened the cable by 35 to 50 mm. This prevented the nose release from opening because the belly release limited the action of the entire release circuit.

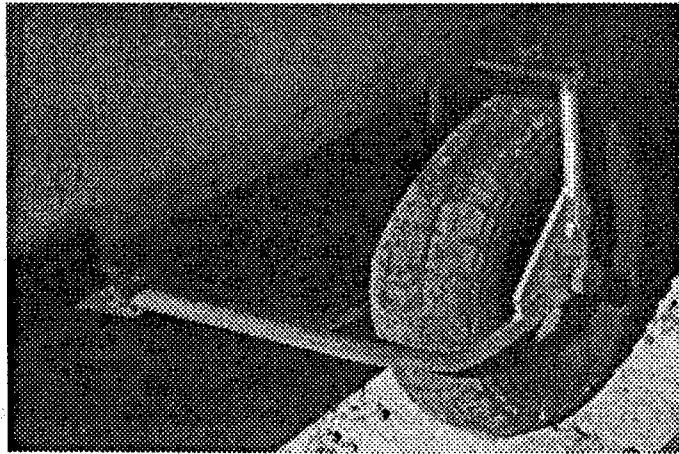
Figure 4 Alternate Tailwheel Type 1

The castoring tailwheel originally fitted to most Blaniks has caused a significant amount of damage such as cracks, loose rivets and worn pins to the rear fuselage, fin and tailplane because it lacked adequate shock absorption, thus causing high fatigue loads and

because when the castor was offset the eccentric load caused high twisting loads on the tailwheel mounts.

There has been a significant number of fixed tailwheel modifications fitted to Blaniks over the years and three examples are shown here the best of which use pneumatic wheels of 200x50 or 210x65 size.

Copies of the drawings of the Tailwheel Type 1 are available from the GFA Secretariat as GFA MOD 82-19 (Courtesy of Dieter Hillenbrand) on request.

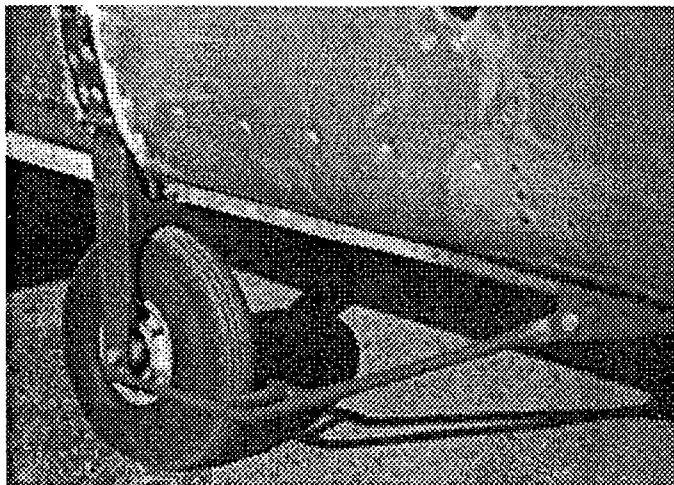
Figure 6 Alternate Tailwheel Type 3

Because most of these tailwheels are taller than the original castoring tailwheel the glider may tend to land tailwheel first landings although this has not proved to be a significant problem in normal operations.

Fixed tailwheels pose some problems for ground handling as the glider tail can no longer be pushed sideways. If a fixed tailwheel is fitted the glider should also be equipped with a taildolly which includes a swivelling pneumatic wheel for all ground handling.

The optimum solution to the problem of damage to the rear end of Blaniks seems to be a pneumatic fixed tailwheel for flight operations and tail dolly with a swivelling pneumatic wheel for ground handling.

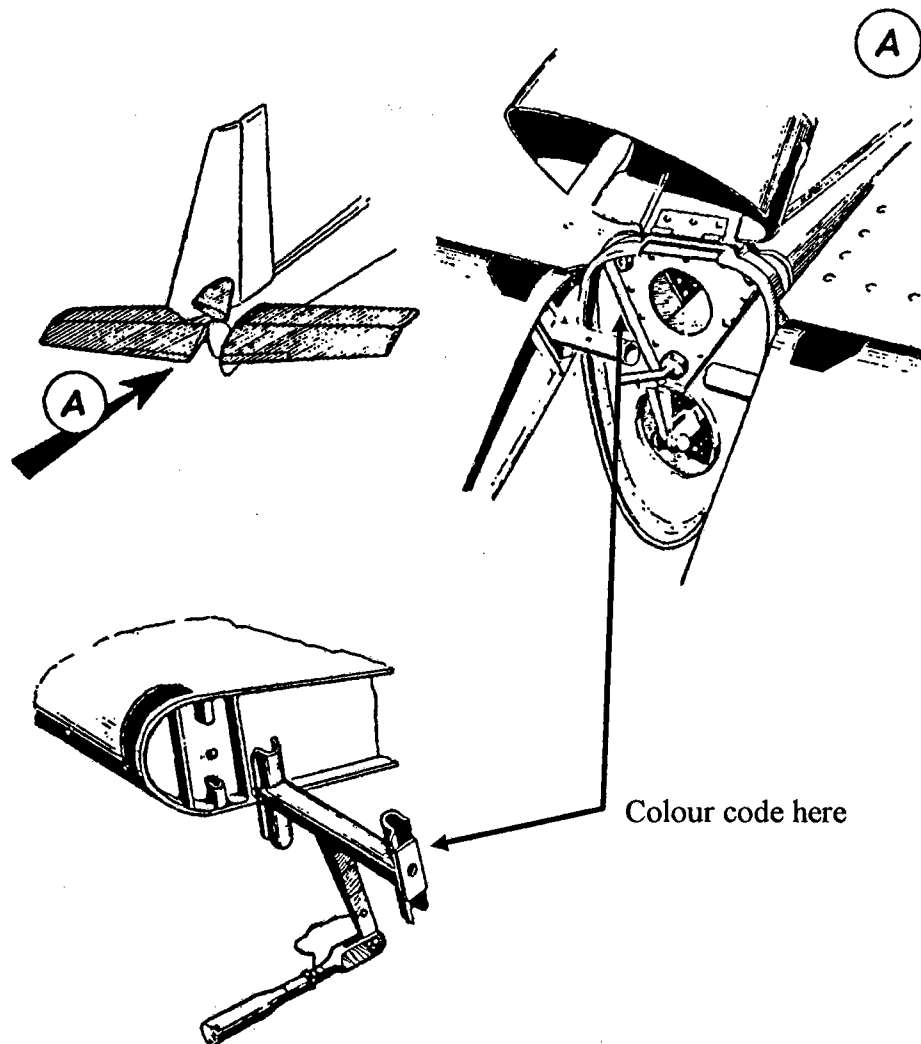
Figure 7 Tailplane T Piece Colour Coding

There have been a number of incidents in Australia and England where the T piece joining the two elevators has been fitted back to front. This results in excess down elevator and no up elevator.

To aid refitting this part correctly paint one end of the T Piece a distinctive colour (red is the normal colour) and then paint the fuselage on the same side with the same colour. Painting the elevators will not aid in reassembling these parts as the elevators can be fitted to either side.

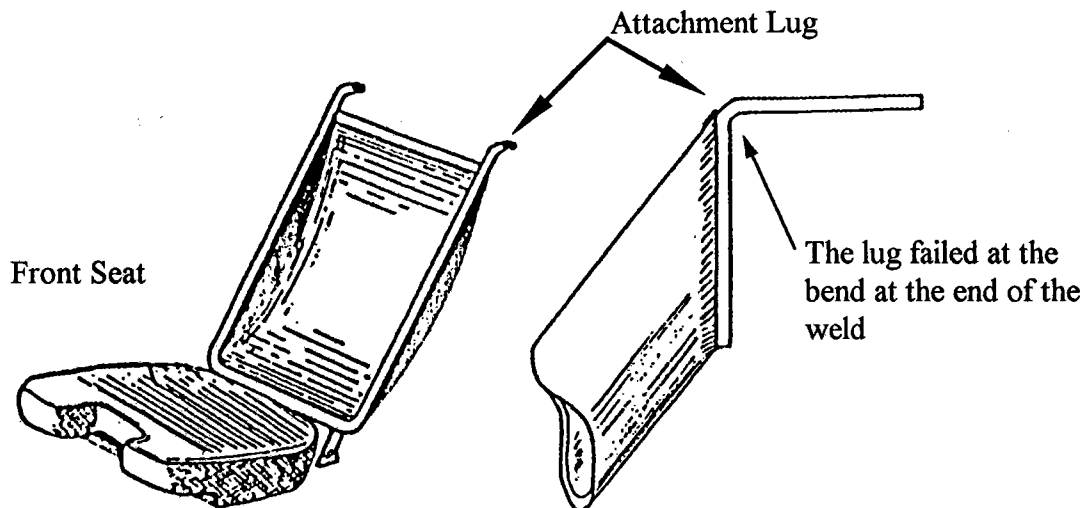
Figure 10 Position of Lug Failure

A Blanik was involved in a stall/spin accident and during the investigation it was found that the front pilot left shoulder harness attachment point had failed before the harness. This failure may have contributed to the injuries sustained by the pilot as he may not have been properly restrained.

As there has only been one case of failure and that was in an accident (which would have placed unusual load on the part) no mandatory action was taken however it is recommended that one of the two following mods be incorporated to prevent failure of the harness mount.

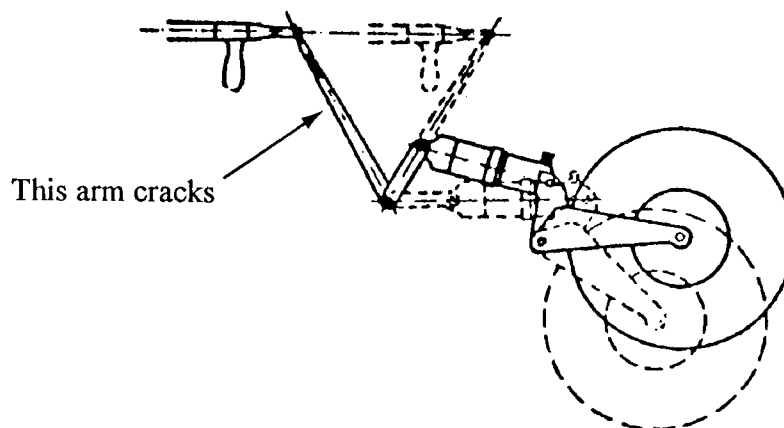
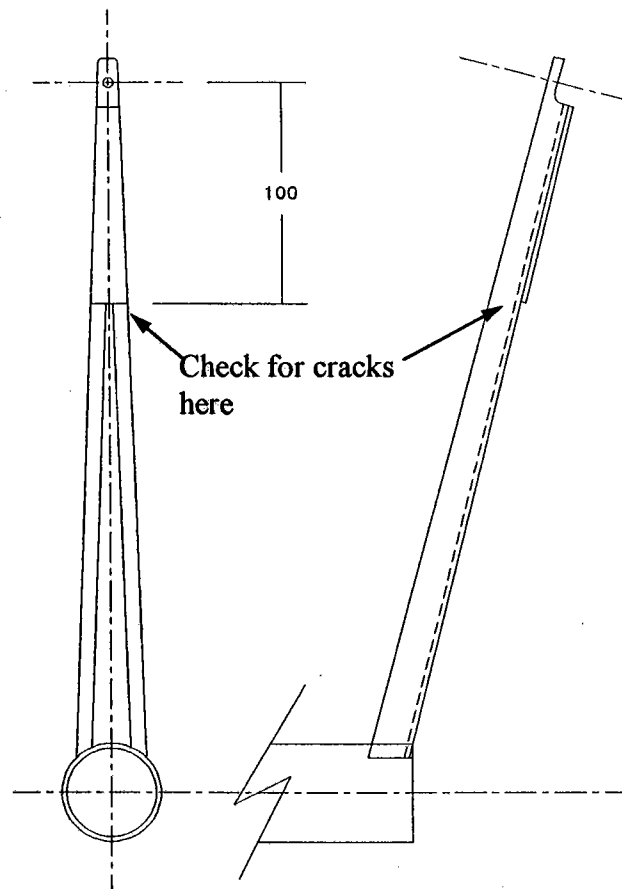
Figure 13 Undercarriage operating arm

The undercarriage actuating arm is prone to cracking at the section change and should be carefully inspected at each annual inspection and following a heavy landing.

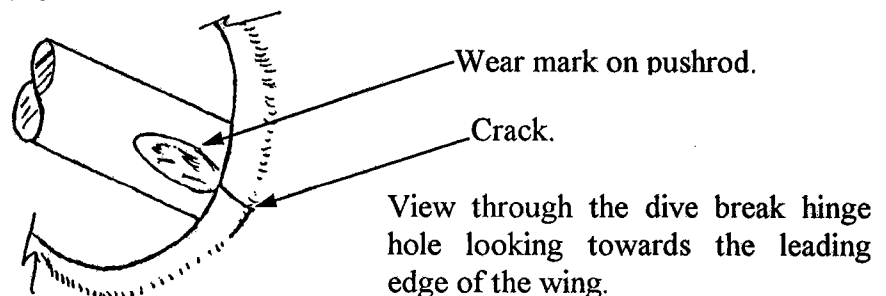
Figure 15. Typical Wear Pattern.

During trairling, if the aileron circuit is not locked, the pushrod can rub on the edge of the lightening hole in Rib No. 17 resulting, in some cases, in substantial wear on the pushrod, as the aileron moves backwards and forwards. See Item 16 for the location of rib 17

The rib may be cracked as a result of the contact, which can be seen through the lower dive brake outboard hinge hole. If found, the damage to the tube should be polished smooth with fine grade paper. A small crack in the rib is not detrimental to the structure.

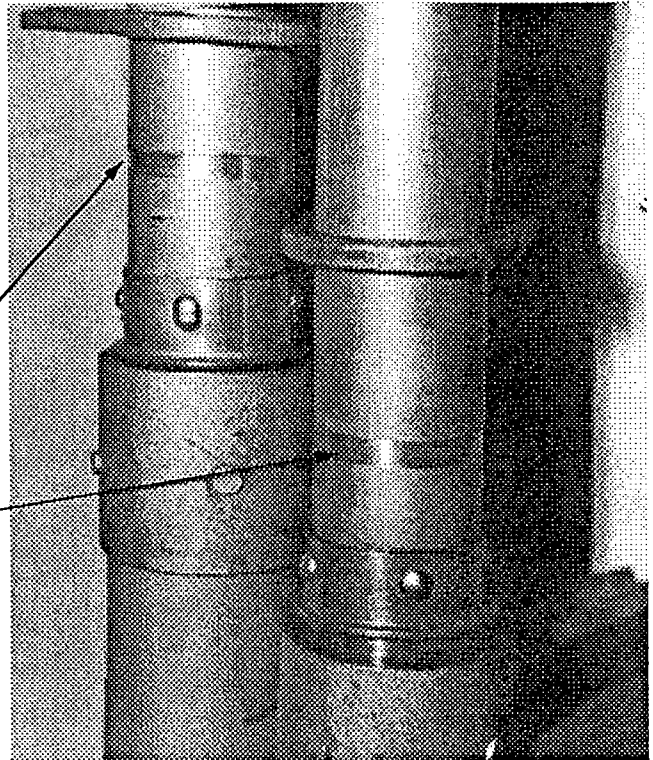
Figure 16 Wear Caused by Displacement of Bearing

Excessive chordwise movement of the flaps may be caused by the thin fibre bearings bolted to rib 13 moving out of its housing. This allows the torque tube to bear directly on the bearing housing which can result in wear on the torque tube.

Wear marks on left and right torque tubes. Wear is 2/3rd s through the tube wall.

To prevent the fibre bearing from coming out of its mount fit a hose clamp around torque tube so that the bearing cannot be displaced along the torque tube.

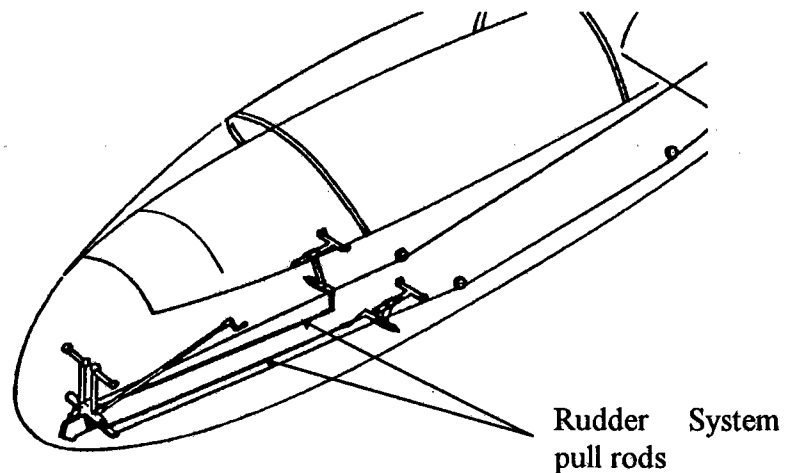
Figure 17 Rudder Pull Rods

This type of damage is caused by the rear pedals being used as a type of rudder lock. If the rear pedals are locked and the rudder is loaded by a gusty wind then the pull rods are placed in compression. These rods were only designed for tension loads and so fail at quite low compressive loads.

If the rods are found to be gently curved they may be straightened once without work hardening or weakening. If they are kinked then they must be replaced or repaired in accordance with a standard repair scheme.

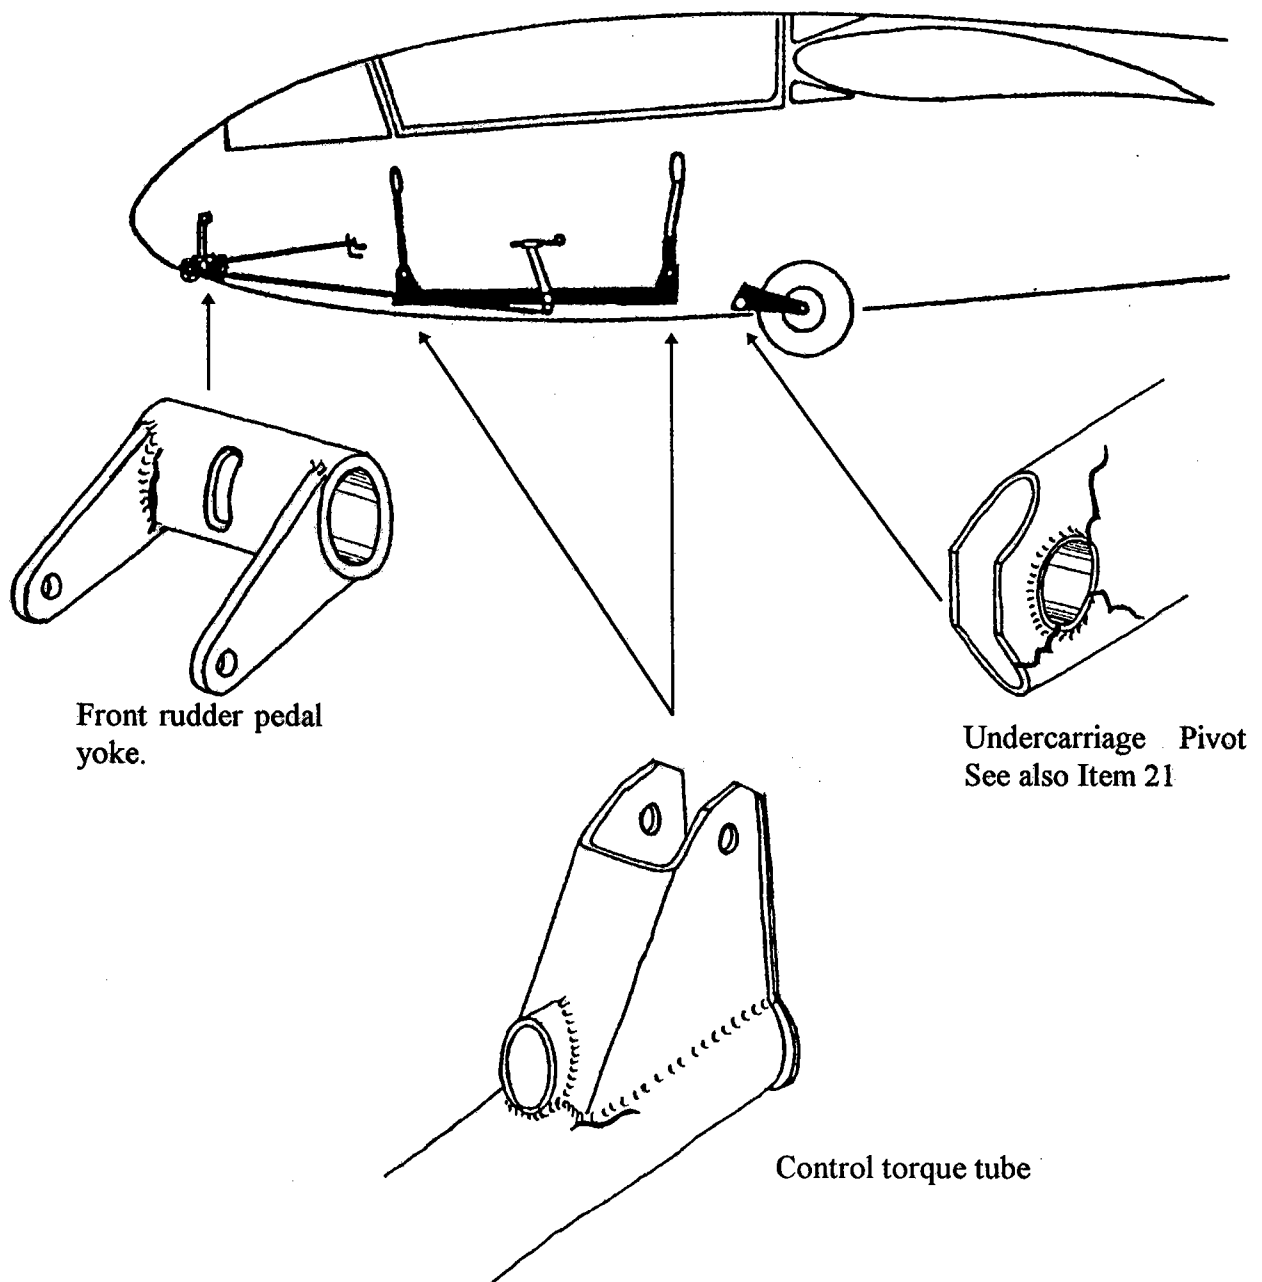
Figure 20 Known crack locations

The area around a weld is the most likely place in a structure for a crack to develop.

The following places are areas where cracks have been found and repaired by welding. All welds should be checked for cracking as a routine part of any Annual Inspection.

If cracking of the undercarriage pivot as per Item 13 is detected and the damage is such that rewelding the cracks is not possible then a new steel fitting made from laminated steel in accordance with MOD 88/16 may be installed.

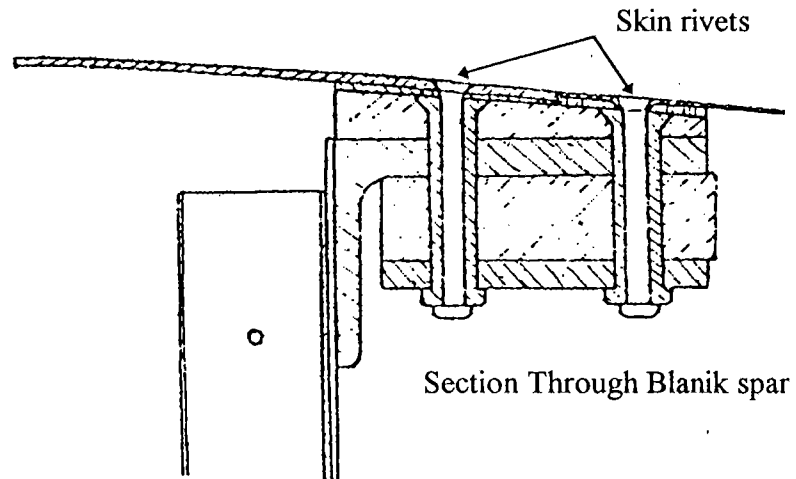
Figure 21 Rivets prone to looseness

GFA AD 53 requires among other things the checking of the rivets in the flangeplates of the wing spar (in the area about 200 mm from rib 1) for looseness.

Because the rivets are difficult to replace a GFA approved modification is available as MOD 86-2 available from the GFA Secretariat on request.

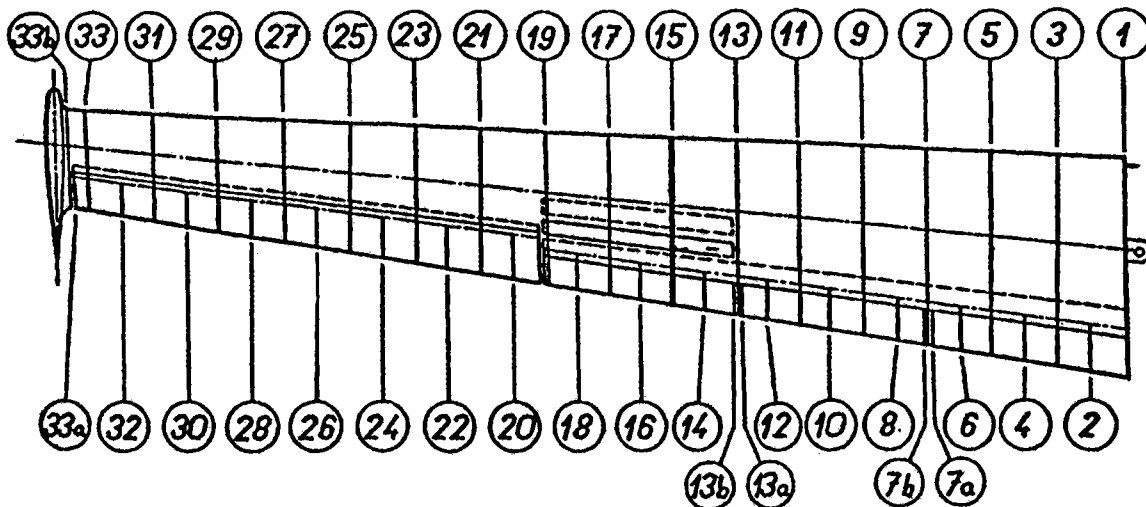
Figure 23 Wing Stations

STATION 25. Some Blaniks (but not all) have a butt joint between the leading edge skins at this station which has been found to have enough working rivets to reduce the wing frequency by 10 cpm (or more). The rivets were not obviously loose or working and they were only found after careful inspection which included lightly loading the wing tip with the wing on trestles (one at the root end and one just inboard of station 25) and using a magnifying glass to watch the rivet lines take load and noting the loose ones.

STATION 7. At this point on the top of both wings, over the main spar, three skins come together such that they make a small hole, over the spar, which will allow moisture into the wing, onto the spar cap and very severe corrosion has occurred in one case.

If corrosion has started in the top spar cap, or between the top cap and the inside of the top skin, it may be visible as a bulge in the skin between rivets. Bulge's between rivets can also be the result of manufacturing technique or flight overload.

Any spar cap corrosion is serious and may require a major repair to the cap. GFA approval must be obtained from the CTOA for any repairs to the spar caps.

Blaniks were originally manufactured with a "varnish" applied over the external skins and the skin joints sealed with the same material to keep moisture out. With time and use that varnish disappears and should be replaced particularly along all wing skin joints. If this is done be very sure that there is no corrosion already present which you may simply cover up.

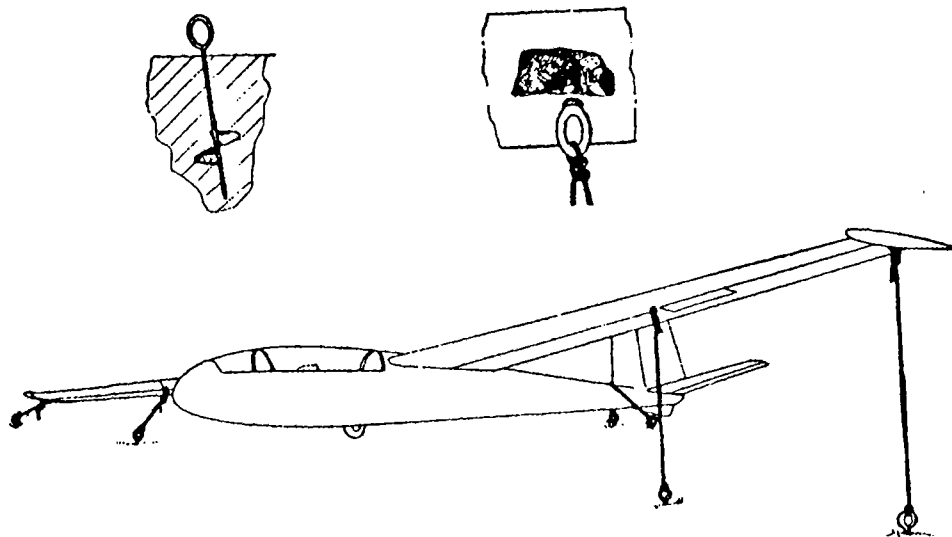
Figure 24 Tie down points

The Blanik has two tie down points per wing (4 total) one at each wing tip and one about half span in the underside of each wing which ensures that the sailplane can resist strong winds without overloading the wings which can occur if only one set of tie downs are used for anchorage. There have been cases reported where the outer wings of a Blanik were bent up in very strong winds because only the inner tie downs had been used.

Obviously a little care should be exercised to have the rope tensions evenly balanced to properly share the wind loads.

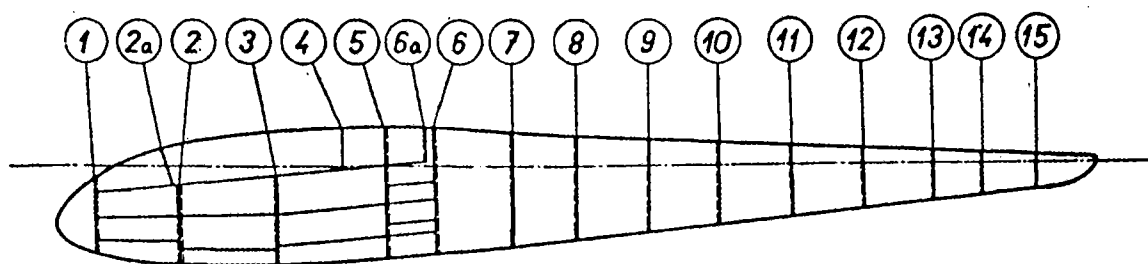
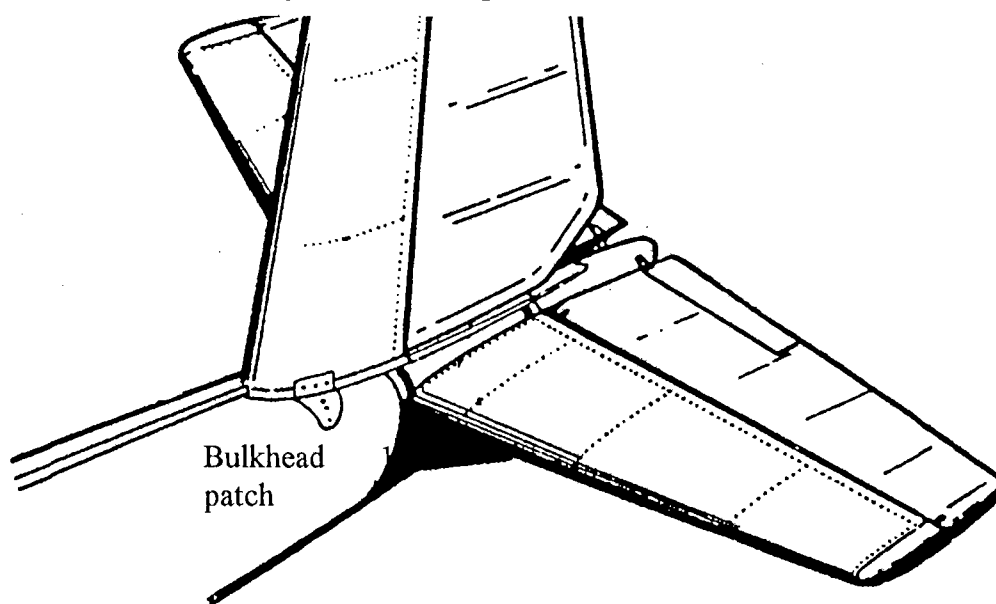
Figure 27 Patch for bulkhead 13

A number of Blaniks have experienced cracking of bulkhead 13 at the top of the frame directly under the fin. Because of the large amount of work necessary to repair this bulkhead in relation to the relatively light frame a repair scheme has been developed which places a doubler over the fin and fuselage to transfer the loads. The bulkhead is left in place without repairing the crack.

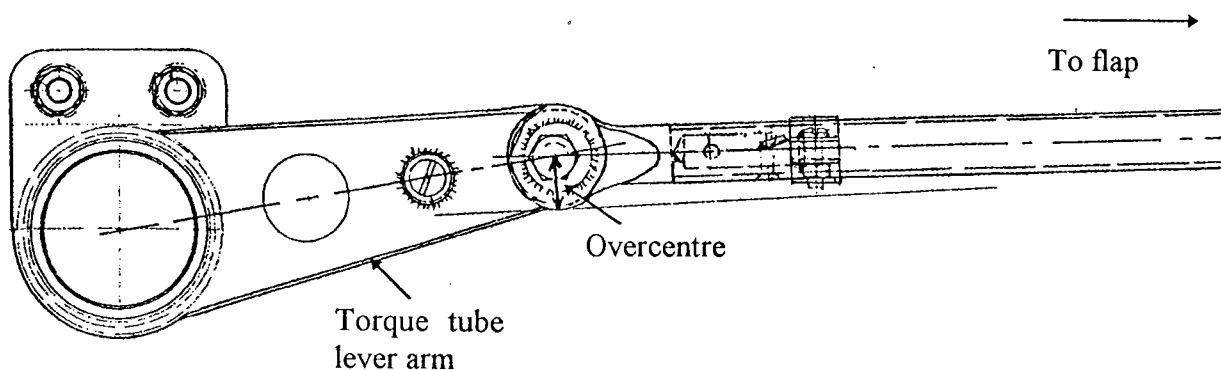
Figure 28 Flap drive mechanise full extended

Over the years Blaniks have been prone to high closing loads on the flaps. The problem is caused because the mechanism overtravels allowing the torque tube to take the flap pushrod overcentre.

The overtravel of the system should be adjusted out if possible or a stop may be fitted to the wing which prevents the torque tube lever arm from going over centre.
