## AIRWORTHINESS ADVICE NOTICE

TYPE AFFECTED: LS 3, LS3a and LS 3-17.

SUBJECT: Miscellaneous airworthiness information.

| <b>GFA AN 54</b> | <b>ISSUE: 5</b> | <b>5 April 2023</b> | <b>Page 2 of 3</b> |

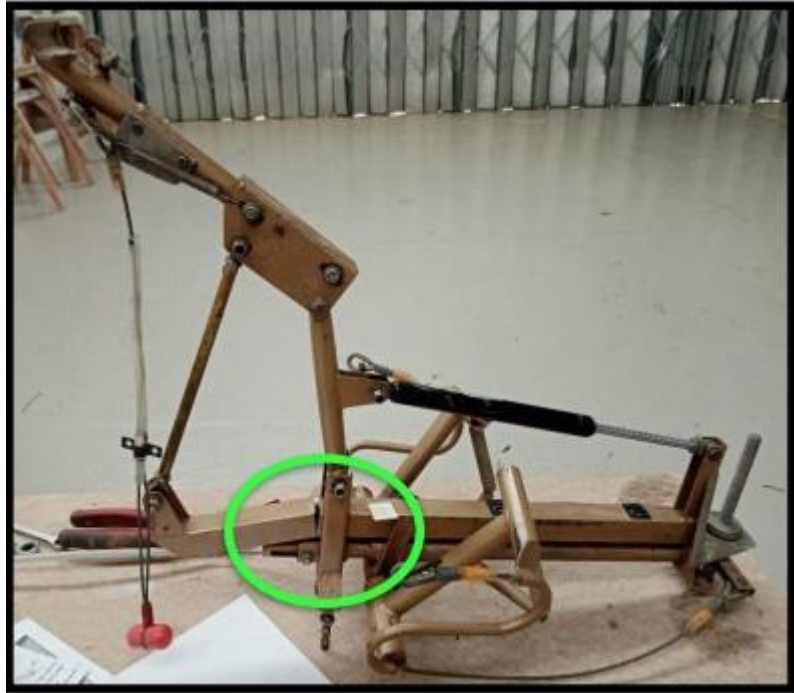
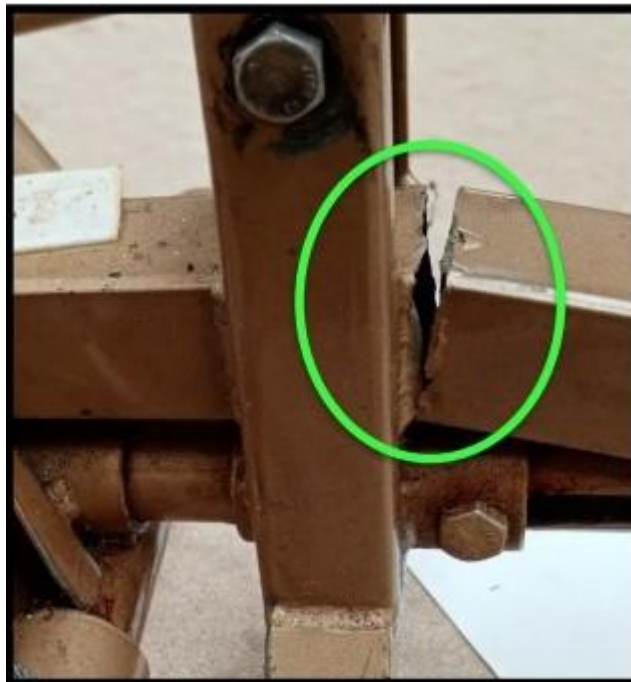
2. There have been defect reports received both here and overseas relating to canopy support structure failures in LS1, LS3 and LS4 type sailplanes.

The canopy when extended is supported on a structure which is subjected to in service fatigue loads caused by opening in windy conditions and tow-out with canopy unlocked (causing bouncing on the strut).

The fatigue accumulates and can result in failure of the lower 25 x 25 mm square (fore and aft) structure anchored to the floor. This tube is thin walled (<1 mm) and generally fails towards the rear end of the central tube. Refer photos.

Repair welding work requires the four floor mounting points to be jugged to ensure the geometry is maintained and the part fits back in place. The repair should be carried out in accordance with an engineering order or approved data equivalent.

It is highly recommended that the area be inspected for defects or cracking at every Daily Inspection.
