# THE GLIDING FEDERATION OF AUSTRALIA

## AIRWORTHINESS ADVICE NOTICE GLIDER/POWERED SAILPLANE

GFA/AN 57

SUBJECT: The likelihood of winch or aerotow cables catching on tailskids and other protrudances.

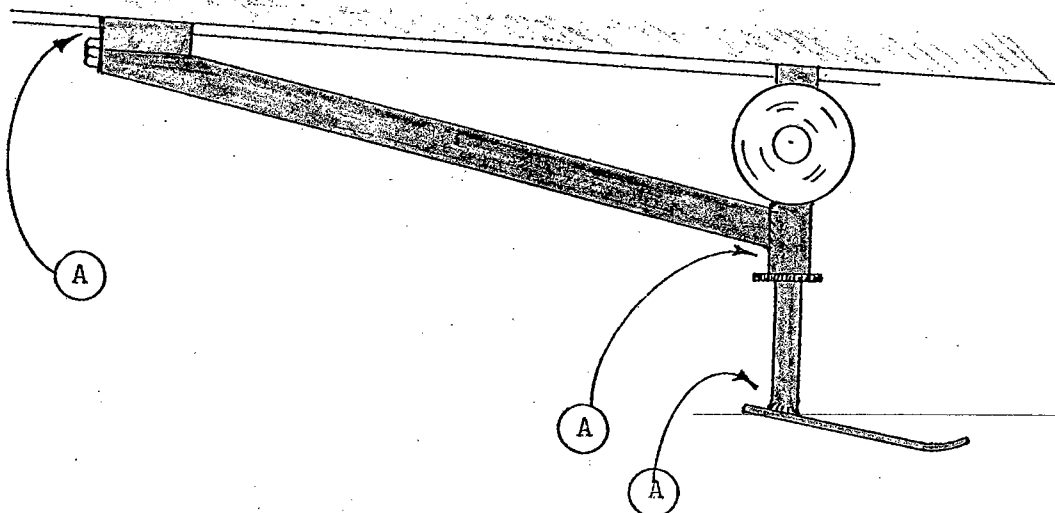
The sketch below shows a modification of a Blanik tail wheel assembly, carried out after the standard swivelling wheel became unserviceable.

The modification kept the sailplane operating, and was probably nearly as good as the original installation, but it introduced three points of concern.

The points marked "A" presented themselves as slots that could trap a tow line in the event of a winch launch malfunction.

The prospect of having a DEPLOYED drogue chute trailing along behind the sailplane following a broken wire half way through a winch launch should have been obvious to everyone concerned with the operation.

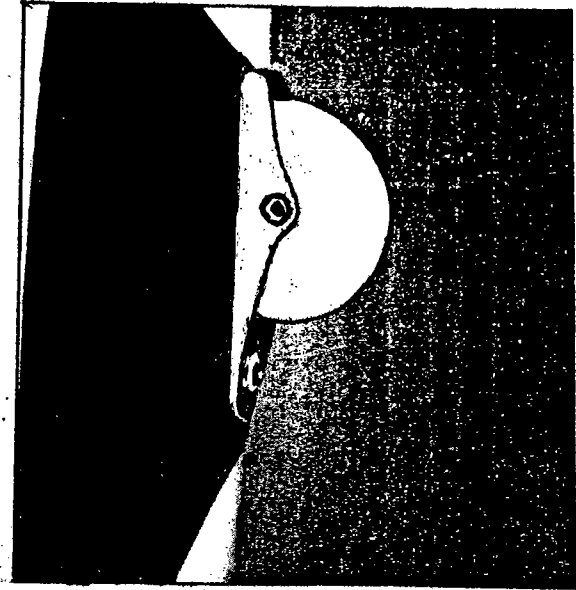
Fig. 9 Modification of Cirrus tail skid

With respect to the modified version of the Cirrus tailskid, presented in figure 9, it has to be said that also this design allows a cable to be caught. If the wheel is blocked by, for example, dirt a steel cable may "saw" into the wheel.

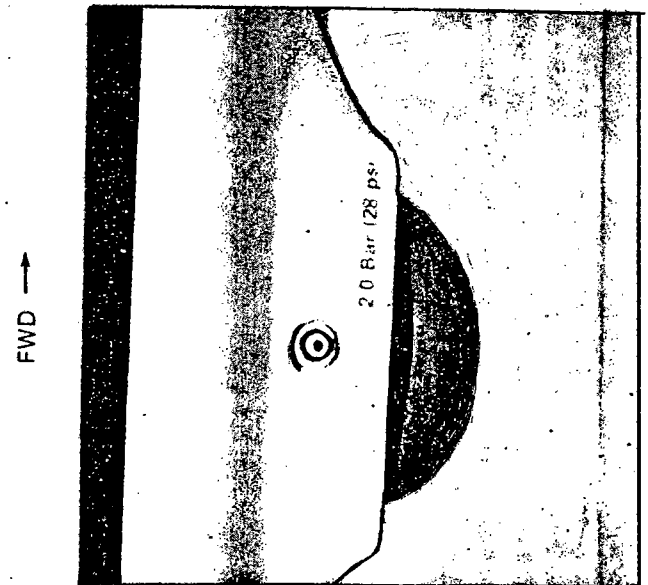
Fig. 7 Tail wheel of Pik 20

In general it is advisable for tail wheels that protective structure is present below the axis of the wheel, see figure 7.

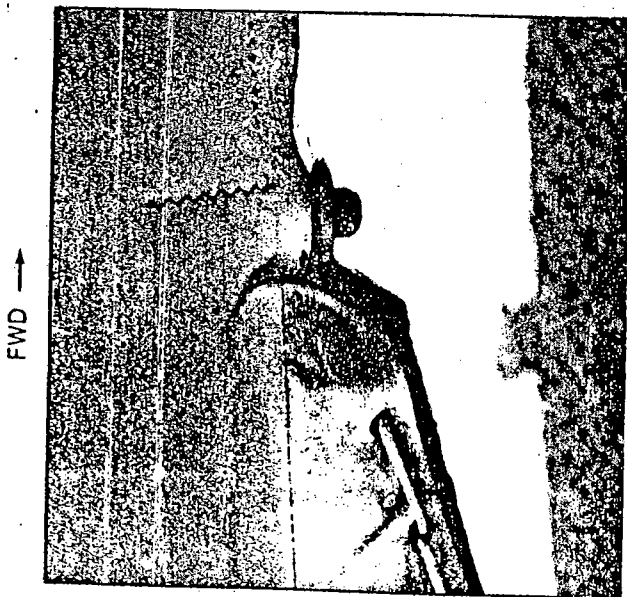
Fig. 10 Detail of tail skid of Ka-8

In figure 10 a detail is presented of figure 3.

The chances of catching a cable are remote. However, sometimes a longer bolt end is used or a ring between skid and fuselage or the forward flat part of the tube is bent. In such cases it is possible to catch a cable. In the past protecting plates have been used at this location. Good maintenance may solve the problem.

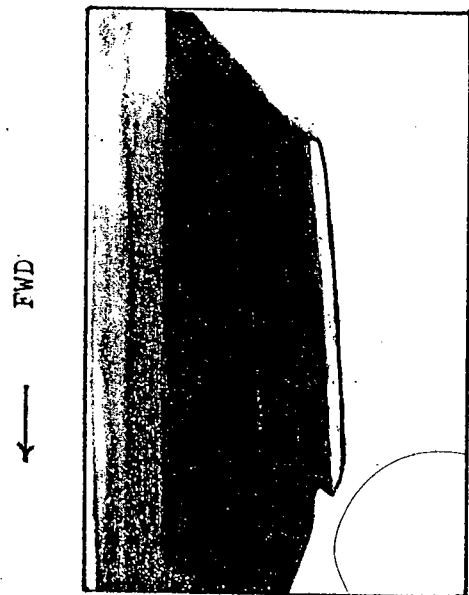
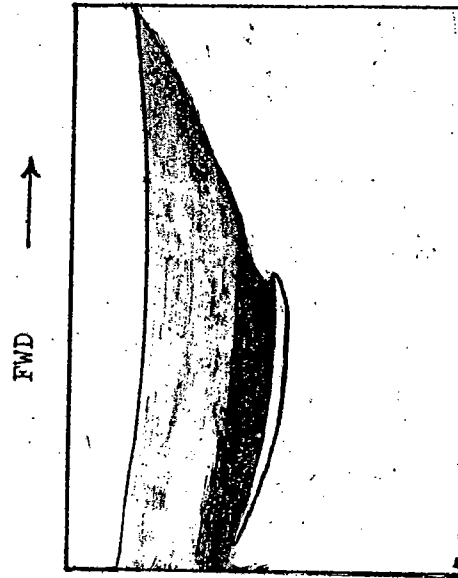
In figure 11 and 12 examples are given.

In these cases indeed deformation of the synthetic rubber block was experienced.

Fig. 12 Detail of tail skid of ASK-21

Fig. 11 Detail of tail skid of Astir

By regular inspection deformation of the synthetic block can be found. However, this inspection has to be done frequently because the problem may result from only a few flights.

A solution to the problem may be to increase the density and so the stiffness of the rubber block at least locally at the forward side. Further, care should be taken that the metal wear plate does not stick out in forward direction with respect to the lower side of the synthetic rubber block.
