AIRWORTHINESS ADVICE NOTICE

Astir CS
Astir CS 77
Astir CS Jeans
Club Astir II
Standard Astir II
G 102 Club Astir III
G 102 Club Astir IIIb
G102 Standard Astir III

Miscellaneous airworthiness information.

**THE GLIDING FEDERATION
OF AUSTRALIA**

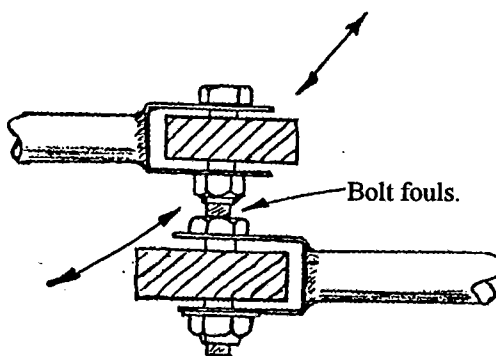
FIGURE 1 BOLT INTERFERENCE

- MAINTENANCE NOTES: 1. Divebrake/aileron system interference. With the divebrakes fully out and the ailerons deflected full right the bolt connecting the left hand side dive brake rod end to the forked aluminium casting fouls the aileron push rod end bolt. This is caused by installing the bolt with the head up. The bolt must be installed with the head down.

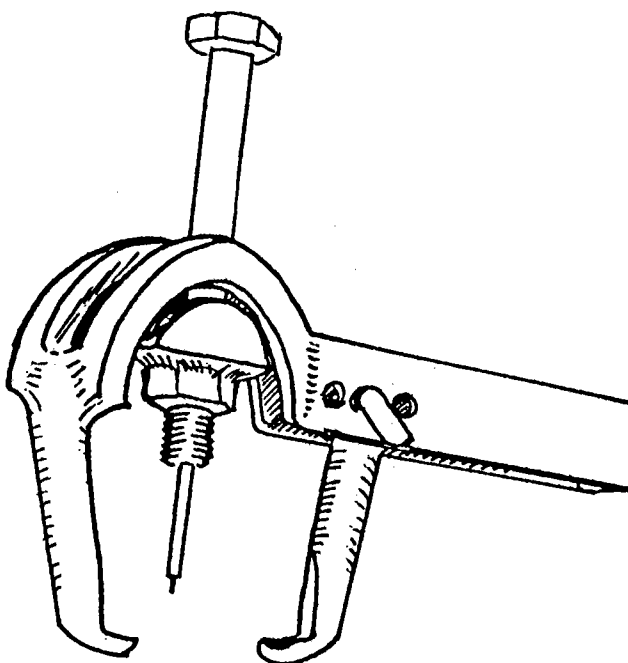
FIGURE 2 HINGE PIN REMOVER

3. Hinge roll pin removal. The most common method of removing the ailerons and elevators is by use of a hammer and pin punch. This type of impact can be quite damaging to the hinge and its attachment to the main structure. The following sketches have been offered by one of our inspectors as an alternative tool for roll pin removal, which does the job quite well and may prevent delamination of hinge attachments. (See GFA AD 213.)

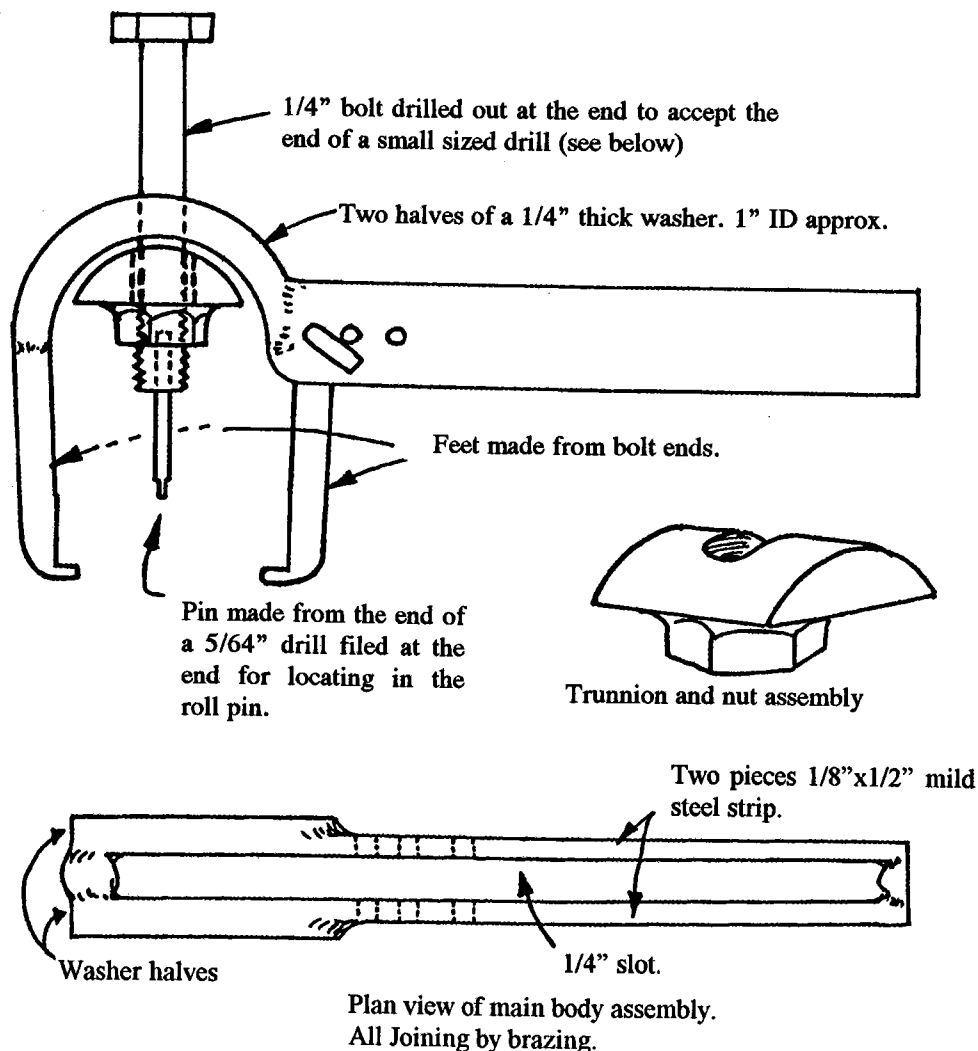
FIGURE 4 REMOVER TOOL DETAIL

The tool has to span differing hinge lengths of 30 mm, 35 mm and 42 mm. The holes in the main body assembly are drilled to suit these spans.

The feet are chiselled out at the 'instep' to suit the diameters of the hinge pin ends otherwise they will slip off when the bolt is being wound down and damage the aircraft finish. For Roll Pin insertion use another bolt in the tool with a flat ground end.

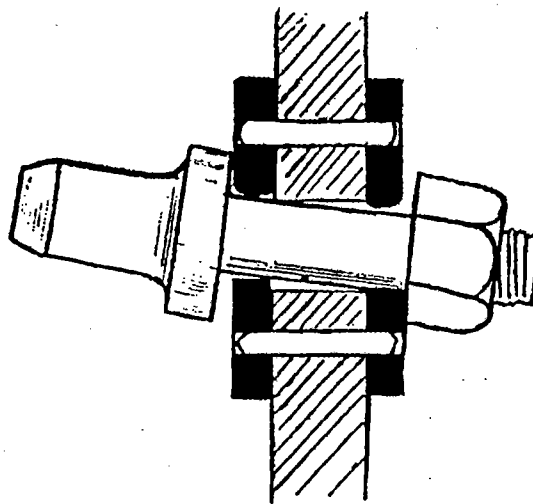
FIGURE 5 TAILPLANE PIN INCORRECTLY INSTALLED

4. Installation of tailplane/fin locating pin (CS, CS 77). One of the contributing factors in the problem of these pins cracking in service may well be the way they are installed.

The following sketch shows by exaggeration how some pins have been found to fit, which will result in overstressing the flange when the nut is done up. Also, sharp corners on the washers will "bite" into the radius at the root of the flange, also causing stress concentration.

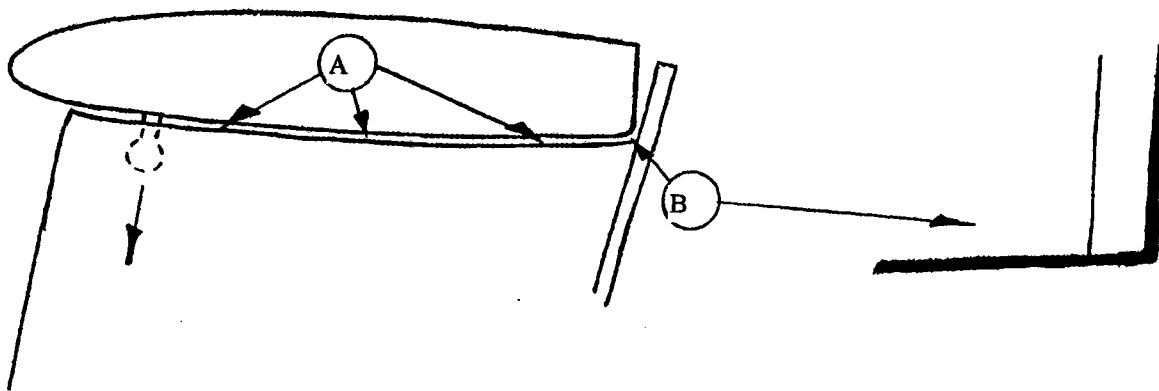
FIGURE 6 TAILPLANE FIN INTERFERENCE

7. Interference between tailplane and fin. One case has been reported of fin/tailplane interference prevented the front locking ball from engaging properly. This defect showed up as tailplane freeplay and may have resulted in disconnection of the tailplane in flight.

Top surface of the fin was relieved (see "A") to provide clearance between bottom surface of stabiliser and top of fin allowing ball to move further into the correct position. However, (see "B") a wrap of glass and resin was overly thick and prevented the stabiliser from moving fully back. The excess was removed allowing the stabiliser to move back and the ball to engage the seat in the correct position.

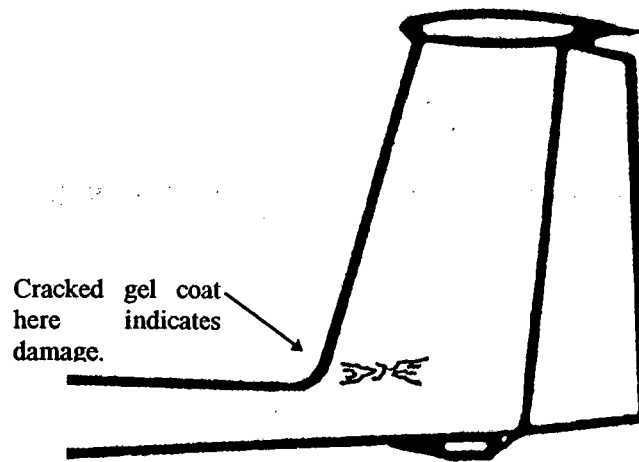
FIGURE 7 FIN DELAMINATION INDICATIONS.

9. Fin structural damage. Several cases of fin damage have been found following ground loops or flight incidents where the fin has applied substantial torsion to the rear fuselage boom, causing internal crushing of the horizontal rib, evidenced by gel coat cracking at the base of the fin near the fin leading edge.

This type of damage may not be obvious to the eye and applying load to the fin may not show excessive distortion or structural "softness", however by listening closely at the cracked area while the fin is loaded will result in hearing broken epoxy and glass rubbing together.

By 1984 there were 4 reported incidences of fin delamination. Should delamination be found it must be reported to the CTOA.

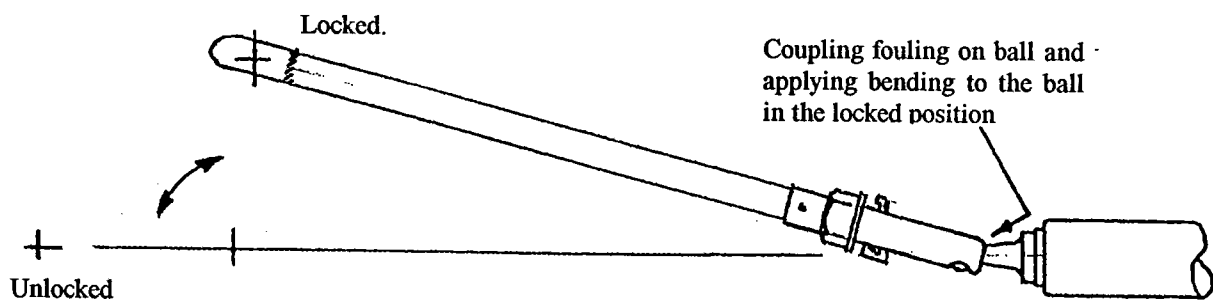
FIGURE 8 DIVEBRAKE PUSHROD INSTALLED INCORRECTLY

11. Incorrect assembly of dive brake coupling. If the right hand dive brake pushrod is installed upside down the L'Hotellier coupling can bind up with the dive brakes locked as illustrated. This is usually severest at 1/2 brake travel.

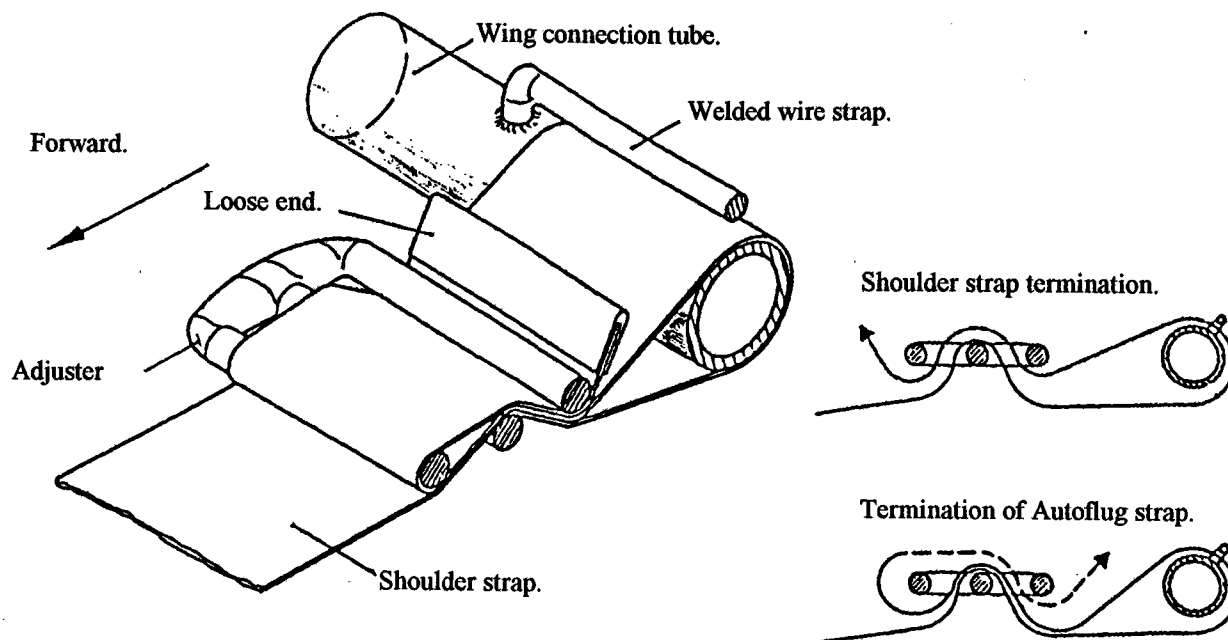
FIGURE 9 HARNESS INSTALLATION

12. Shoulder harness attachment. Occasionally during Daily and Annual Inspections the shoulder harness straps have been found installed incorrectly, the shoulder straps were found looped over the small diameter wire strap, instead of wrapped around the front wing connection tube.

The wire strap is there to locate the shoulder strap sideways and has no other purpose.

The illustration shows the correct shoulder strap location and the correct method of finishing off the end of the shoulder strap through the adjuster.

Note: Autoflug require the strap end to be folded back through the adjuster as in Sketch (b).

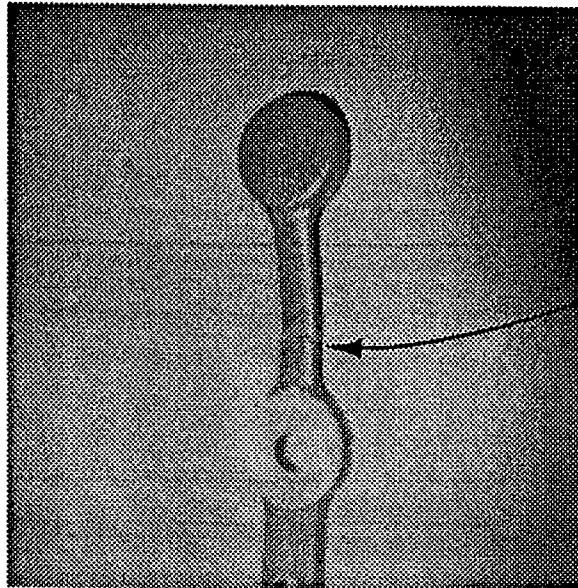
FIGURE 10 FAILED TRIM LEVER

In one case a pin hole in the plastic allowed sweat to contact the aluminium which caused a corrosion spot which then propagated as a crack and the lever failed.

Crack and failure
from pin hole in
plastic

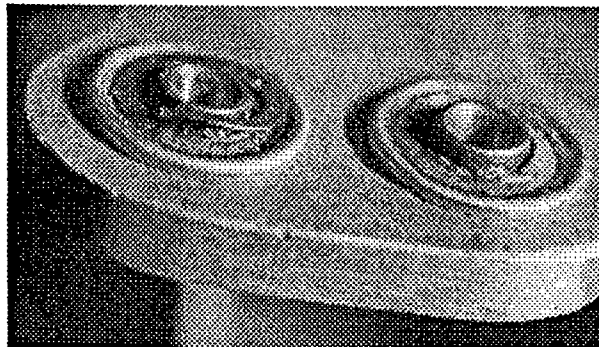
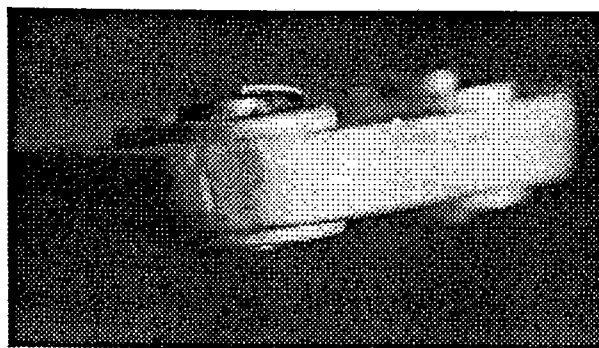
FIGURE 11 THE DISPLACED BEARING SEAL

During an Annual Inspection the metal seals on a number of control system bearings were prised out, apparently for the purposes of lubrication. These bearings are lubricated for life and require no routine lubrication. If a bearing seems to require lubrication it is faulty and should be replaced.

In the particular case someone tried to reinstall the seals and the end of the seal popped up and jammed the aileron circuit.

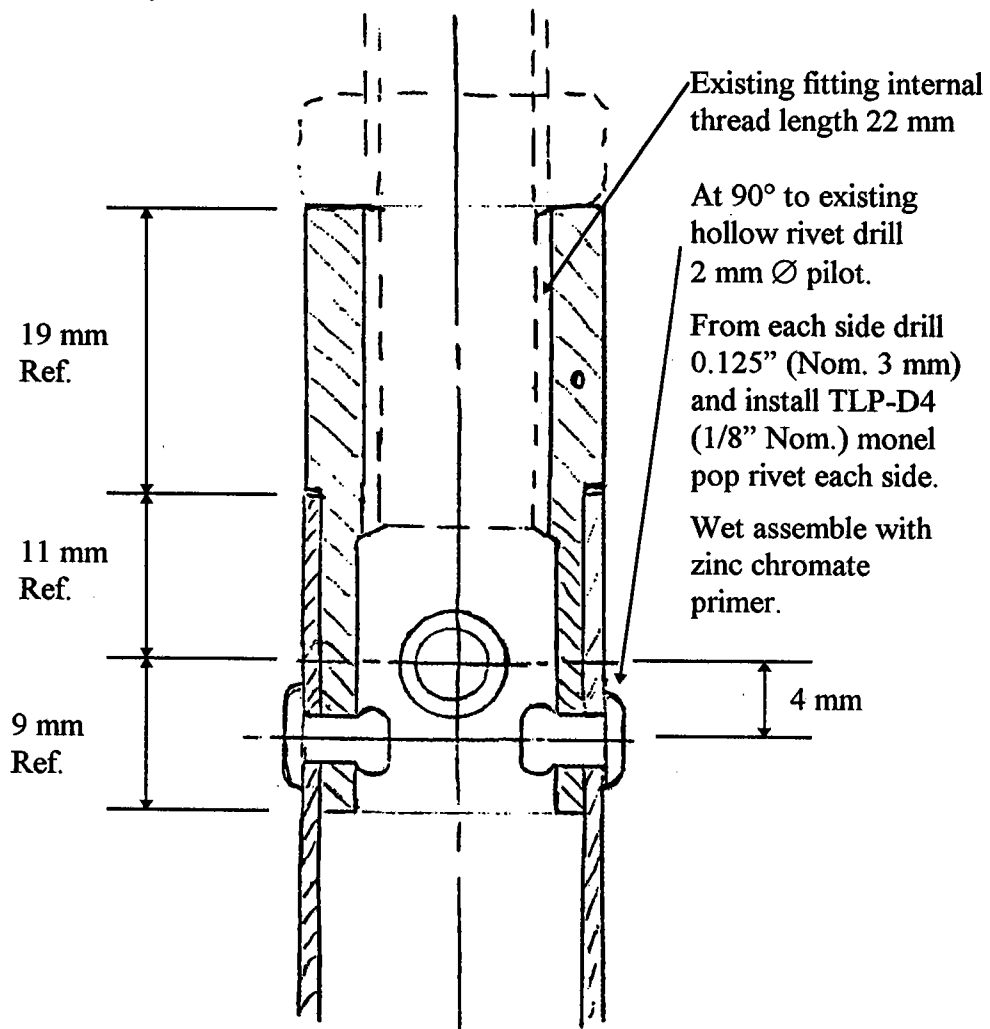
FIGURE 12 LOOSE ROD END REPAIR SCHEME

17. Loose elevator pushrod ends. A number of cases have been reported of loose elevator pushrod ends. The original design only used one tubular rivet to secure this part and so to remove slop a design involving the installation of two monel pop rivets has been developed by G. Sunderland.

Note: This repair scheme was developed for an Astir CS and if any difficulties are encountered with other types then the CTOA should be contacted so that any necessary variations which may be required are recorded in this AN.
