# The Gliding Federation of Australia Inc

## Occurrence Summaries

01/01/2011 to 31/12/2011

**The Gliding Federation of Australia Inc**  
**SOAR Accident and Incident Occurrences**

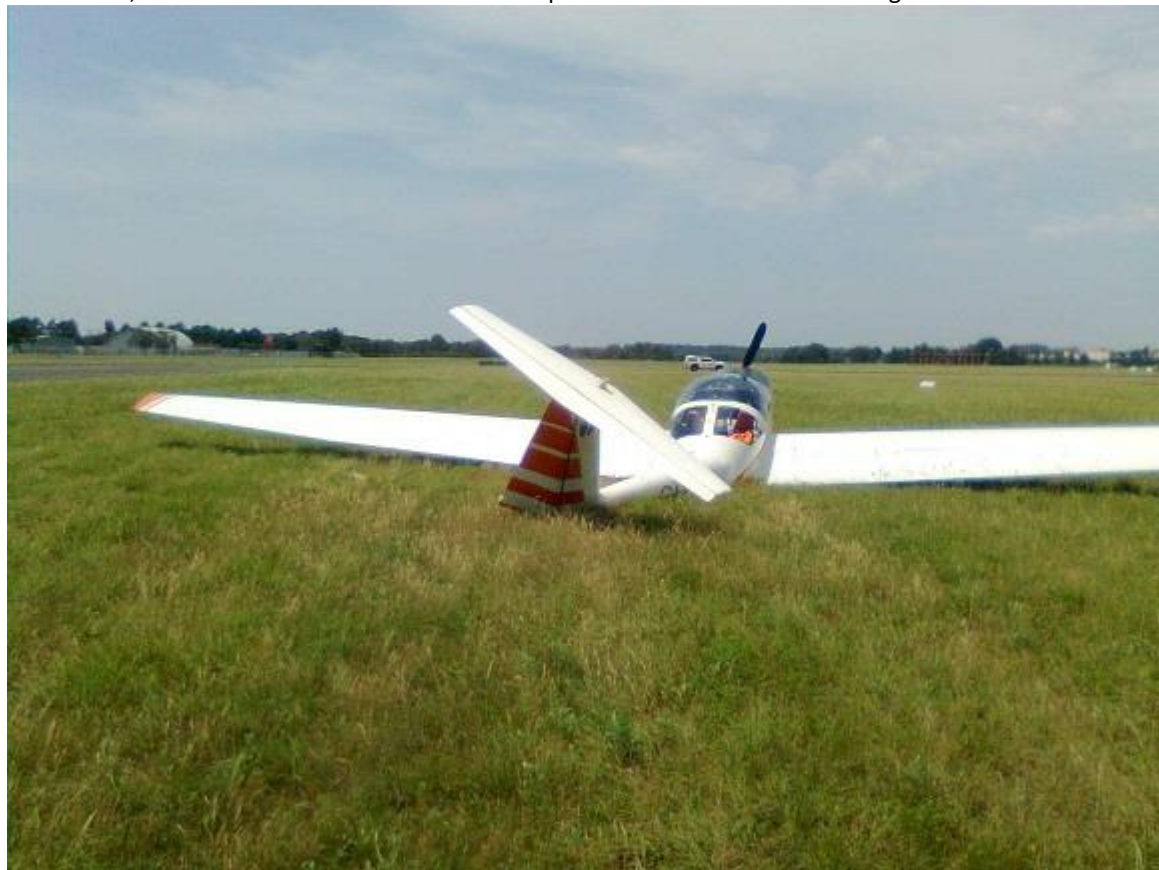
| Low level wind shear caused loss of airspeed and diminished control authority on approach while close to the ground. A subsequent wind gust could not be sufficiently countered and the left wing impacted terrain, resulting in a ground loop and the aircraft sliding backwards in the direction of landing. The tail wheel was | | | | | |

sheared off, the tail boom broken and the wheel spats and vertical fin were damaged.
