The Gliding Federation of Australia Inc

Occurrence Summaries

01/01/2013 to 31/12/2013

Accident and Incident Summaries

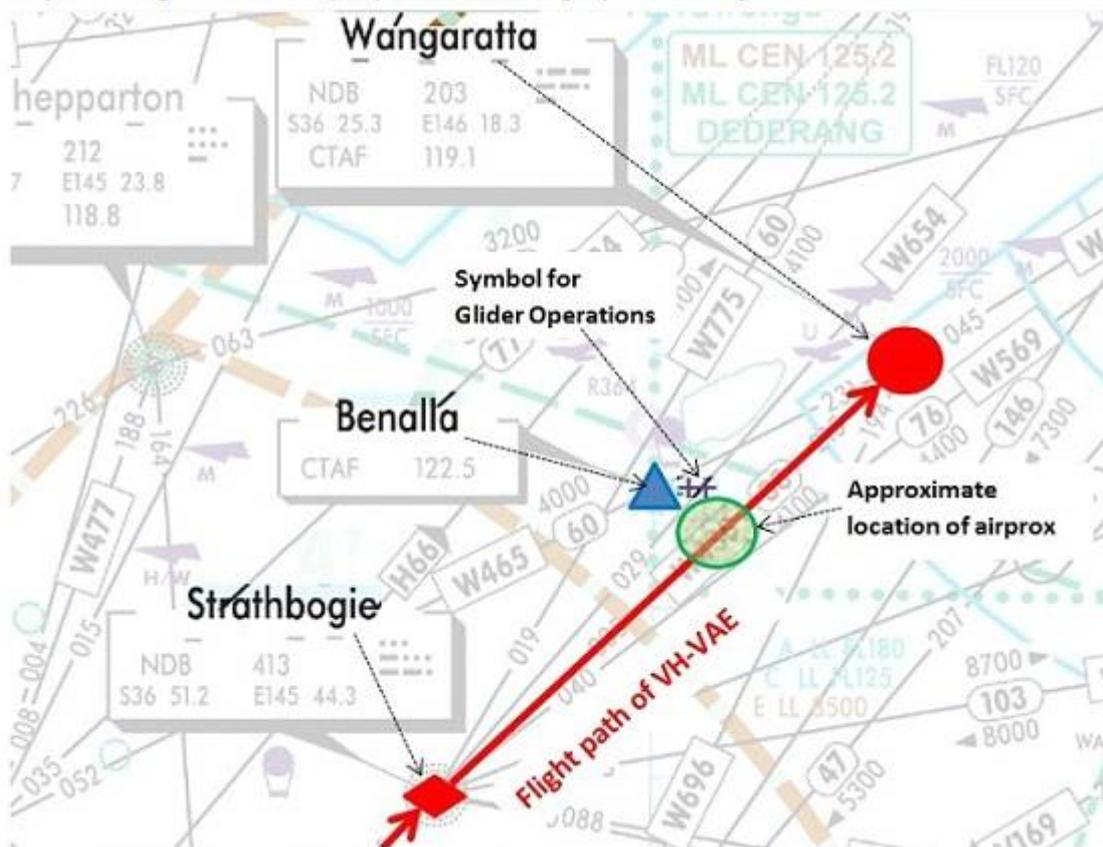
Map showing VAE's track (red) and the Gliding Operations symbol at Benalla

Date	16-Feb-2013	Region	VSA	SOAR Report Nbr	S-0230
Level 1	Airspace	Level 2	Aircraft Separation	Level 3	Near collision
A/C Model 1	Unknown		A/C Model 2	Hawker Beechcraft	
Injury	Nil	Damage	Nil	Phase	In-Flight
				PIC Age	
<p>ATSB INVESTIGATION - What happened</p> <p>On 16 February 2013, a Beech B200C aircraft was being operated on an aero-medical flight under instrument flight rules (IFR). On board the aircraft were the pilot and a paramedic. The aircraft was cleared by air traffic control at Flight Level (FL) 150 from Essendon to Wangaratta, Victoria, via the Strathbogie IFR reporting point. The flight path of the aircraft passed within about 5 NM of Benalla Airport. At 1453 Eastern Daylight-saving Time, the Beech B200C was about 15 NM from Wangaratta on descent through 6,000 ft above mean sea level, with an indicated air speed of 240 kt, when the pilot observed a white glider with red markings approaching at the same level. The pilot reported that the windscreen's central pillar may have obscured the approaching glider, as he first saw it about 150 m in front of his aircraft tracking from the 1230 to 1 o'clock position. The glider passed the left side of the aircraft with separation reducing to about 70 m at the same altitude. Due to the relative speeds of both the Beech B200C and the glider, the pilot of the Beech B200C did not have an opportunity to take evasive action, nor did he observe the glider take evasive action. The glider did not appear on the Beech B200C's traffic alert and collision avoidance system (TCAS), nor were any broadcasts heard from the glider pilot on the area very high frequency (VHF). Attempts to identify the glider were unsuccessful.</p>

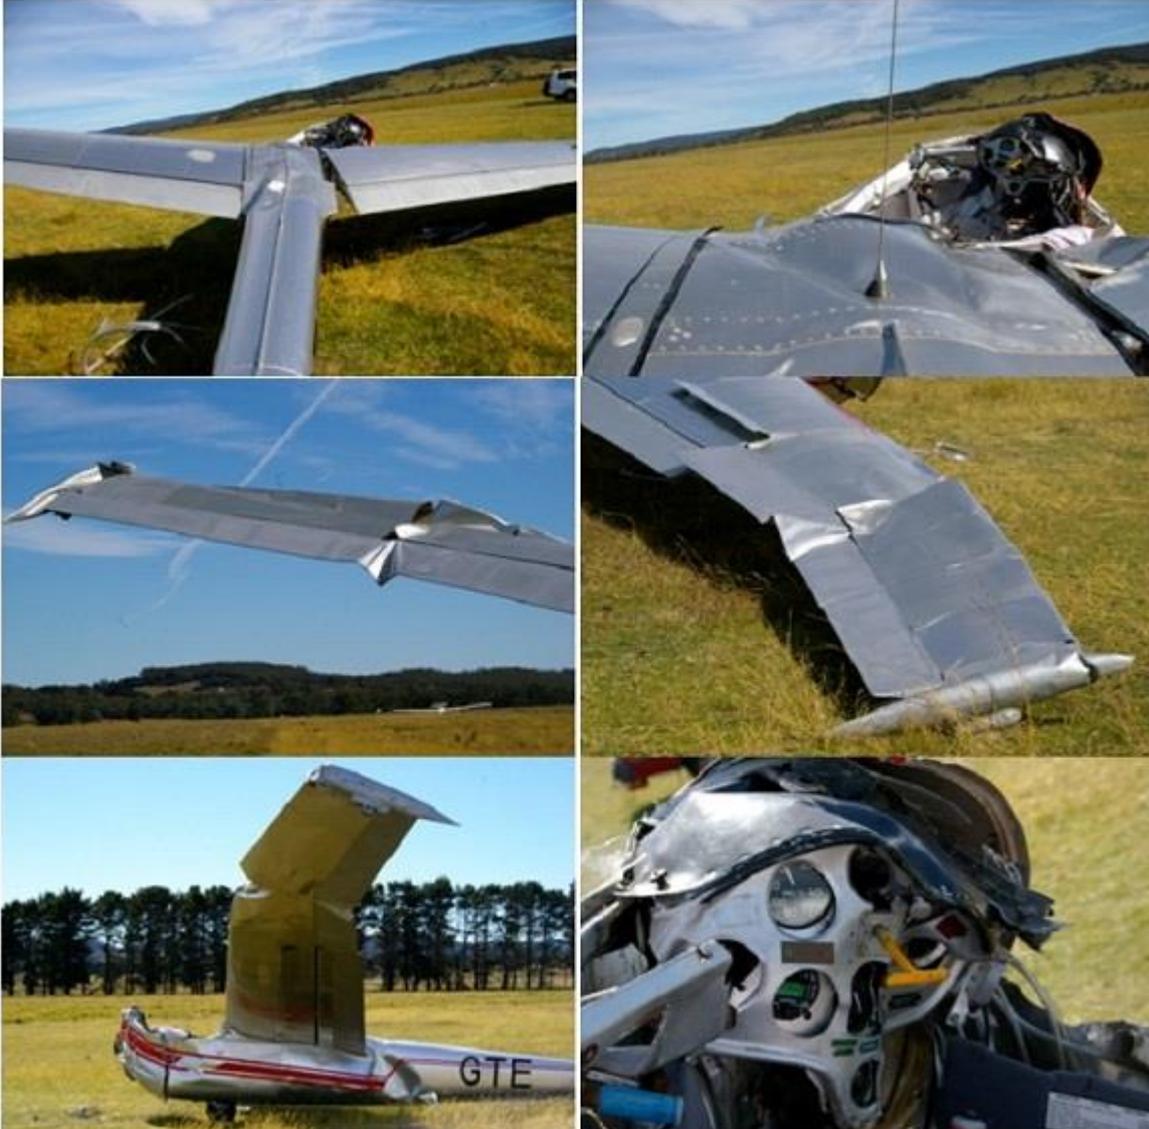
Ground Impact Damage Views of Blanik

- The impact of the collision destroyed the Blanik's rudder, severely damaged the right elevator, disconnected the actuating rods for both elevators, and severely damaged the right tailplane. Yaw and pitch controls were therefore lost. The Blanik command pilot reported disconnected controls. The Blanik was most likely completely uncontrollable from the instant of the collision onwards.

- Post-collision damage to Blanik was extensive, consistent with a high vertical kinetic energy collision with the ground from a stall.
- Post ground impact, the winch rope was found disconnected from the glider. This may have been due to the rope back-releasing from the glider's centre of gravity release mechanism during the pitch-up manoeuvre post-collision.

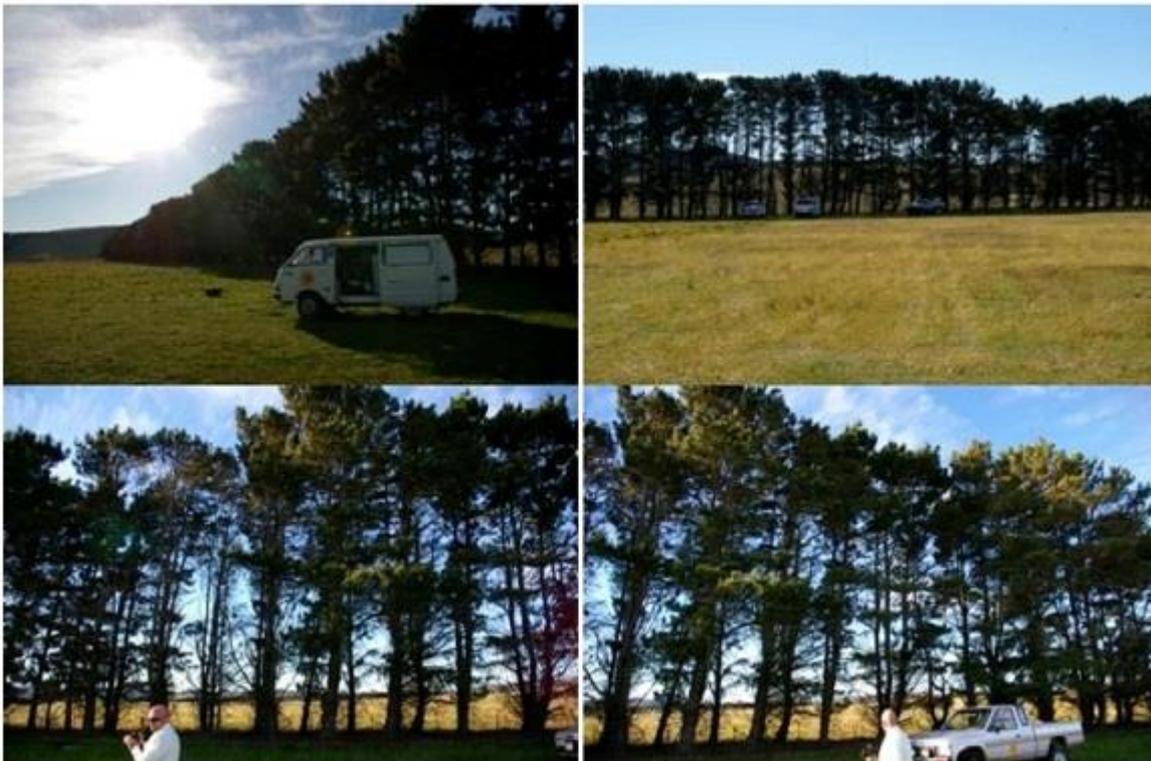
Launch Point Views at Threshold of Runway 23

limited positions on the base leg. It was not visible on the final approach path. With a flight path corresponding to a moderate approach on Runway 23 and 50ft obstacle clearance over the pine trees, the first 75 metres of the runway were not visible for much of the approach, due to obscuration by the trees. A shallower or flatter approach path would cause the trees to have obscured more of the runway length. The Blanik crash site was about 150 metres from the launch point. When the Mini-Nimbus was passing over the pine trees, the glider blind arcs forwards and below would have obscured the launch point and Blanik from view. A displaced threshold for the launch point, more distant from the pine trees, would have been required to reduce their apparent elevation. This was compounded by operational decisions made that day that did not achieve required separation of launching and landing operations. The operations crew did not use an alternate, laterally displaced landing area such as Runway 23 Left, due to long grass growth, infrequent mowing and presence of stock; and also conducted both launches and landings from the same runway, without a displaced threshold that might have improved visibility of other gliders in the circuit area.

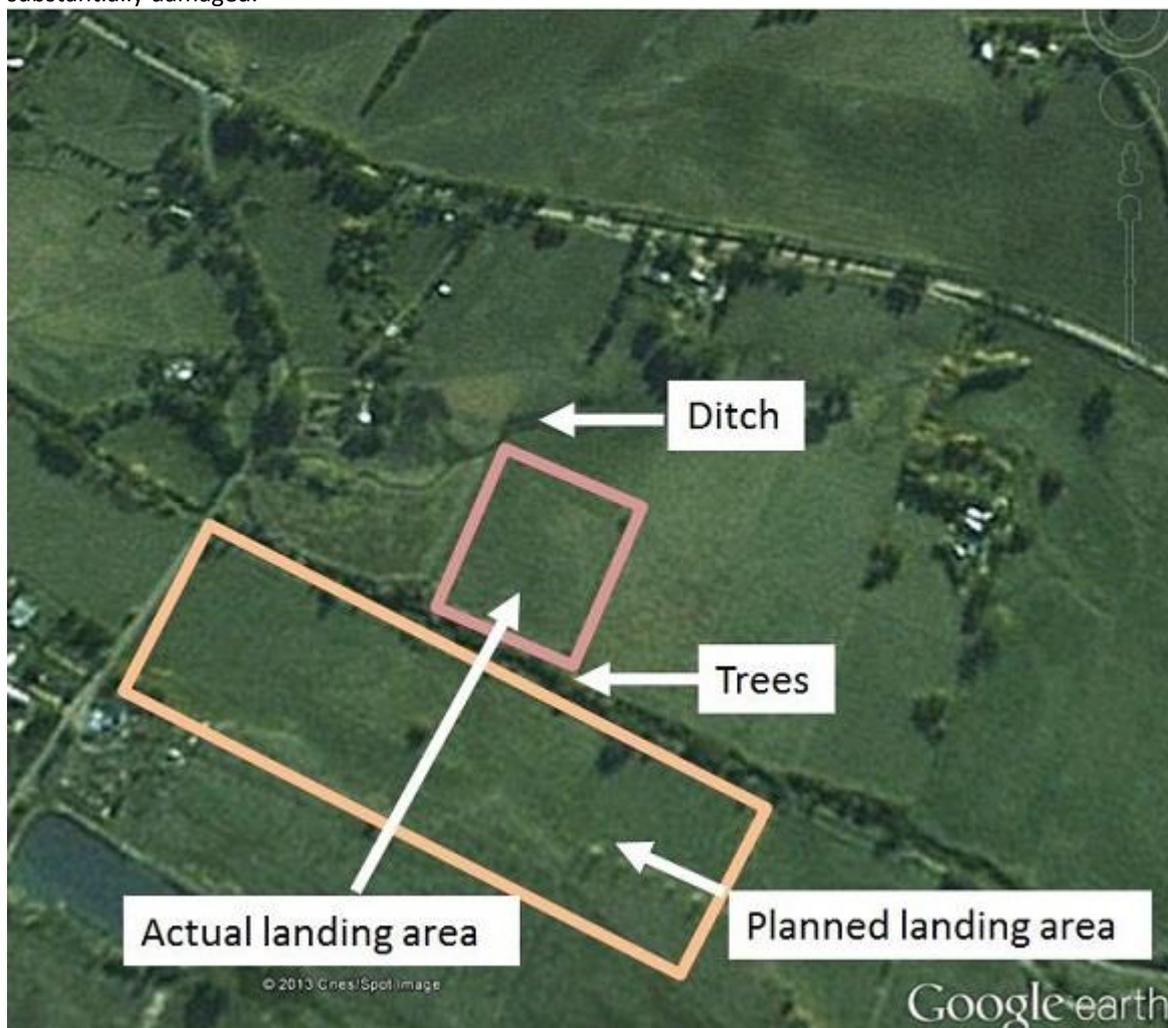
Figure 1: Landing area

waiting to be towed aloft, the pilot discussed his plans with the chief flying instructor, who advised the pilot that there would be better lift to the southeast of the airfield as indicated by the presence of cumulus clouds. The pilot then amended his planned flight to follow the clouds and lift to the south-east of the airfield. At about 1320, the glider was launched and climbed to about 4,500 ft above mean sea level, overhead the airfield. The pilot tracked towards a quarry and a series of small hills and then followed the clouds to the south-east. While flying, the pilot maintained a lookout below for suitable paddocks for an outlanding. Once over the hills, the pilot reported that at about 1430, the wind changed from a south-easterly to a south-westerly direction. The pilot reported that at about the same time, the Cu clouds dissipated and the lift disappeared. The pilot observed that the glider was not within range of a return to Benalla or the last suitable field he had identified, and commenced looking for a suitable field for an outlanding. The pilot identified a field about 1 to 2 NM ahead in a valley. The selected paddock appeared to be suitable, however, when at about 500 ft above ground level, the pilot observed that the surface had rocks and holes and quickly chose an alternative field. The alternative field was perpendicular to the planned landing area and the glider would be landing towards the north-east. There was a row of trees on the approach end of the field and a ditch at the far end. The pilot conducted an approach to the field and the glider passed over the trees at about 50 ft AGL. The pilot then attempted to reduce altitude and airspeed by conducting shallow turns and flying diagonally across the field. The glider landed heavily in the north-eastern corner of the field. The pilot sustained a serious injury due to the hard landing and the glider was substantially damaged.

This incident highlights the importance of pilots of recognising their abilities and limitations, and to ensure they feel confident with the planned flight. It is a reminder for glider pilots to keep a constant lookout for suitable fields in which to conduct an outlanding.
