GFA AD 600
(ISSUE 2)

GFA AIRWORTHINESS DIRECTIVE

TYPE AFFECTED: DISCUS bT Serial no's: 77, 106, 146, 151 up to & including 154, 156, 158, 161 & 162

SUBJECT: Wing,
bonding of spar cap to spar web

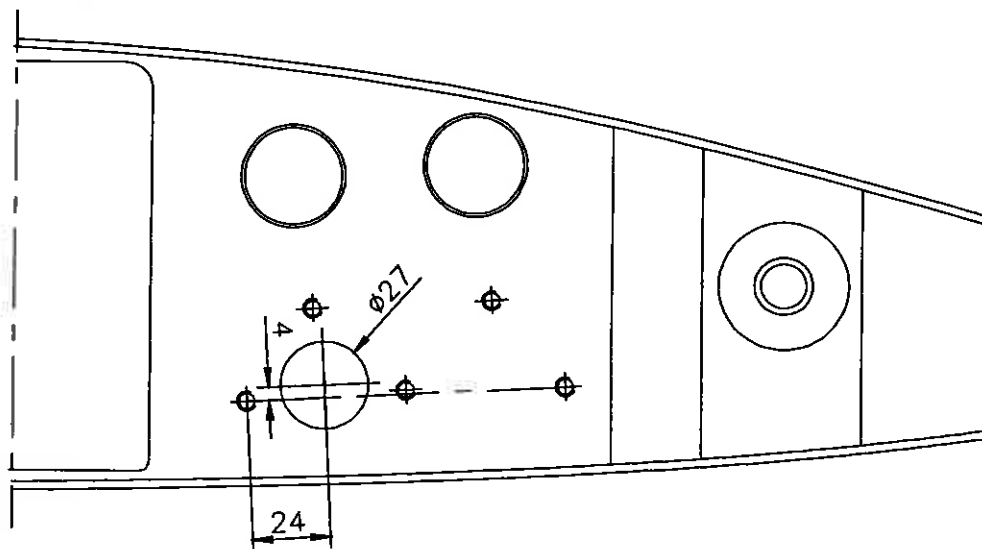
inspection opening in the root rib
(starbord root rib is shown, laterally
reversed on the port root rib)

- a) Remove the attachment fitting together with the bell cranks for airbrakes and ailerons at the root rib.
- b) Cut the inspection opening in the root rib, see page 6.

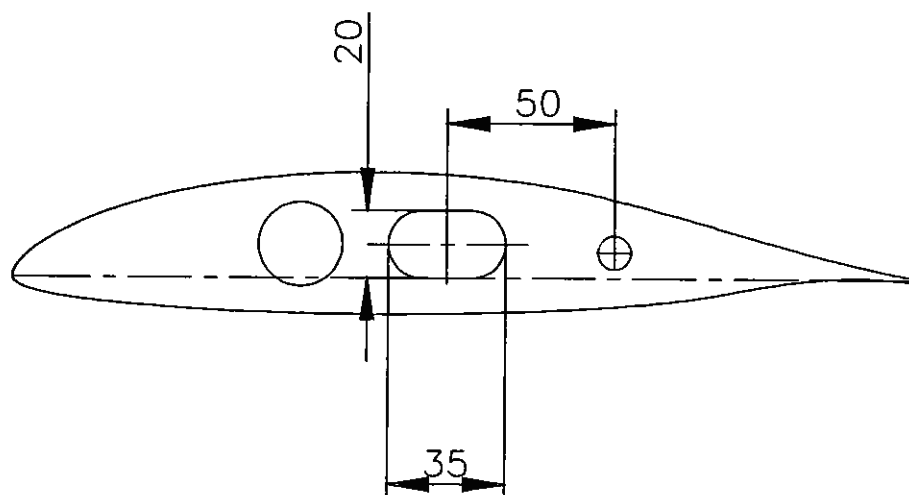
inspection opening in the outer wing rib
(only for aircrafts with winglets)

- c) Cut an inspection opening in the outer wing rib, see page 6.

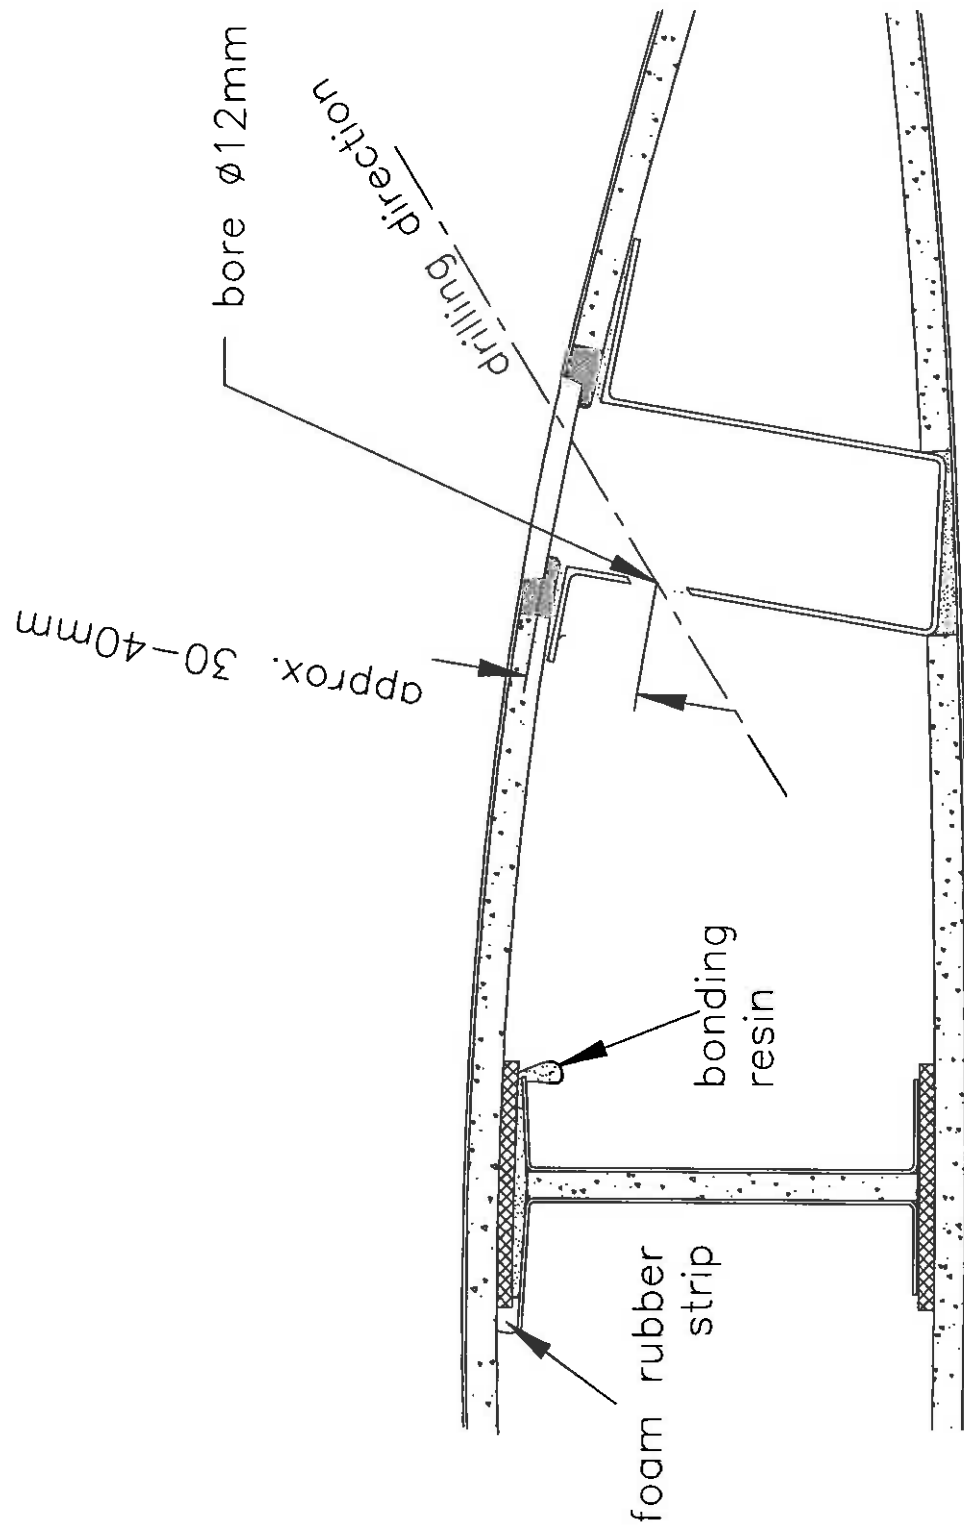
Wing cross section in the airbrake area

The bonding on the rear side of the spar cap and spar web on the upper wing surface has to be checked, see cross section on page 8.

It is required that the gap between GRFP-spar web and CFRP-spar cap is completely filled with bonding material.

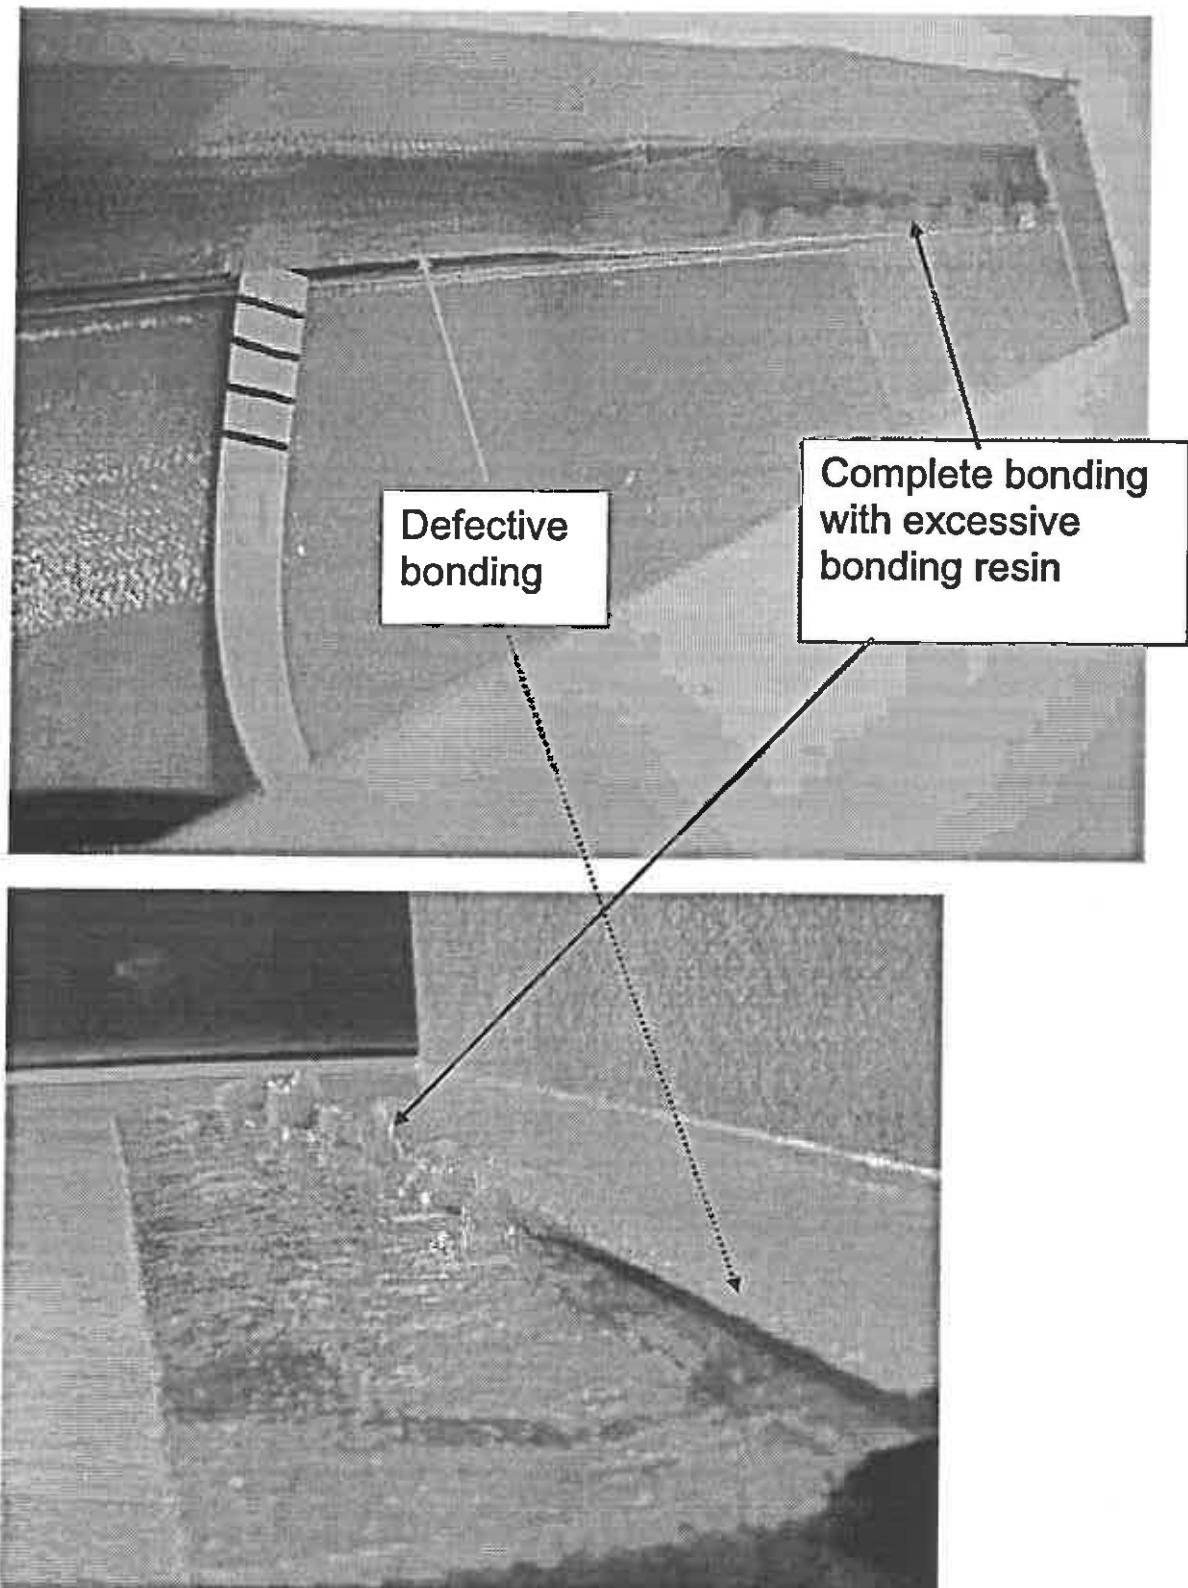
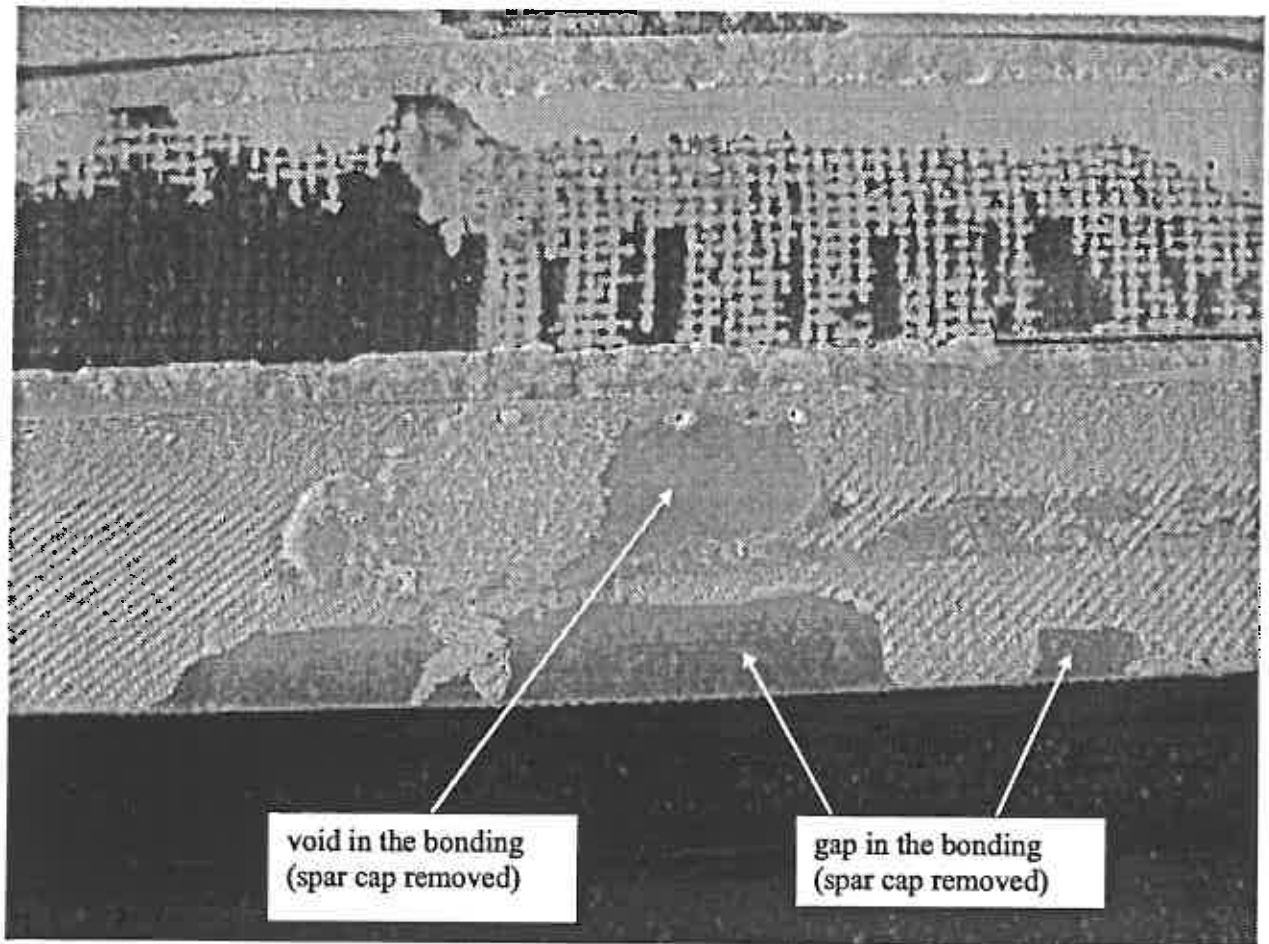
- a complete bonding with excessive bonding resin, see page 9
- a defective bonding – insufficient bonding resin, see page 9 and 10

When identifying the area of the gap, always investigate the extension of the void in span wise direction. Some photos on page 9 and 10 show examples of defects in the bonding.
