AIRWORTHINESS ADVICE NOTICE

TYPE AFFECTED: ASK 21 / ASK 21 Mi.

SUBJECT: Miscellaneous airworthiness information.

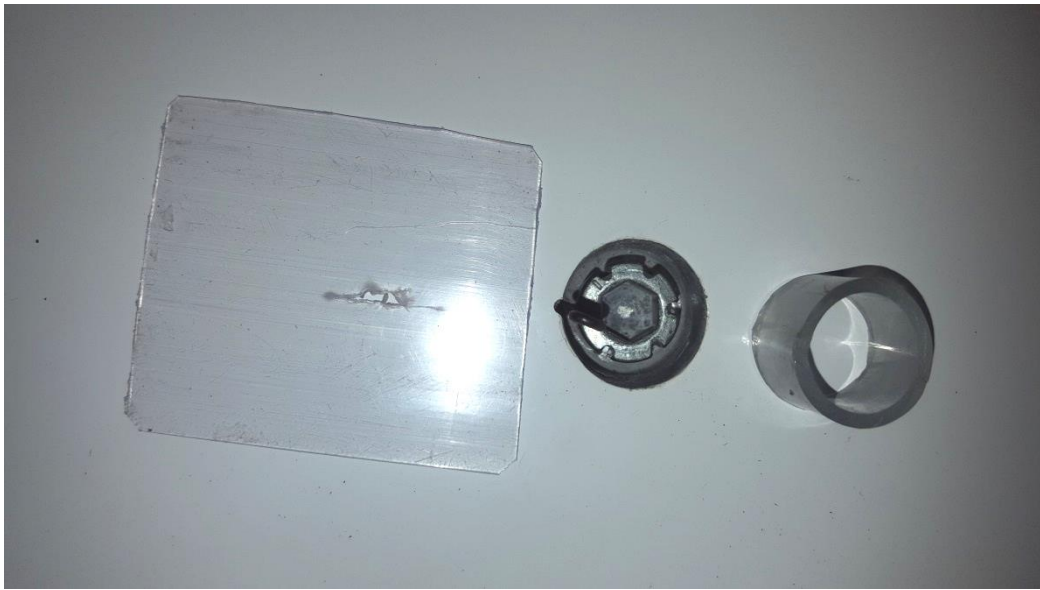
Figure 1: Vinyl Tube And Plastic Cover Adjacent To Tailplane Retaining Bolt

2. OPTIONAL TAILPLANE LOCKING PIN RETAINER. The GFA has tested 16mm (ID) clear vinyl tubing placed over the tailplane attachment bolt / safety pin assembly. The vinyl hose, when correctly positioned, ensures a positive lock of the locking spring prior to applying the transparent plastic cover as detailed in AWA 2020-4. Pope Clear Vinyl Tubing Joiner – 16mm or similar is available at your local hardware store. The hose is soft and flexible and will assume the hex shape of the bolt head. It should be cut relatively square at a length of 12-13mm (maximum 13mm). Note: when tubing length less than 12mm it can be more difficult to remove the tubing when derigging.

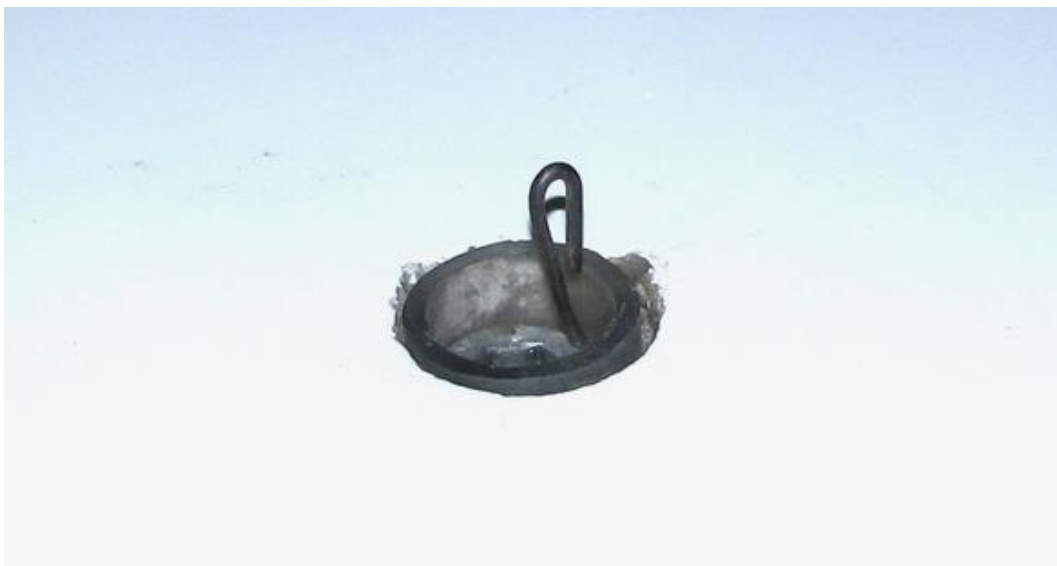
Figure 2: Vinyl Tube Inserted Over Safety Pin And Tailplane Retaining Bolt

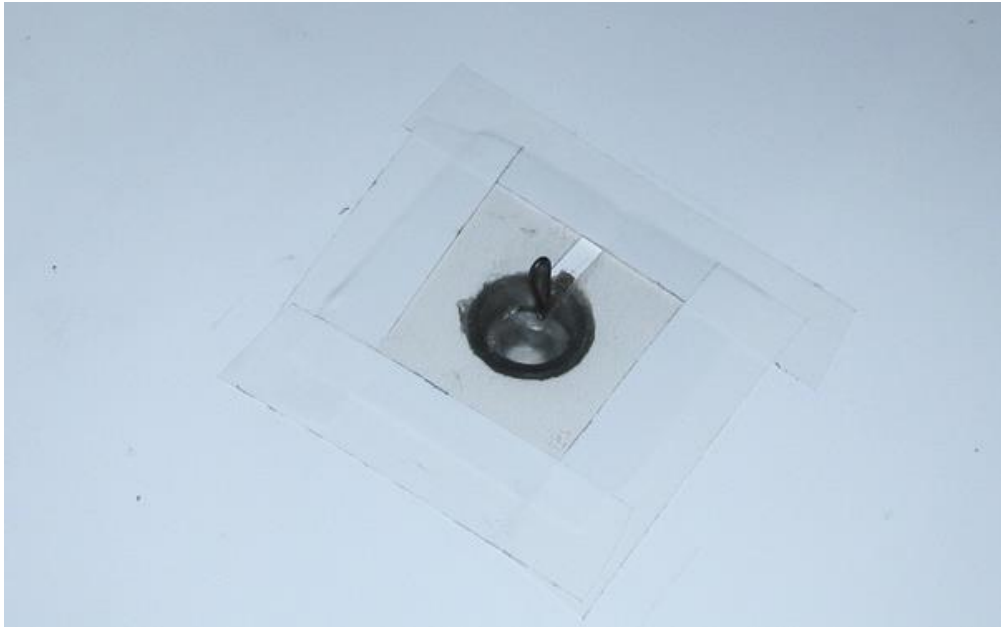
Figure 3: Taped Transparent Cover Over Vinyl Tube. Note Slot In Cover For Safety Pin

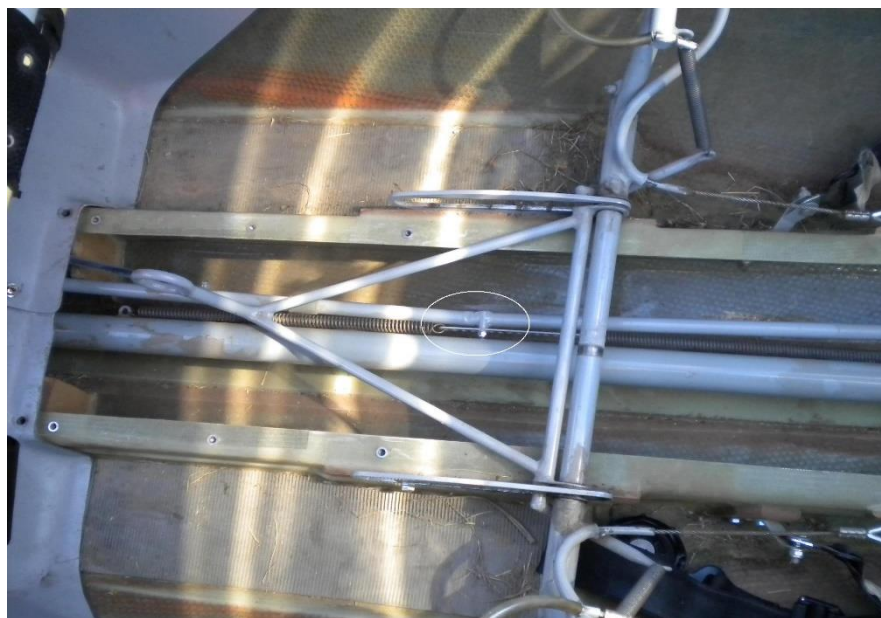
3. Whilst performing a pre-take off check, a restriction in the movement of the controls were identified. GFA AWA 2010-1 now cancelled was issued addressing the failure.

The restriction was caused by a bend (bent area circled above) in the pushrod connecting the front and rear trim levers. This bend resulted in the pushrod being displaced downwards into an area normally occupied by the aileron / elevator control tube. This in turn caused blockage of right aileron travel. The damaged rod can be seen only when the cockpit floor is removed. It was not identified how the damage occurred but there are two ways an excessive load to the trim

When performing annual inspections, or whenever the cockpit floor is removed, it is highly recommended that the trim connecting pushrod be inspected for any obvious bending damage or deformation.

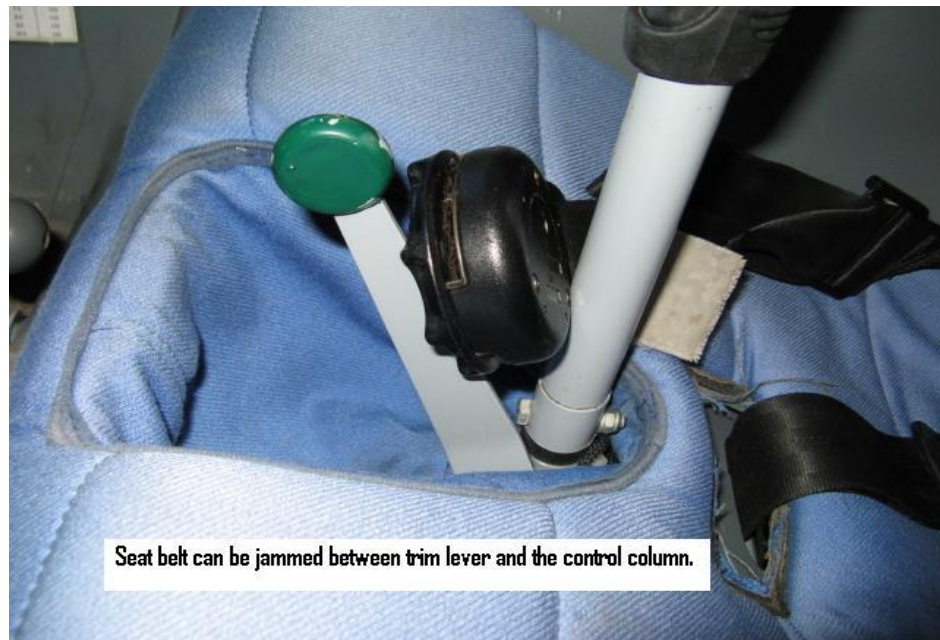
lever could be applied. The picture below shows how it is possible for the front harness buckle to lodge between the front stick and trim lever. Forward movement of the stick, or more likely the rear stick would exert significant pressure on the trim lever resulting in very high compression loads in the pushrod connecting the two trim levers. Similar loads could also be applied if an occupant entering the front cockpit accidentally put a foot on the front trim lever.

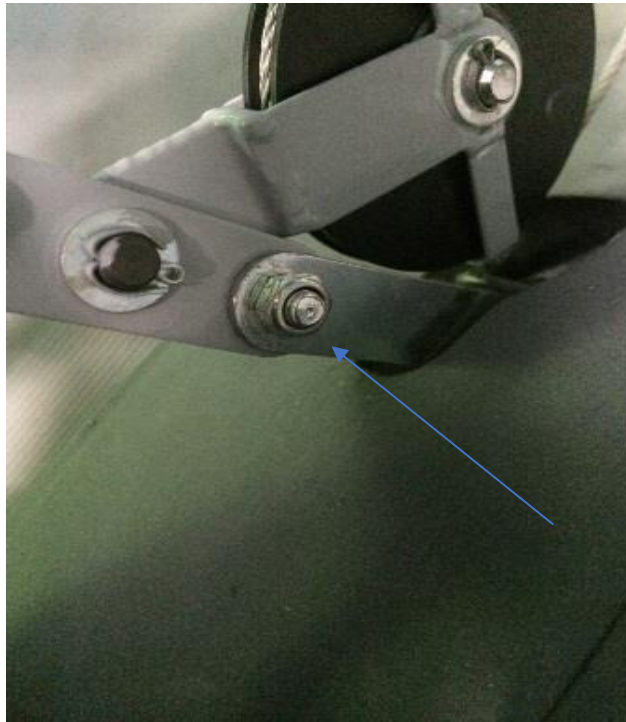
4. An un-commanded ASK 21 Mi aerotow release occurrence were reported, the sailplane had recently undergone maintenance and returned to service. In the fault finding process, the TOST release was tested and found to be serviceable. Friction in the release control circuit however was found to prevent full release closure. AWA 2015-2 was raised, now cancelled.

During the investigation it was found that when gently closing the release, the TOST unit remained partially open. Releasing the release knob at the fully open position permitting rapid closing resulted in full closure. An overtightened bolt in the system (shown in photo below) was found to cause binding preventing full closure. Slight backing off of the nut freed the assembly returning full functionality.

The above overtightened bolt prevented the release system to 'action' correctly.

The affected bolt should be either stepped or bushed to prevent crushing. Manufacturer Alexander Schleicher has been advised.
