AIRWORTHINESS ADVICE NOTICE

SUBJECT: The British Gliding Association has issued a Mandatory glue joints inspection notice.

Number:
042/07/2004

Subject: Structural inspections

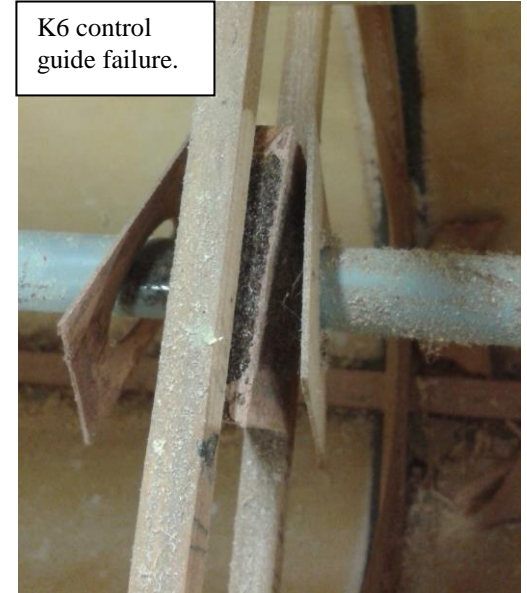
Try and establish the glue type used. We are most concerned about the longevity of Kaurit glue. It is usually pink in colour (see figure 4) but has been known to be other colours if a filling agent has been used. You might have to remove some paint to determine the glue used in each critical component. On all control guides carefully check the felts are adequately retained. (see pic of K6 control guide for example of failure.

K6 control
guide failure.

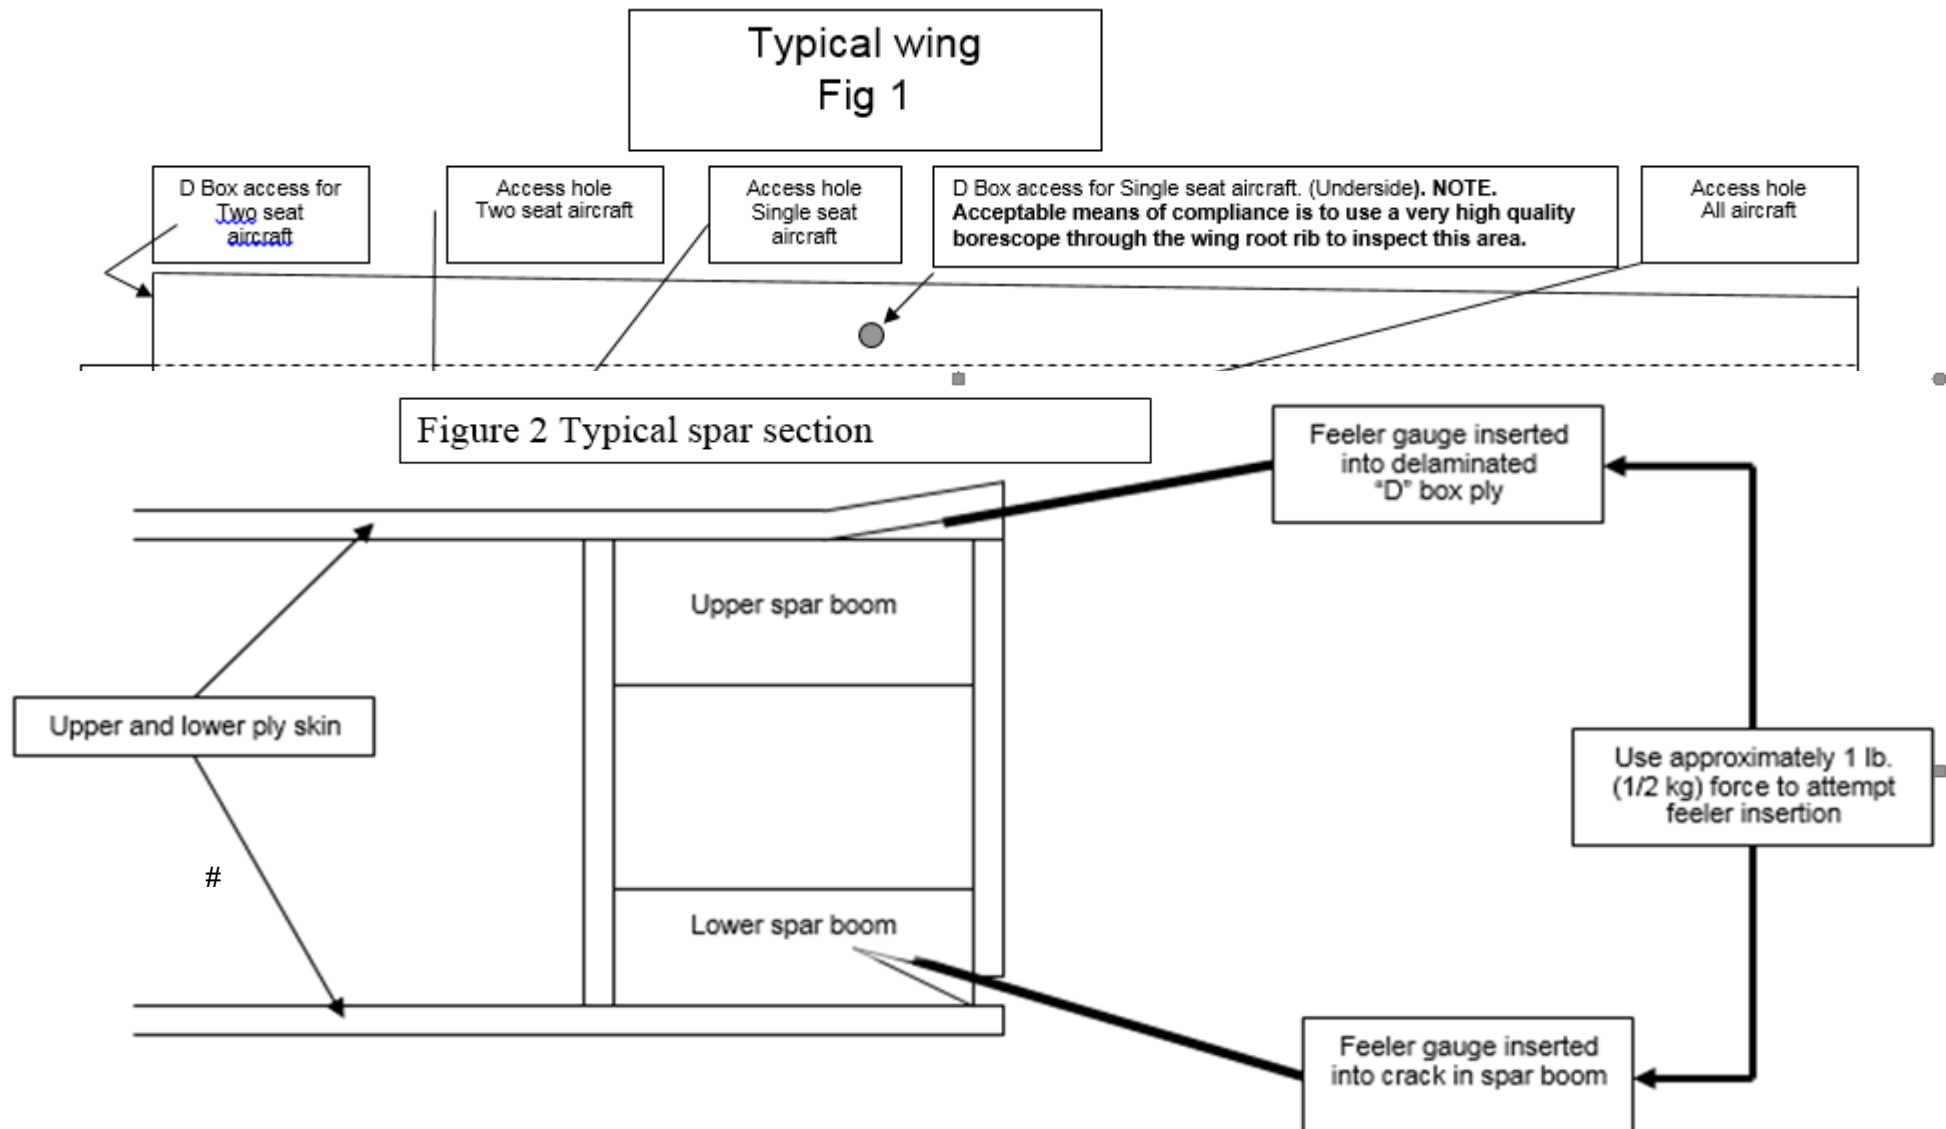
Single seat aircraft: Adjacent to the rear face of the main spar immediately inboard and outboard of the air brake box. See fig 1.

Two seat aircraft: Adjacent to the rear face of the main spar immediately outboard of the air brake box and at the drag spar intersection with the main spar. See fig 1.

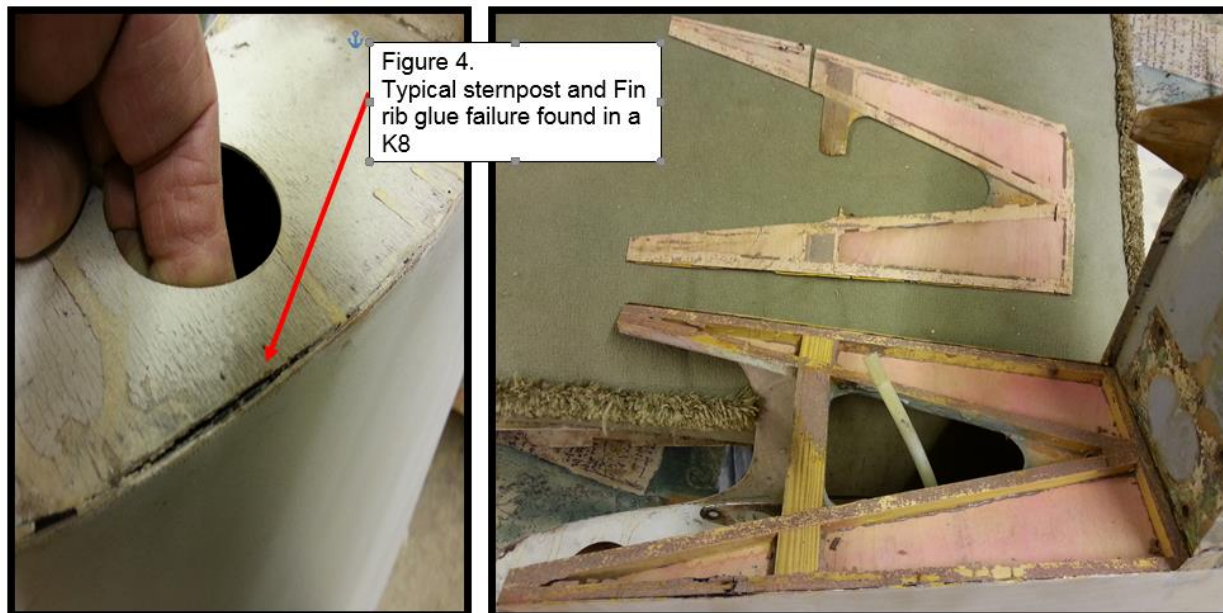
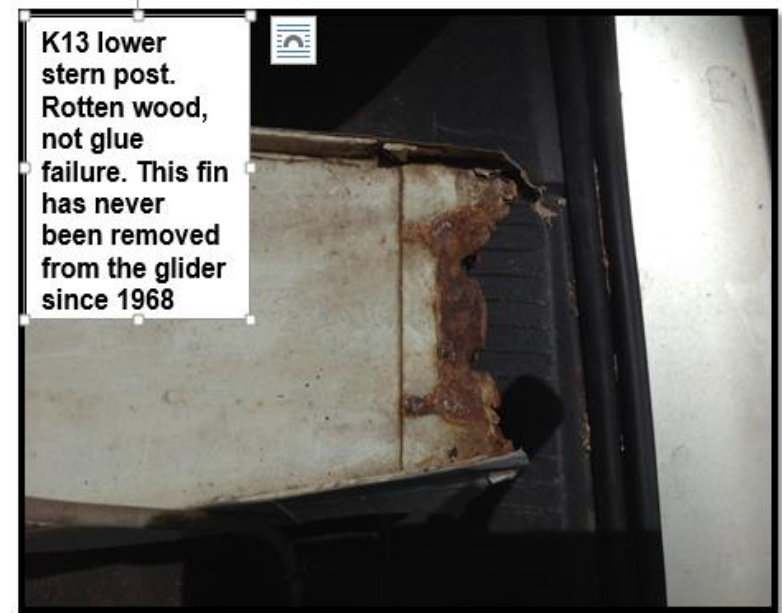
D Fin inspection. If performing the inspection during a fuselage recover then the fin is to be removed (except K6s where they are not bolted on) See figure 4 for images of glue failure found previously. Please look at this video for advice on how to find problems.

Remove the fin (does not require much fabric work) This must be done on all types apart from K6 and K14 types (Indicate on the form returned to the BGA when the fin was last removed) as checking in situ gives very poor access and finger pressure has to be applied, to ensure that the glue joints still have the required high strength. Inspect base of fin rib and put some pressure on it pulling it away from the fin. Check the entire stern post both sides by applying gentle pressure to the plywood that bonds onto the stern post spar. Apply gentle but firm pressure to shear web plywood away from the spar caps to ensure there is no disbonding over the entire length. You are looking for any sign of disbonding or rotten wood (especially at base of fin). Apply significant pressure to the elevator drive mount to ensure that rib is completely bonded. Note, often the bolts that hold the fin onto the fuselage are rusty and should be replaced.

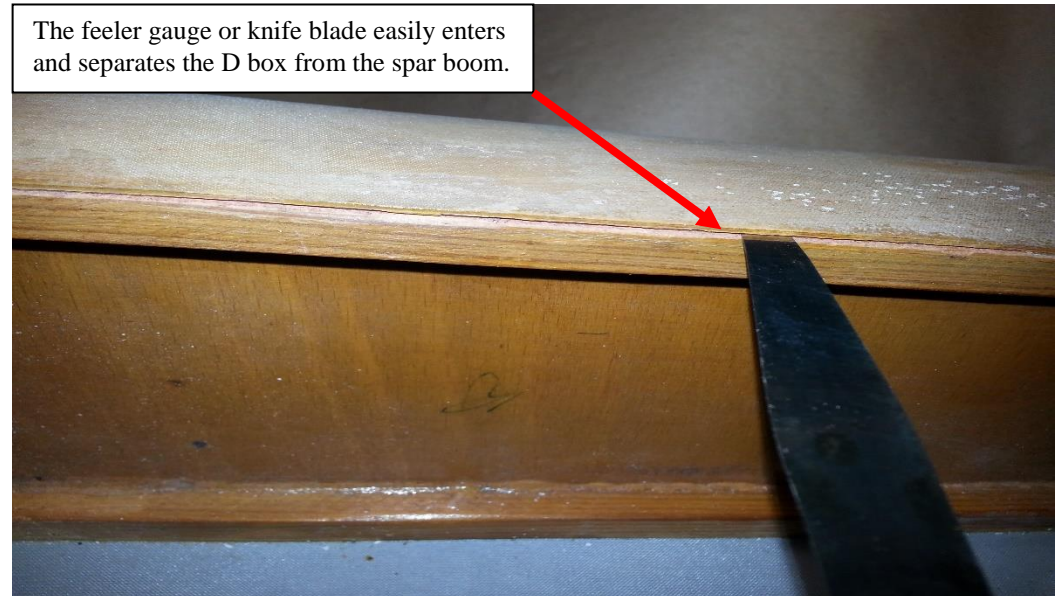
The feeler gauge or knife blade easily enters and separates the D box from the spar boom.

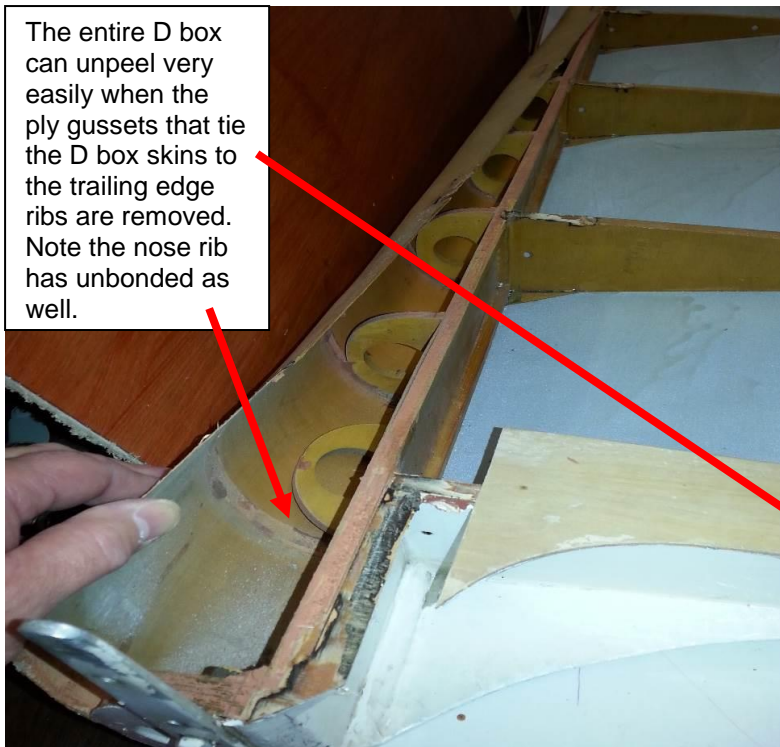
The entire D box can unpeel very easily when the ply gussets that tie the D box skins to the trailing edge ribs are removed. Note the nose rib has unbonded as well.

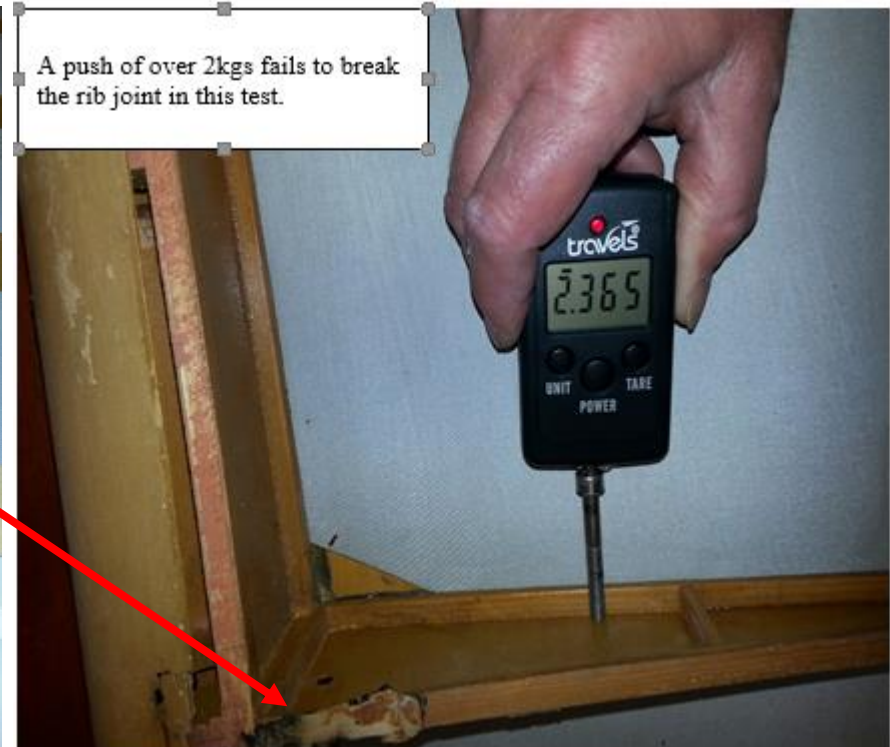
A push of over 2kgs fails to break the rib joint in this test.
