GLIDING FEDERATION OF AUSTRALIA

AIRWORTHINESS DIRECTIVE - GLIDERS

GFA/AD 14/E. SCHNEIDER 5

Glider Types Affected: ES - 52 Kookaburra, all models
ES - 56 Nymph: ES - 57 Kingfisher:
Grunau Baby II, III and IV

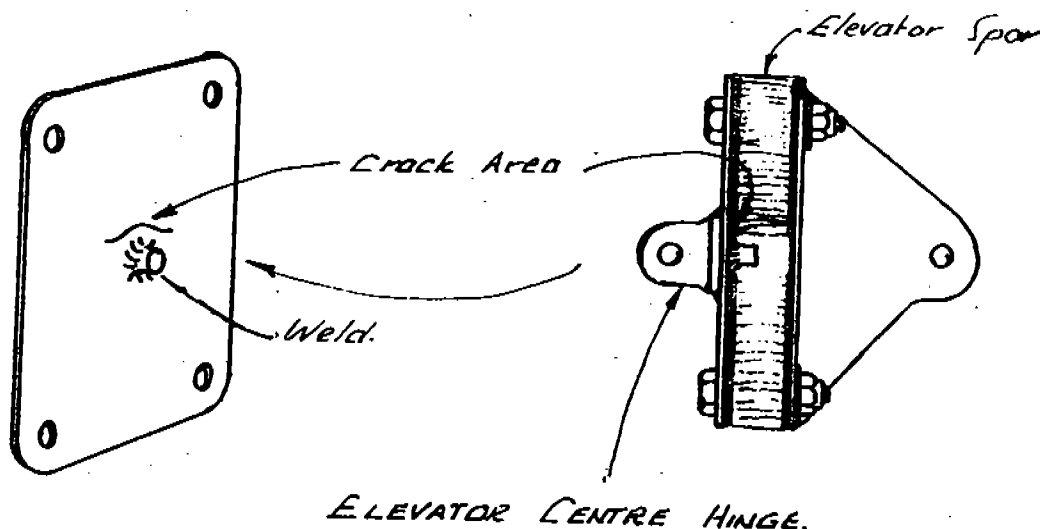
During inspection on a G.B.II and ES-52 Mk. IV Kookaburra similar defects in the elevator centre hinges have been detected. This defect is cracking of the hinge backplate adjacent to the weld.

Excessive bouncing of elevator during ground handling.

Always restrain elevator in neutral position by looping safety harness over control column during ground handling to prevent elevator bouncing against stops.

Before next flight, then on daily inspections and annual inspections, check by inspecting hinge back plate while pushing elevator full down; check for any bulging of back plate or evidence of cracking above hinge boss. If evidence of bulging or cracking is observed remove fitting for further inspection; cracking usually commences at rear face of backplate. For annual inspections remove fitting.

Replace fitting if any evidence of cracking is detected.
