AIRWORTHINESS DIRECTIVE - GLIDERS

GFA/AD 16B/LET N.P. KUNOVIC 4

Glider Types Affected - L-13 Blanik, up to Serial No. 173414

EXTRACT OF SERVICE BULLETIN NO. L.13/025

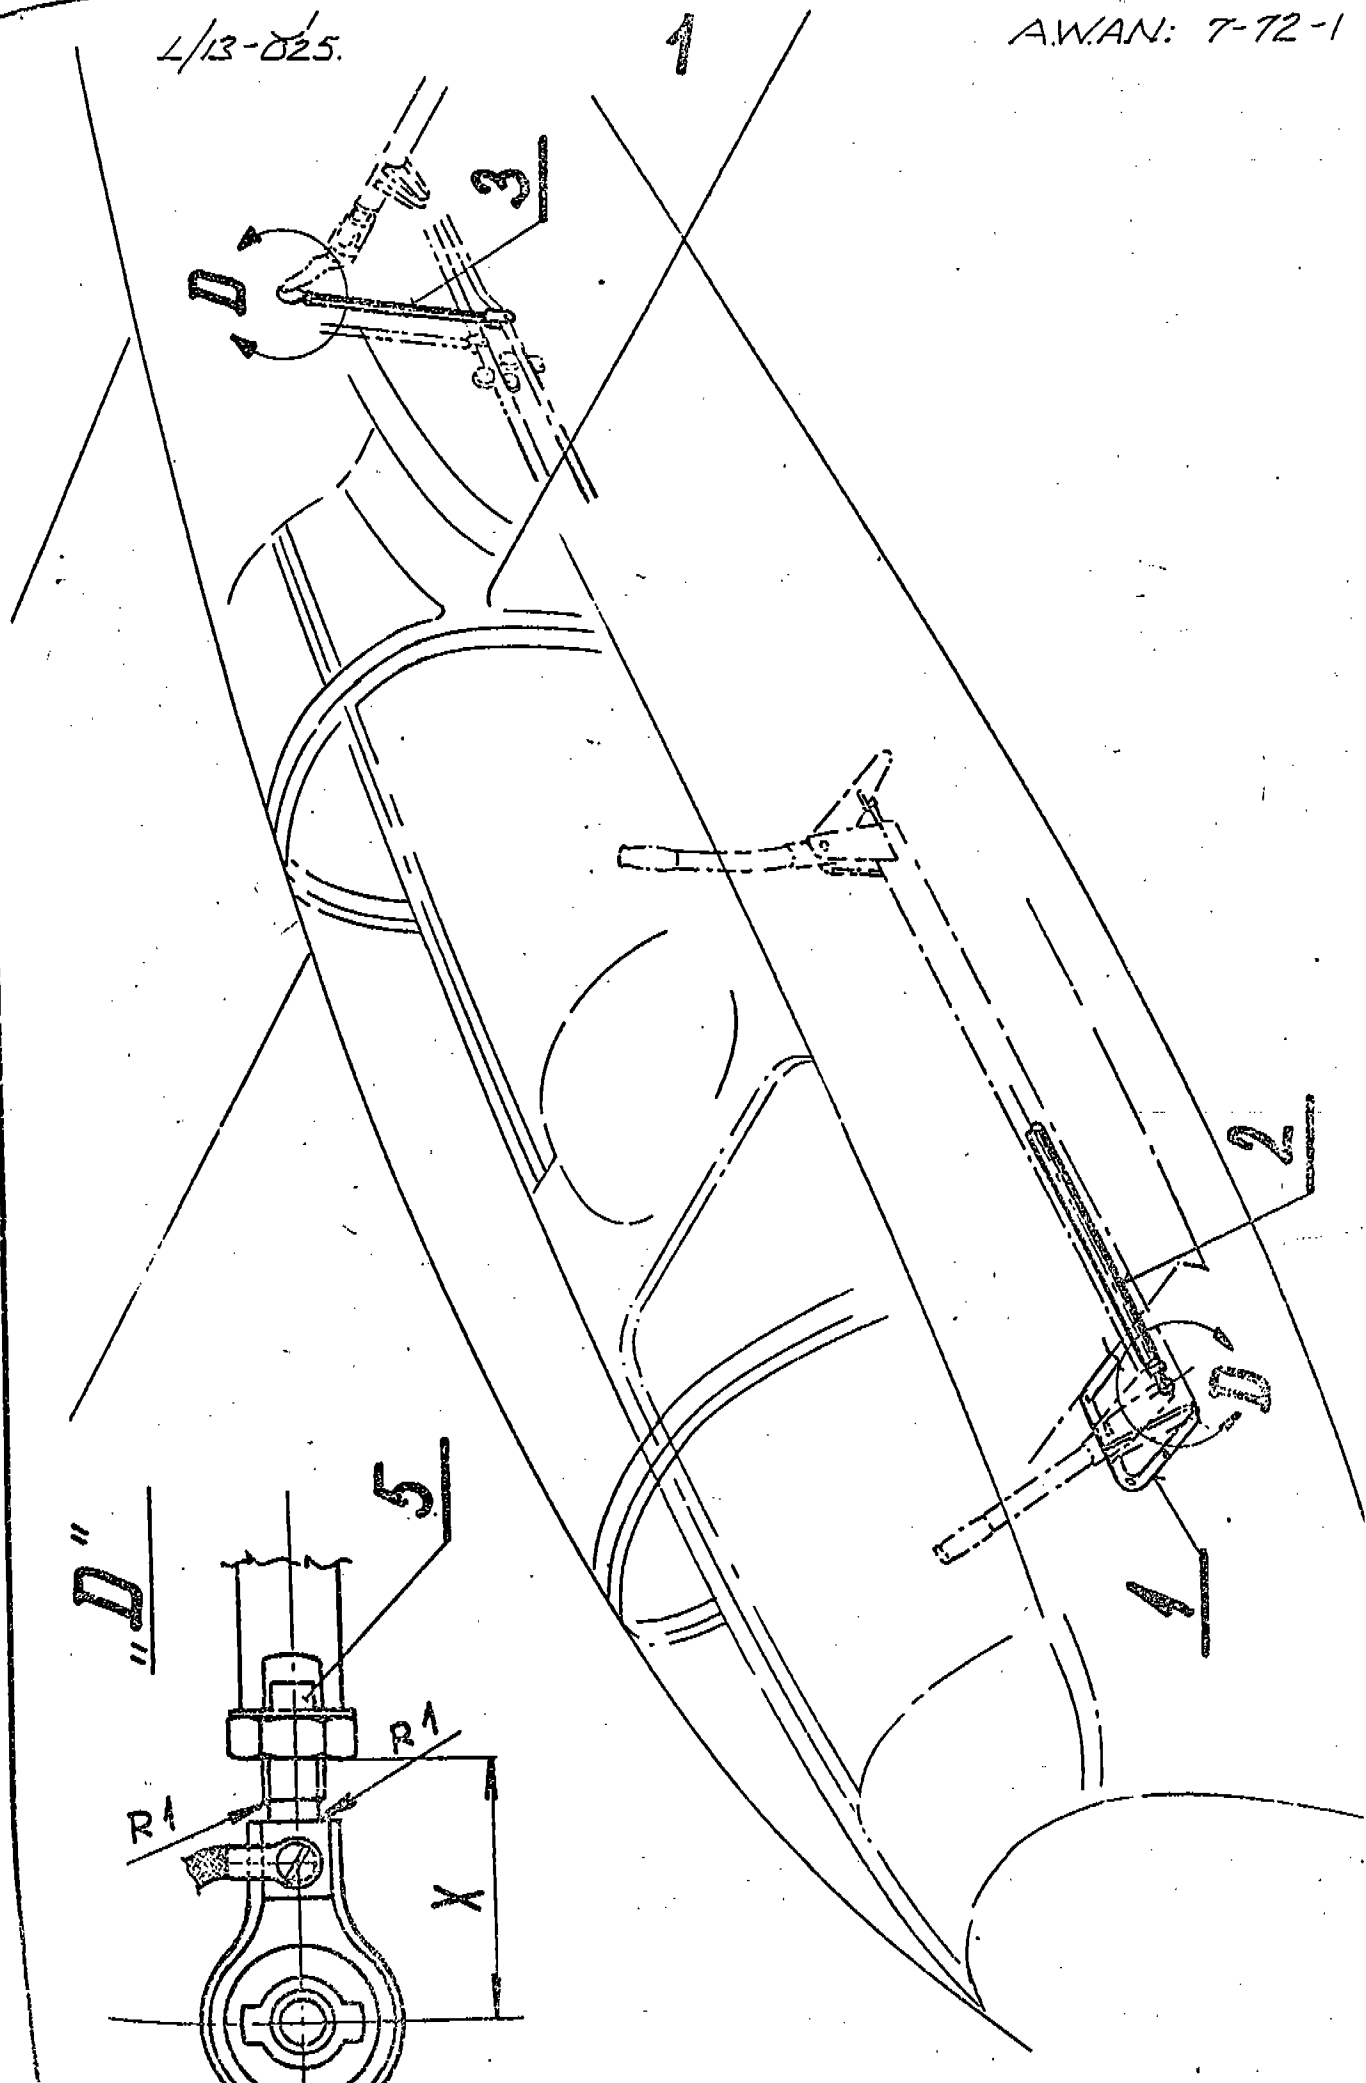
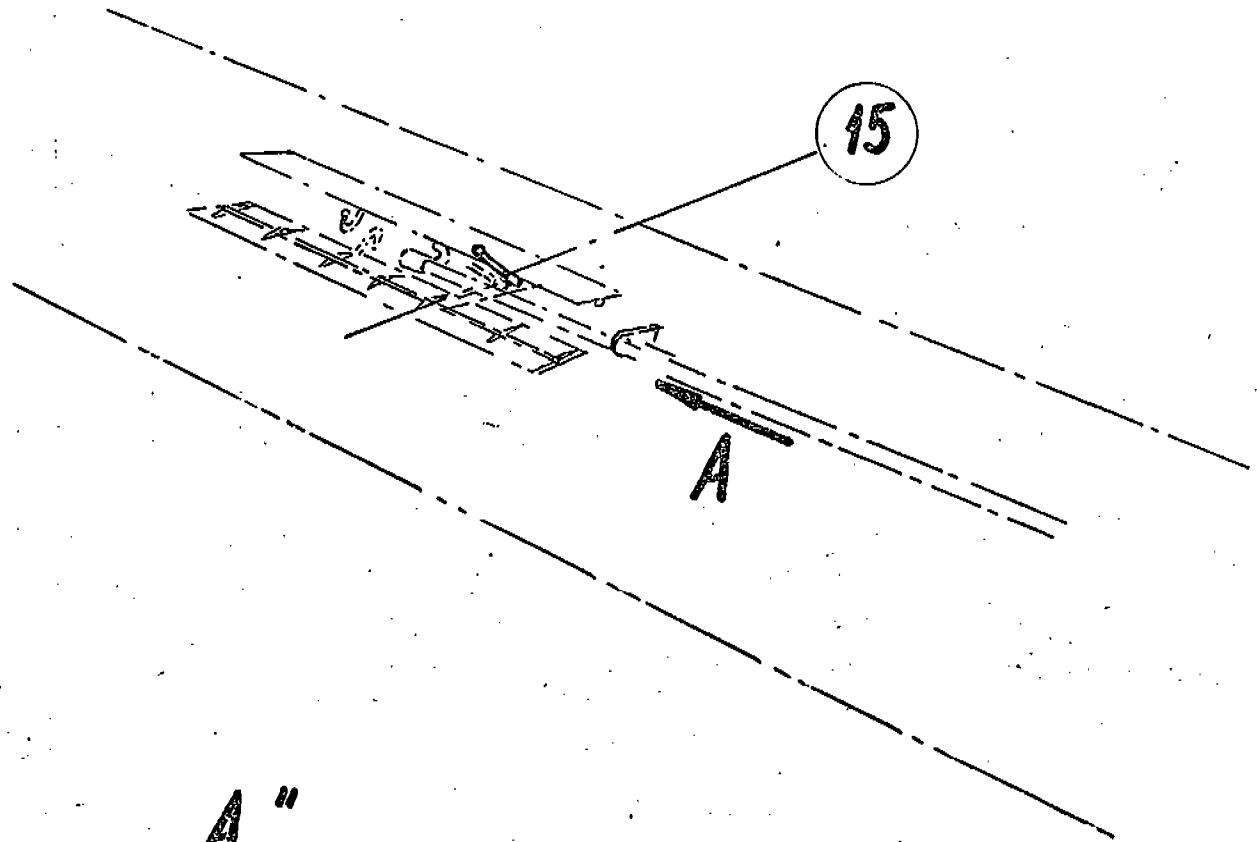
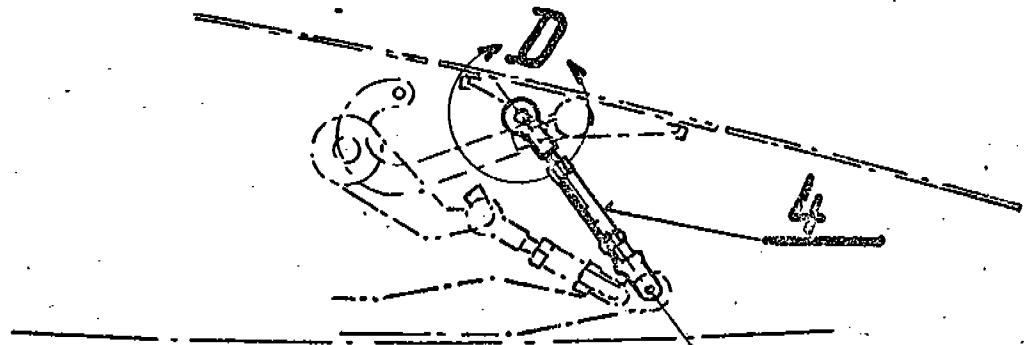
It has been found that a number of control rod ends have been manufactured with inadequate corner radiuses making the rod ends susceptible to fracture.

Before further flight unless the required inspection has previously been carried out, inspect the control rod ends at the elevator push rod at the base of the front cockpit control column, the push rods in the fuselage centre section and the dive brake actuating rods (see illustration).

Remove the frame and control column boot from the front control column. Check the rod end of the push-pull rod to ensure that the radii at the recess at the end of the thread is 1 m.m. - 0.040 inches if the corner radius is less than 1 m.m. or is sharp the rod end must be replaced. Inspect also the push rod ends in the fuselage centre and in the wings near rib 15.

If the lock nut is close to the shoulder so that the recess cannot be properly inspected it will be necessary to release the lock washer and remove the rod end as the tab washer cannot be re-used.

In order to avoid resetting the control rods, measure the distance "x" in view "D" replace rod end with new tab washer in place and adjust to the same dimension and lock with nut and tab washer.
