AIRWORTHINESS DIRECTIVE - GLIDERS

GFA/AD 16C /LET N.P. KUNOVIC 4

Glider Types Affected - L-13 Glider Serial Numbers 170101 to 174730

EXTRACT OF SERVICE BULLETIN NO. L 13/031

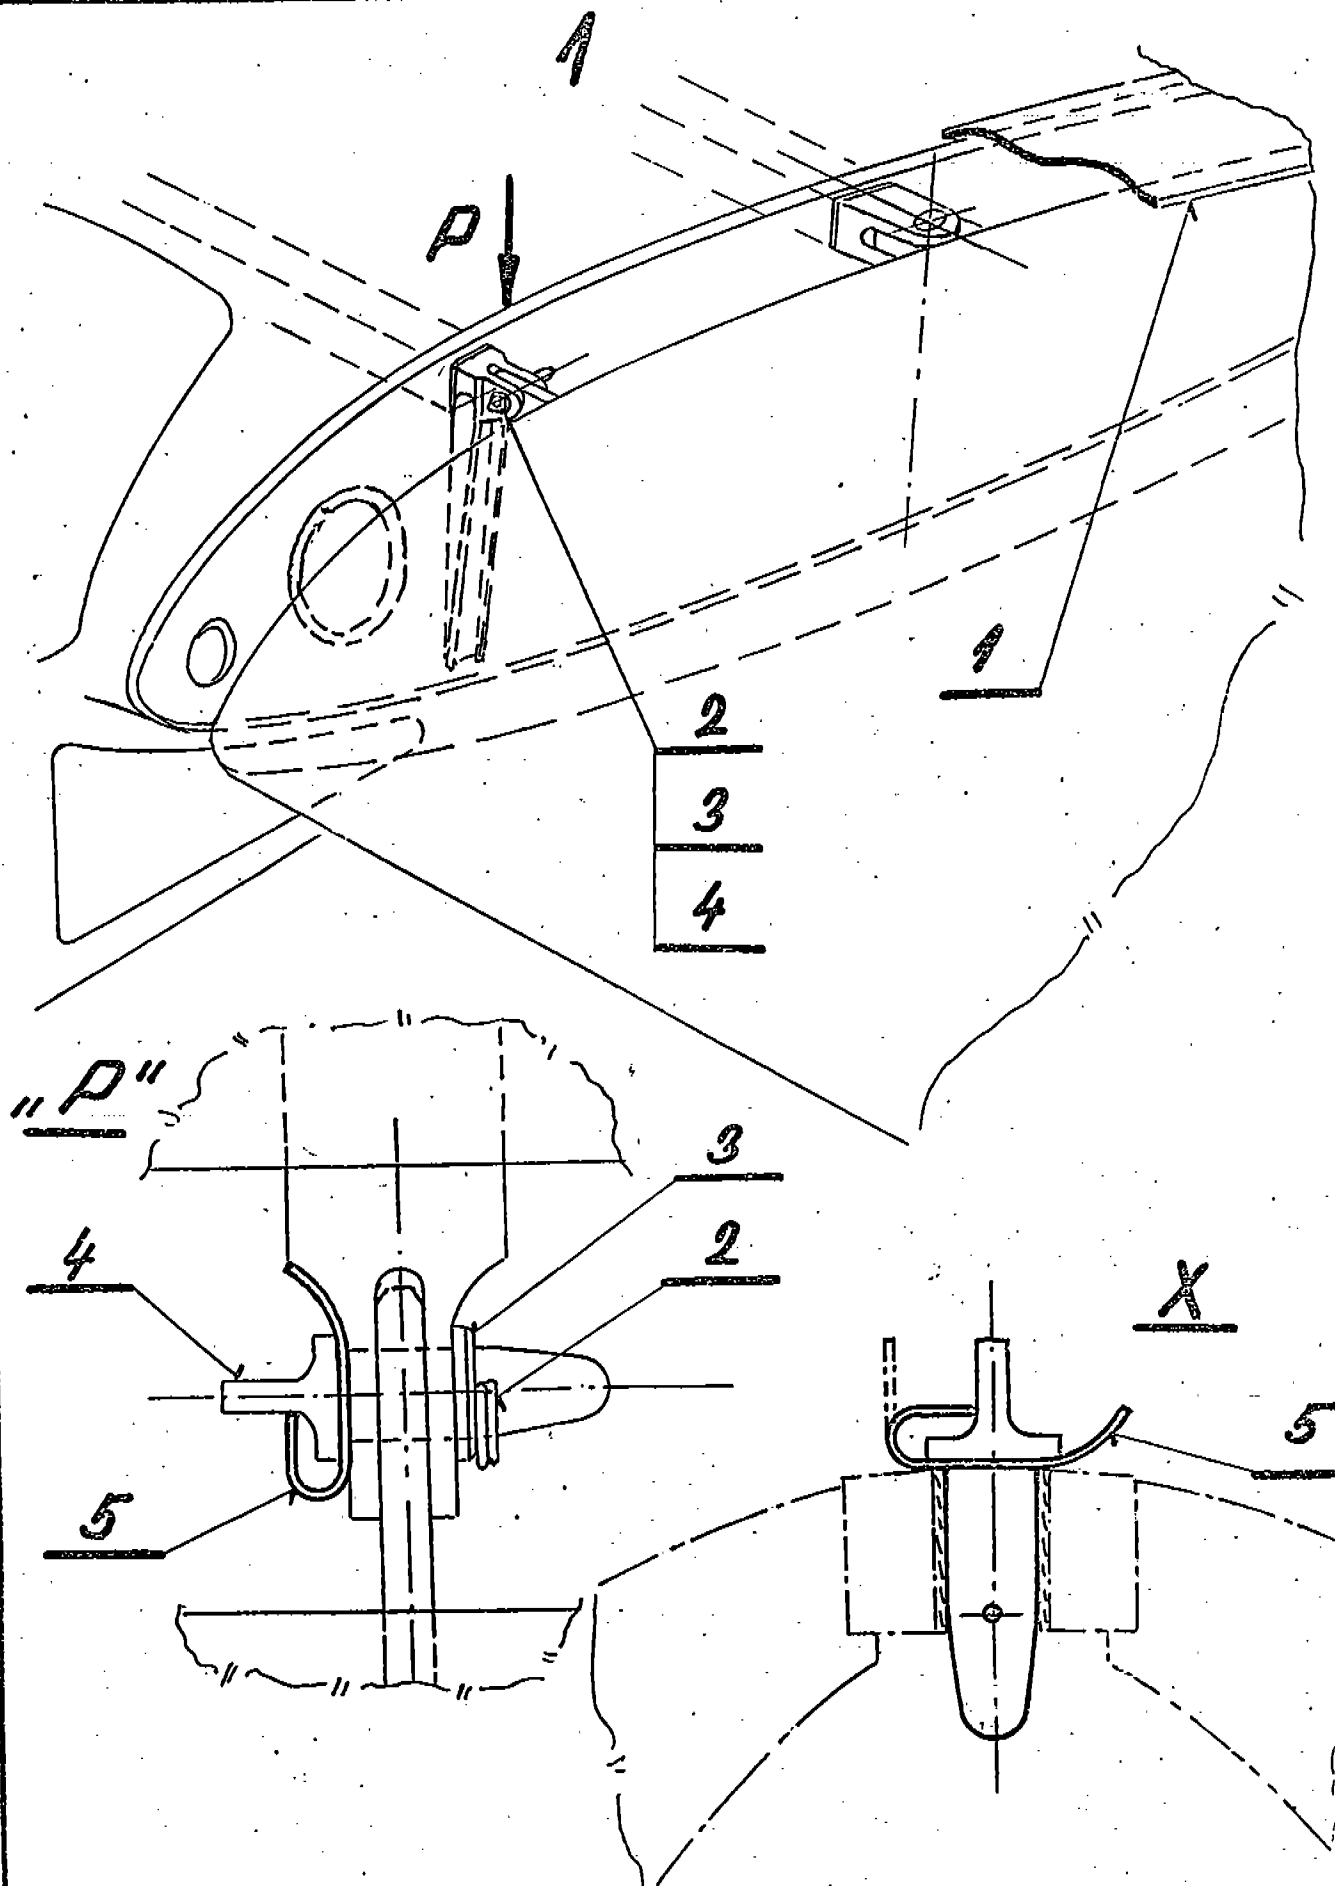
REASON: Rotation of the pins in the front wing root fitting can occur due to vibration, resulting in the release of the securing safety pin.

Secure the pins against rotation as set out below.
Materials to be obtained from the aircraft distributor.

Item 5 - Tab Washer, two required. Drg. No. L.13.100-01.72.

- 1) Remove wing joint fairing (Item 1) from each wing.
 - 2) Remove the safety pin (Item 2), washer (Item 3) and pull out the pin (Item 4).
- Note: These operations are carried out in the same way as when derigging the aircraft for ground transport.
- 3) Place the tab washer (Item 5) over the pin (Item 4) and bend the tab of the washer towards the head of the pin. This should be done in a vyce with soft jaws. See Fig. 1, View X.
 - 4) Insert the pin in the front wing fitting with the bent end in the half-round recess in the fitting.
 - 5) Replace washer (Item 3) and secure it with the safety pin (Item 2). If the tab washer (Item 5) does not match the recess in the fitting, rebend it to match the recess closely.
 - 6) Check for security and mount the fairing (Item 1).
