AIRWORTHINESS DIRECTIVE -- GLIDERS

TECHNICAL INSTRUCTION NO. 58

Inspection of T51 Dart Main Spars

**TITLE** INSPECTION OF DART 15/17M ALUMINIUM ALLOY (DURAL) SPAR BOOMS

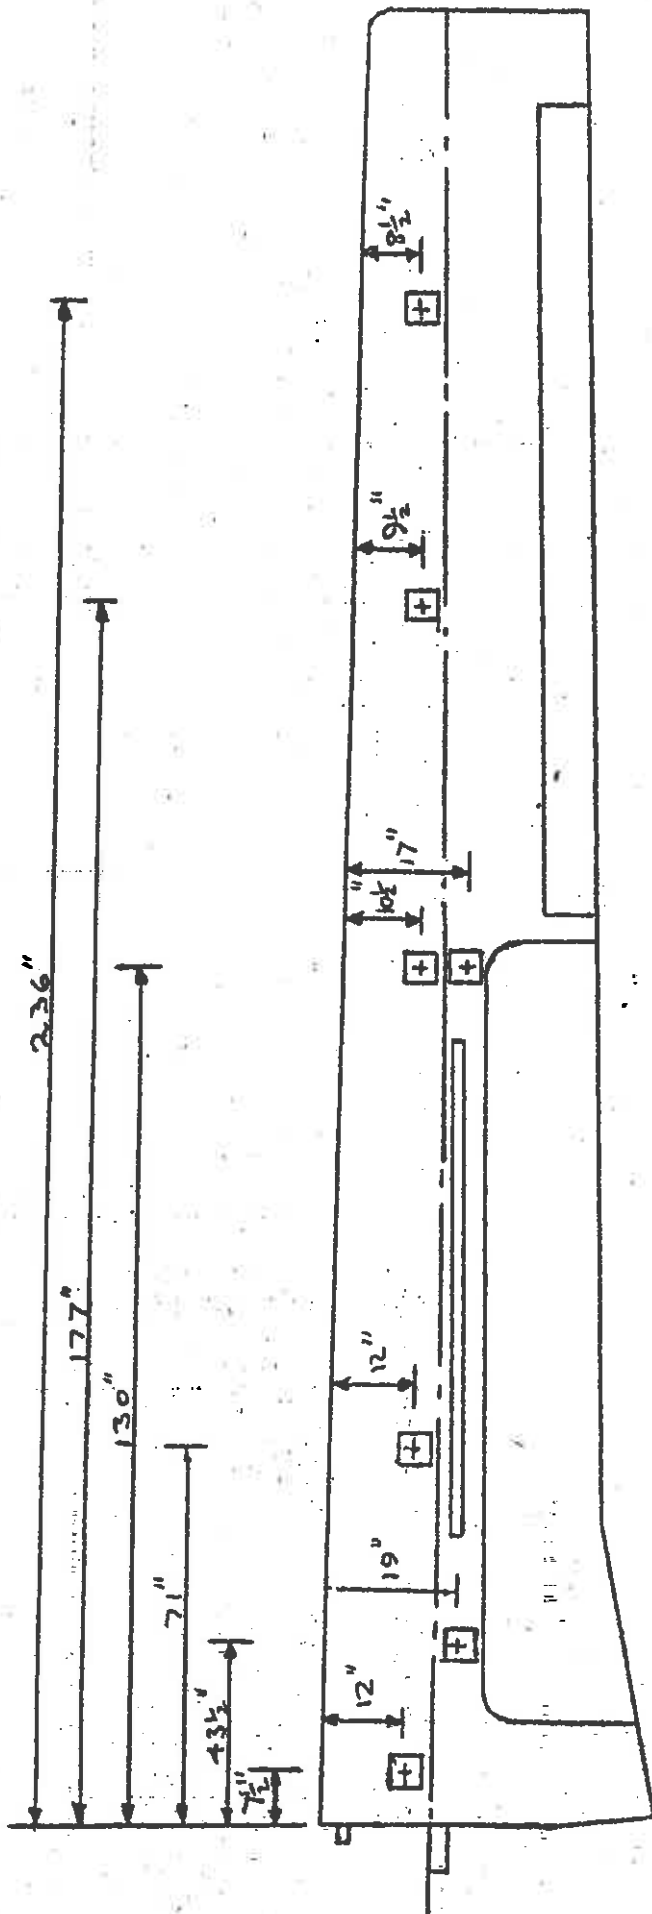
CUT INSPECTION HOLES IN LOWER SURFACE OF BOTH WINGS AS SHOWN.

1. Mark the hole centres as shown on the diagram, drill  $\frac{1}{8}$ " dia. hole in the ply and gradually open up the holes to 3" - 4" square.
2. Thoroughly inspect the metal portion of the spar paying particular attention to bolted joints and rib attachment points.
3. If any significant corrosion exists, that is more than 0.007" in depth the aircraft will require repair action.
4. The holes in the wing should be repaired in accordance with standard practice and the results of the inspection sent to Slingsby Sailplanes.
5. After the results of the inspection have been analysed by Slingsby Sailplanes further action may be required on an annual basis.
