GFA/AD/20

SLINGSBY 3

AIRWORTHINESS DIRECTIVE GLIDERS.

REFERENCE GFA/SLINGSBY. 1/73/1.

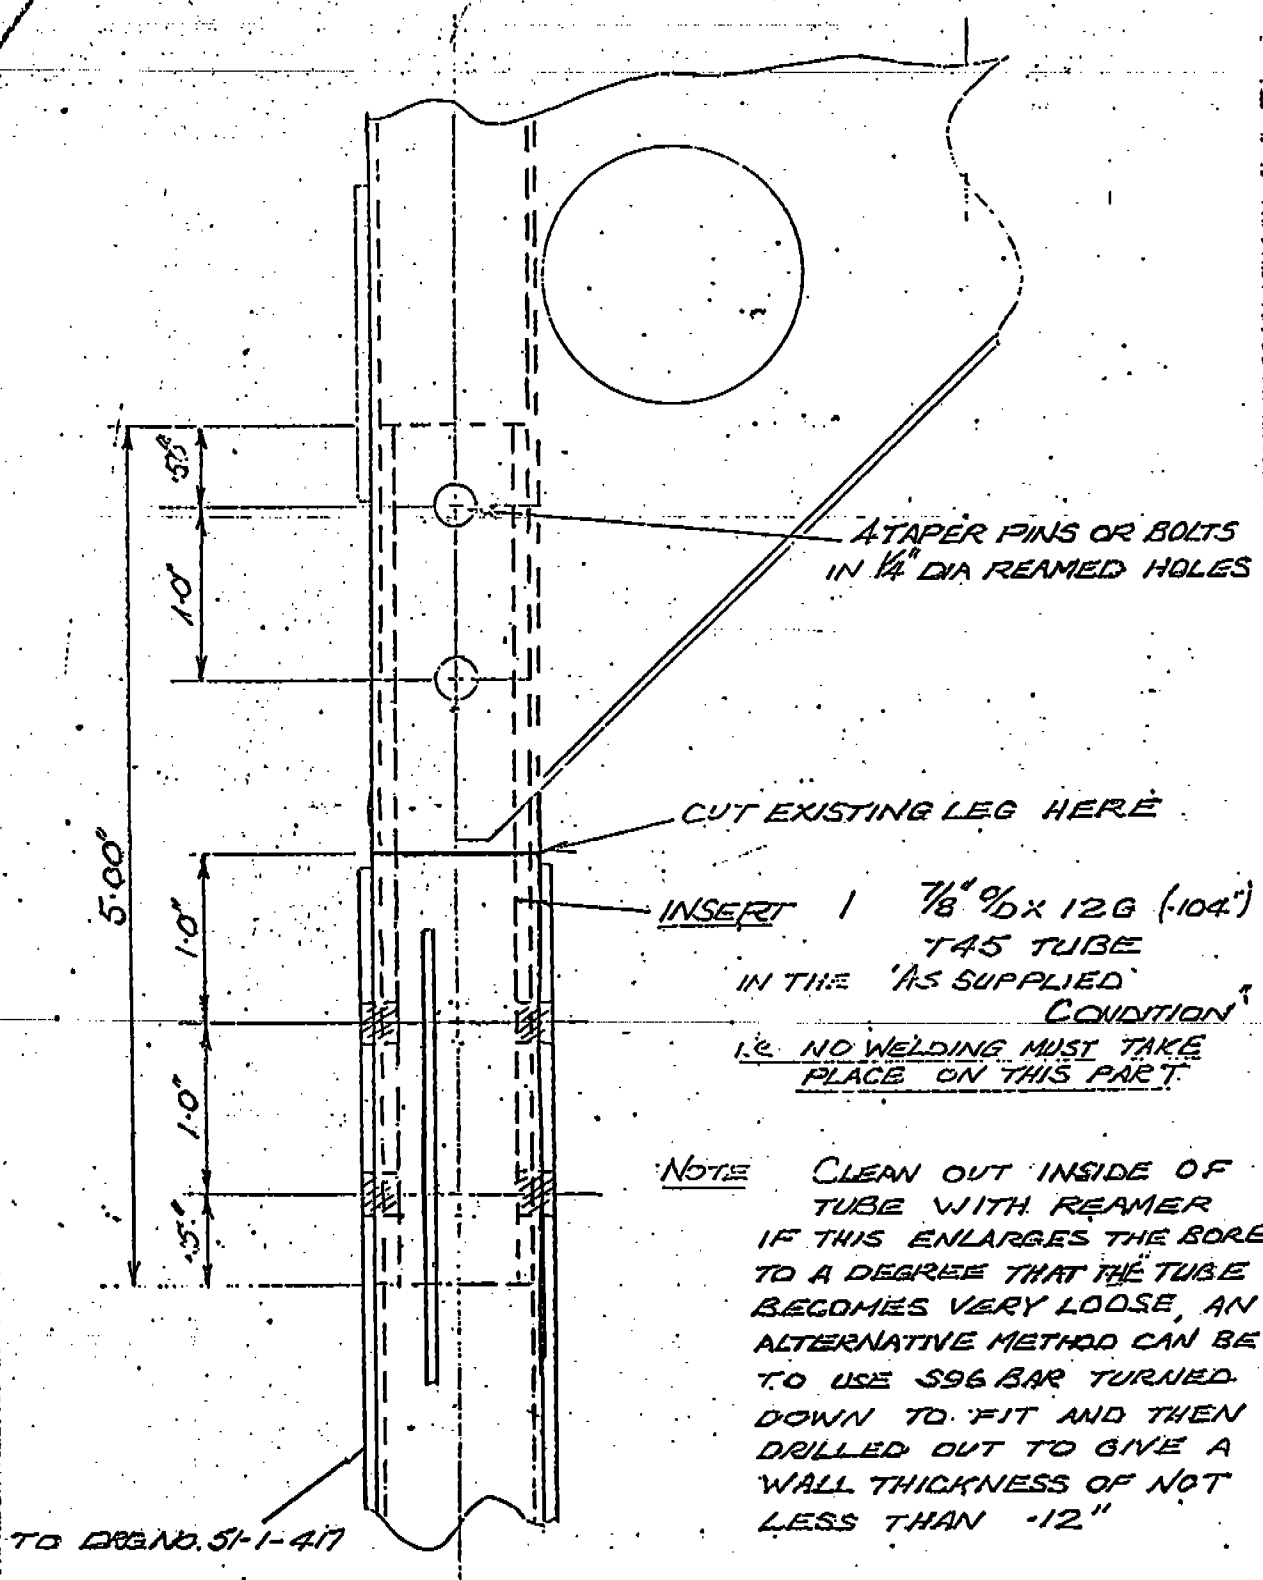
SK51/443

Due to a small number of main undercarriage fork failures a design change has been made, introducing strengthening of the Fork.

This modification is in the form of an internal tube inserted into the existing 1.0" ϕ /D Tubes.

1. Remove undercarriage doors.
2. Disconnect wheel brake.
3. Remove Wheel.
4. Remove radius rod bolts.
5. Remove ply skin between longeron and wheel box top in line with undercarriage pivot bolts taking care not to damage longeron. Remove only sufficient to enable nuts to be removed from undercarriage fork pivots.
6. Remove wheel brake lever.
7. Remove undercarriage fork, 51-1-417.
8. Cut existing fork as shown on SK 51/423 (attached).
9. Carry out instructions as per SK 51/423.
10. Fit $\frac{7}{8}$ " O/D 12G. tube inside undercarriage fork as shown.
11. Drill and Ream for 4 taper pins or bolts, each side as shown.
12. Fit taper pins or bolts.
13. Touch up paint on undercarriage as required.

14. Replace undercarriage fork 51-1-417.
15. Replace wheel brake lever.
16. Reconnect radius rod.
17. Replace wheel.
18. Reconnect wheel brake.
19. Replace undercarriage doors.
20. Check operation of undercarriage mechanism.
21. Splice in 2 mm ply skin where removed and finish to existing undercarriage finish.
22. Ensure that tyre pressure is between 20 and 25 P.S.I.
23. Make the appropriate entry into the glider log-book to certify that the modification has been incorporated.

UNDERCARRIAGE REPAIR SCHEME

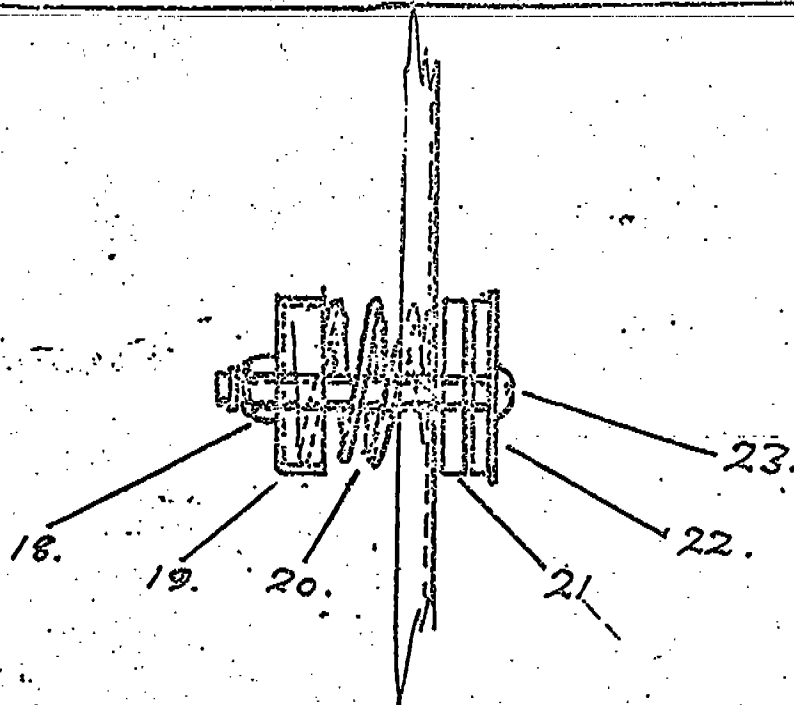
ASSEMBLY OF FRICTION DEVICE. DART MOD 67A.

It has been found that whilst there is no difficulty in fitting Dart Modification No. 67 to the later Dart variants with wooden tailplanes it is not practicable to apply it to those with metal tailplanes, nor to some earlier machines with a small range of cockpit load.

4. Fit items 18, 19, 20, 21, & 23 as supplied in Modification kit in accordance with sketch attached. Use existing large dia. $\frac{3}{16}$ " washer removed from old assembly.

Tension in accordance with rigging drawing 51-1-1 Iss. 6 or 7 or 51-1-201 Iss. 8 or 9 whichever is applicable. No grease whatsoever should be present on the friction device.
