# THE GLIDING FEDERATION OF AUSTRALIA INC

## Airworthiness Alert 2020-2 Jantar Rudder Cable Guide Tube

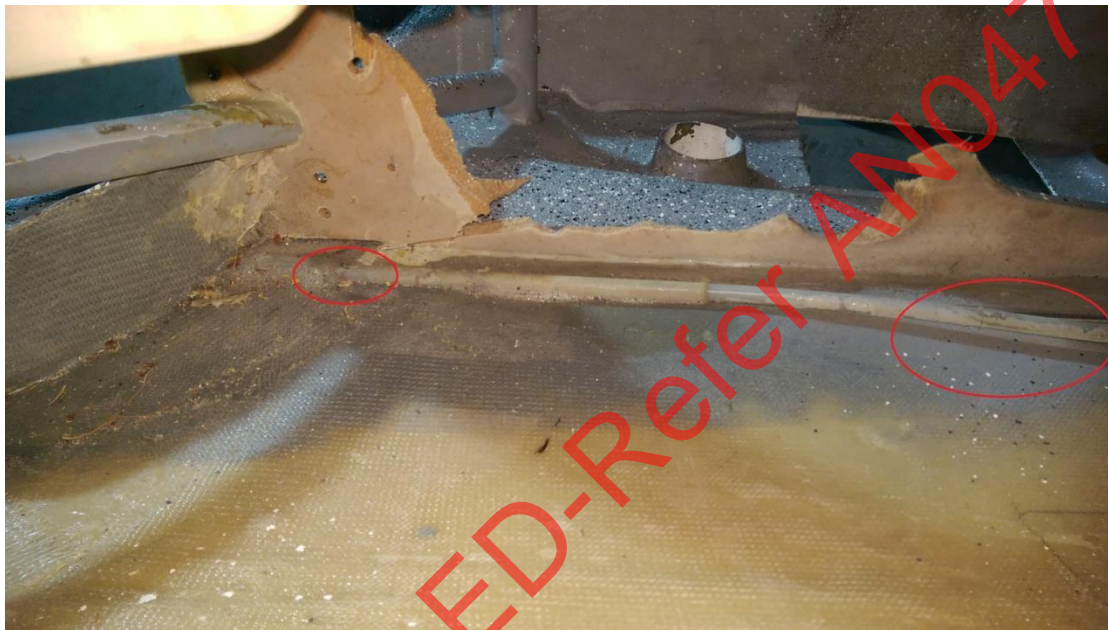
It is known that Jantar types of similar vintage are subject to partial disbonding of the rudder guide tube from the fuselage. The guide tubes are originally anchored by pressing tube into the wet resin during manufacture. The rudder cables can place large side loads on the guide tube where it forms an S shape. Once disbonded in this area, the rudder cables will try and cut the corners of the S and the guide tubes are not stiff enough to prevent this. This allows rudder pedal movement without the rudder moving.

The most recent defect report states both left and right cable guide tubes were found totally disbonded in the centre fuselage resulting in a complete loss of rudder control authority. It was found that if the rudder was held in the neutral position, the rudder pedals could be cycled through the full range without resistance.

**Figure 1:** The above photo taken of the centre fuselage from a Jantar wreck shows a secured or well bonded cable guide tube at left and a disbonded tube section sagging slightly at right. Partial debonding still allows the control to work but as the disbond gets longer, the control on the rudder gets softer and less effective. Experience suggests the tube should be able to be pushed back into position by compressing the tube and bonding it back to the FRP fuselage shell. Ensure the FRP surface is well prepared prior to rebonding.

**Annual Inspection:** The GFA annual inspector when performing annual maintenance on any Jantar type must also be aware of the control systems potential defect failure. The anchoring of the both cable guide tubes to the fuselage interior, particularly the centre fuselage, must be ascertained by both visual and functional means using the above technique. Any disbonds relating to the rudder cable guide tube must be repaired before returning the glider back to service.

It is recommended that inspection of both left and right cable guide tubes be carried out within the next 90 days. Any rectification action as a result of this inspection is to be performed by an inspector holding a Form 2 Maintenance Authority. Record any defects identified in the aircrafts records.
