THE GLIDING FEDERATION OF AUSTRALIA INC

Airworthiness Alert 2020-2 **Jantar Rudder Cable Guide Tube**

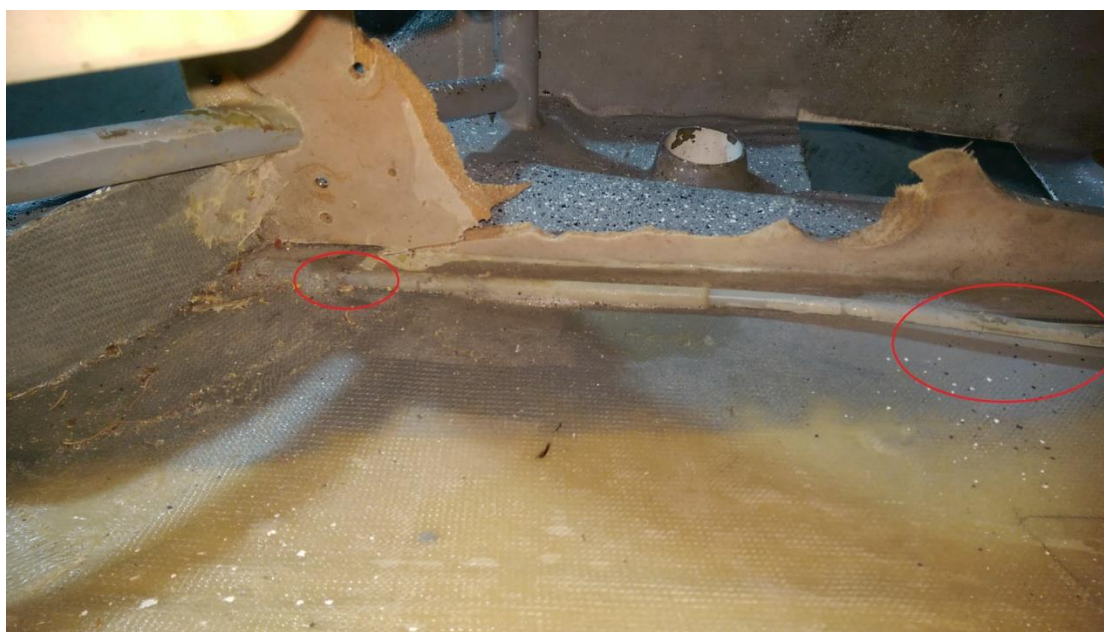
It is known that Jantar types of similar vintage are subject to partial disbonding of the rudder guide tube from the fuselage. The guide tubes are originally anchored by pressing tube into the wet resin during manufacture. The rudder cables can place large side loads on the guide tube where it forms an S shape. Once disbonded in this area, the rudder cables will try and cut the corners of the S and the guide tubes are not stiff enough to prevent this. This allows rudder pedal movement without the rudder moving.

The most recent defect report states both left and right cable guide tubes were found totally disbonded in the centre fuselage resulting in a complete loss of rudder control authority. It was found that if the rudder was held in the neutral position, the rudder pedals could be cycled through the full range without resistance.

Figure 1: The above photo taken of the centre fuselage from a Jantar wreck shows a secured or well bonded cable guide tube at left and a disbonded tube section sagging slightly at right. Partial debonding still allows the control to work but as the disbond gets longer, the control on the rudder gets softer and less effective. Experience suggests the tube should be able to be pushed back into position by compressing the tube and bonding it back to the FRP fuselage shell. Ensure the FRP surface is well prepared prior to rebonding.

Annual Inspection: The GFA annual inspector when performing annual maintenance on any Jantar type must also be aware of the control systems potential defect failure. The anchoring of the both cable guide tubes to the fuselage interior, particularly the centre fuselage, must be ascertained by both visual and functional means using the above technique. Any disbonds relating to the rudder cable guide tube must be repaired before returning the glider back to service.

It is recommended that inspection of both left and right cable guide tubes be carried out within the next 90 days. Any rectification action as a result of this inspection is to be performed by an inspector holding a Form 2 Maintenance Authority. Record any defects identified in the aircrafts records.
