**AIRWORTHINESS DIRECTIVE GLIDERS**

**REF. NO. GFA SCHNEIDER 10/74**

**Glider Types Affected:** Schneider ES.60 Boomerang.

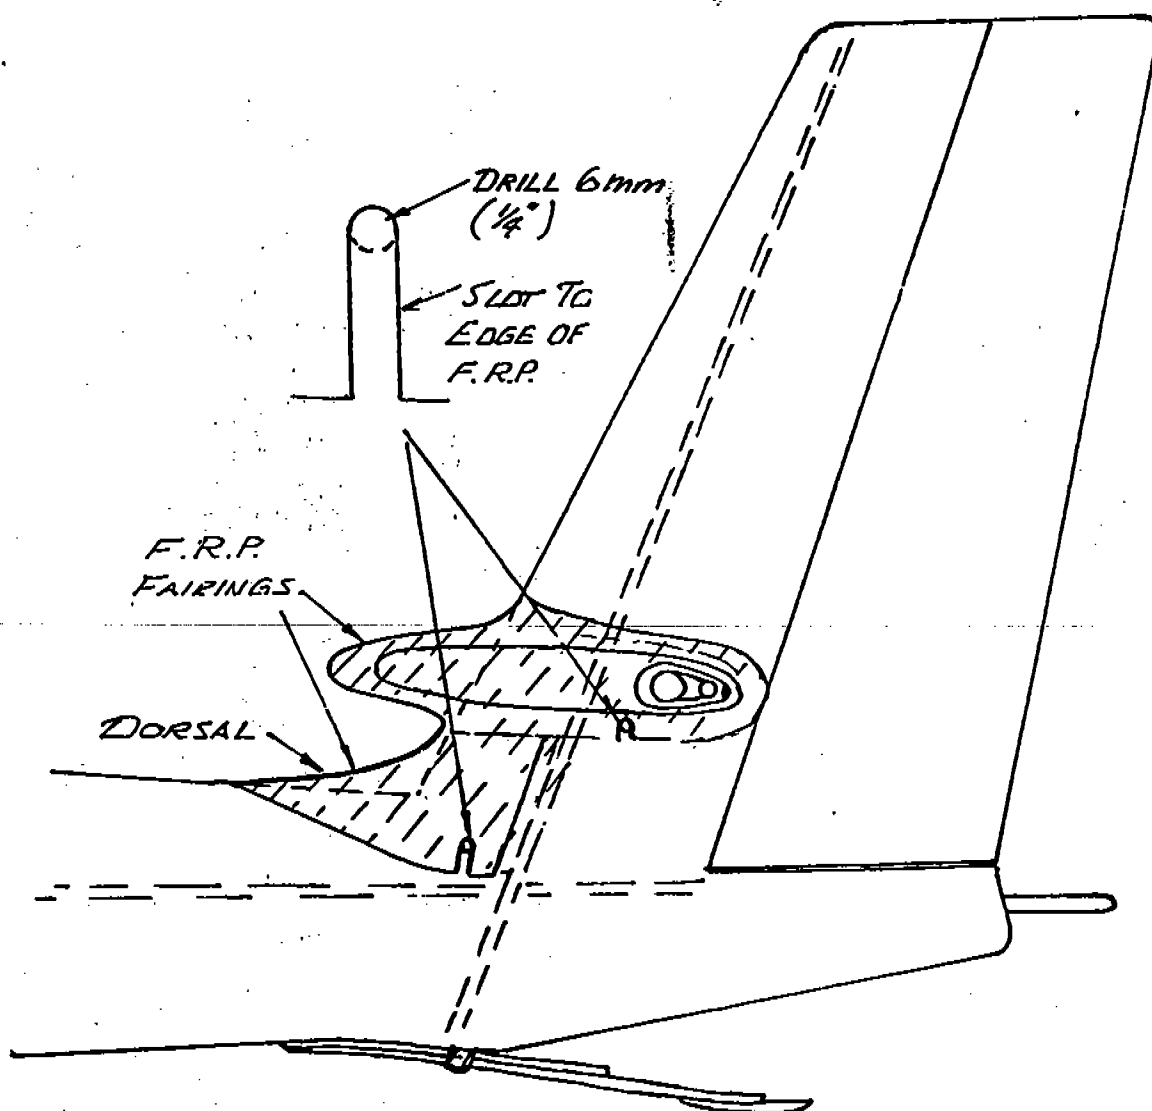
**Background:** Two cases of water damage to the airframe structure within the FRP dorsal fairing at the base of the vertical fin and its junction with rear fuselage have been detected. During rain, water has entered the fin/tailplane junction fairing through the openings for the tailplane mounting tube. The water has then seeped into the space between the dorsal fairing and the base of the vertical fin.

**Required Action:** Drainage holes are required in the FRP fairings on both sides of the aircraft.

Locate the lower edge of the fairings by tapping the FRP with a hard object such as a coin and listening to the change of sound where the FRP is unsupported. Approximately 25 mm (1") above the lower edge of the fairing drill a 6 mm (1/4") dia. hole through the FRP, being very careful not to drill through the plywood beneath. Then, with a fine-toothed saw (a broken off hacksaw blade is suitable) extend the hole as a slot to the edge of the FRP again being careful to avoid cutting into the underlying plywood. This operation is required in four (4) places.
