AIRWORTHINESS ADVICE NOTICE

TYPE AFFECTED: Jantar and Jantar Standard. All variants.

SUBJECT: Miscellaneous airworthiness information.

GFA AN 047	ISSUE: 12	26Oct2022	Page 7 of 8
-------------------	------------------	------------------	--------------------

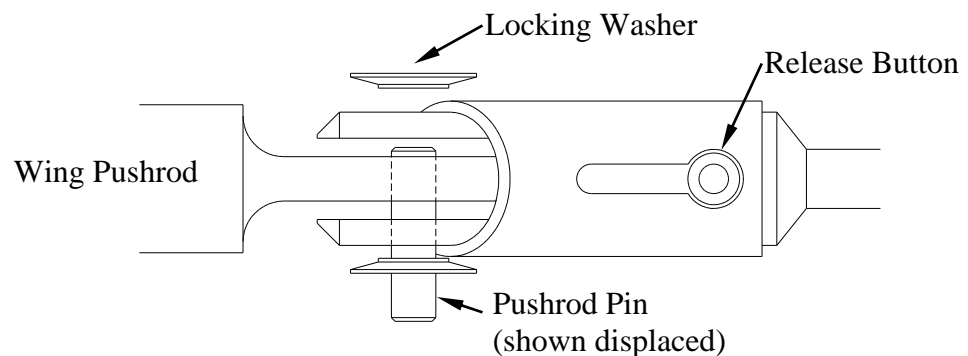
FIGURE 1. LOCKING WASHER SECURITY

Experience has shown that the locking washer on the connecting pin in the elevator and/or aileron connectors may work loose allowing the control to be connected incorrectly as shown in fig. 1.

Should the locking washer be loose then the defect must be rectified before next flight.

The defect may be rectified by either replacing the washer with a new part (the best option) or by cold forming the washer until the hole is between 5.980 and 5.990 mm diameter.

Cold forming should be done by either pressing flat between plates or by placing a steel ball (~ 20 mm ø) on the hole and then tapping with a hammer. If using the steel ball method the washer should be turned over and the process repeated.

Before pressing the washer on, the pin diameter should be checked for the correct size of 5.992 to 6.000 mm diameter.

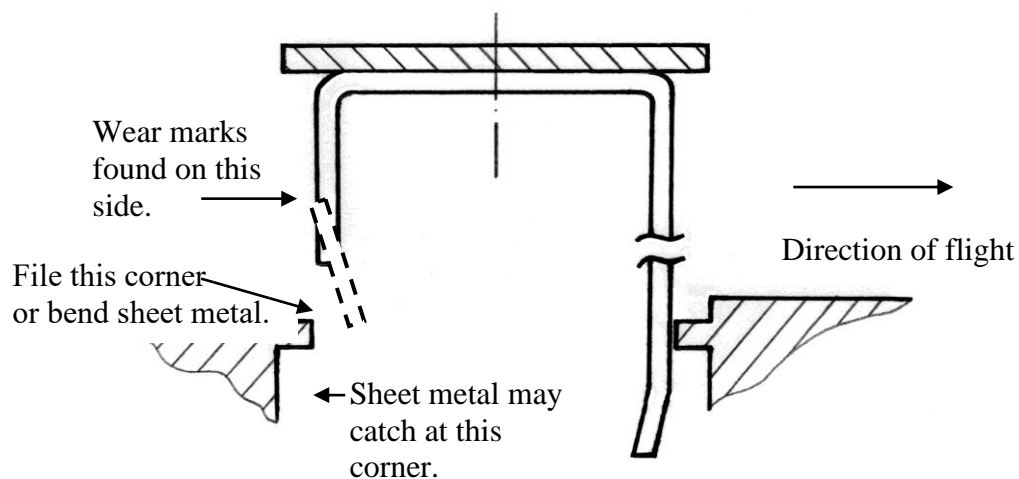
FIGURE 2. POSSIBLE AIR BRAKE JAMMING

3. Scratch marks on the backside of the airbrakes were found on two Standard Jantars (1 and 3). With only little force it was possible to jam the airbrakes when they were extended. So far no incident has been reported but it is strongly recommended to check the airbrakes to prevent possible jamming and perform corrective actions if required (ie. Bevel (file) the corner or slightly bend the sheet metal). See figure 2.

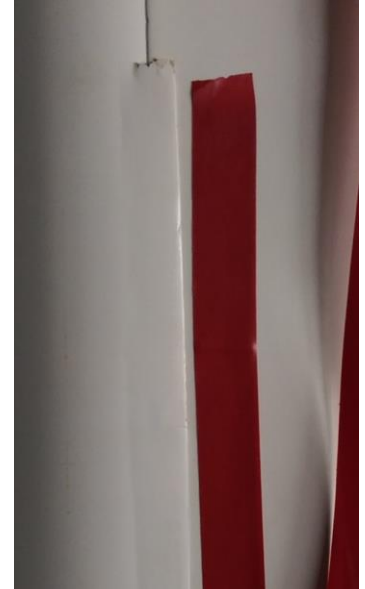
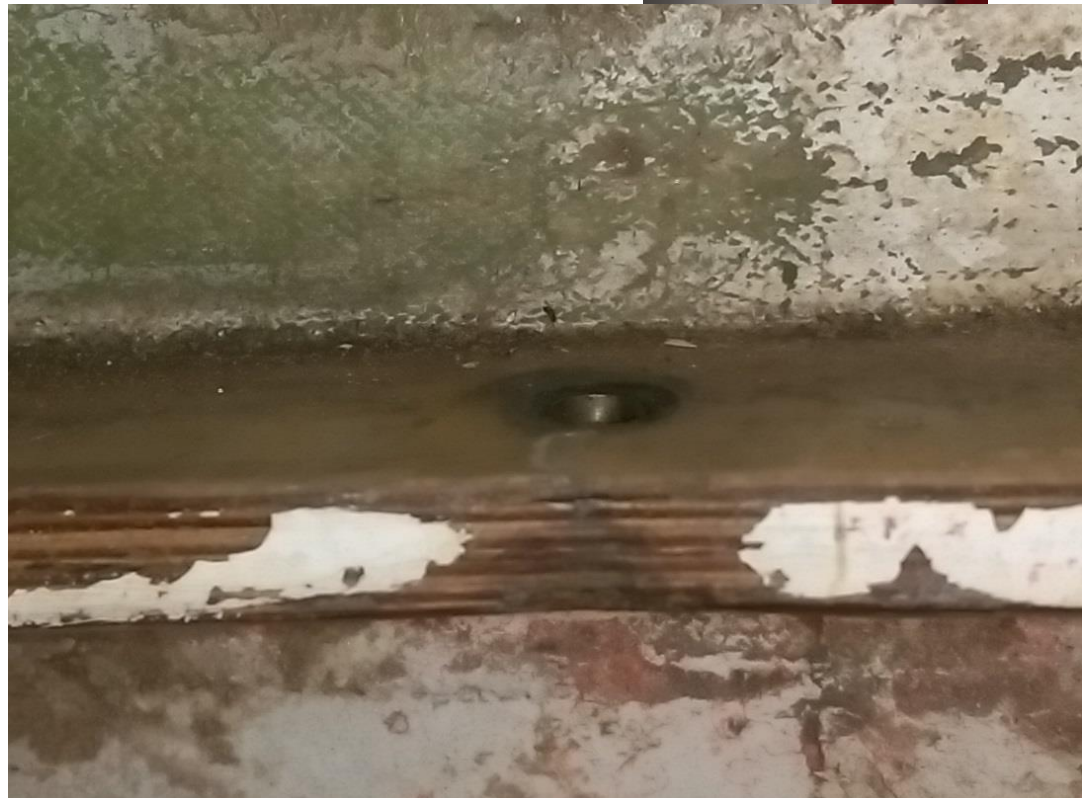
A towing incident applied high twist load to the rudder. This did little apparent damage except for the rudder turning too much and coming out of the fuselage skin – a known defect addressed in AD224. See attached photo with a piece of red tape for scale.

However, on rudder removal it was found that the lower plywood support bracket had cracked loosening the steel bush. The plywood was stressed by the incident and had cracked radial to the hole. See picture below. The bush was loose and at risk of breaking out of the crack.

A second rudder was found cracked in the same location although it was believed undamaged. Both were repaired by reinforcing by an FRP repair around the plywood crack area to secure the bush again. The balance of

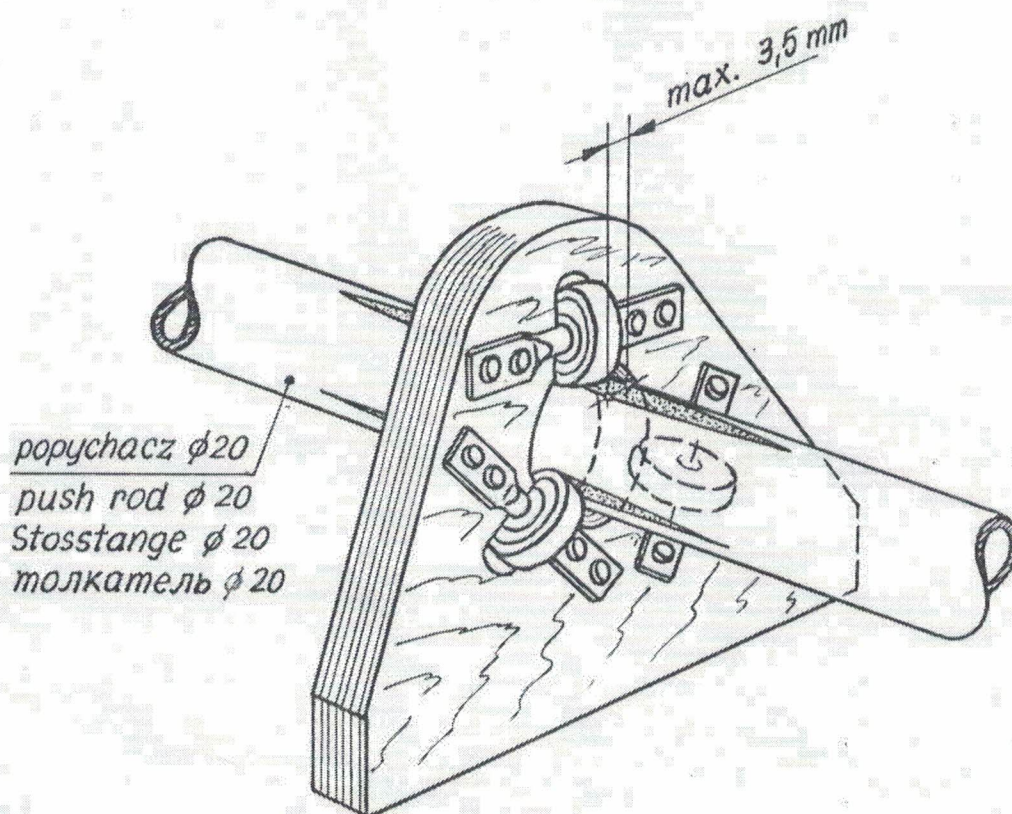
Fig.1.

5.1. The allowed limit width of the roller "trace" on the push-rod surface is 3,5 mm (Fig.1).

5.2. In case the allowed wear value is exceed (even on one place-only) - disconnect the control system and turn the push-rod by 180° . Then secure it and check the adjustment.
