The Gliding Federation of Australia Inc

Occurrence Summaries

01/01/2021 to 31/12/2021

The Gliding Federation of Australia Inc
SOAR Accident and Incident Occurrences

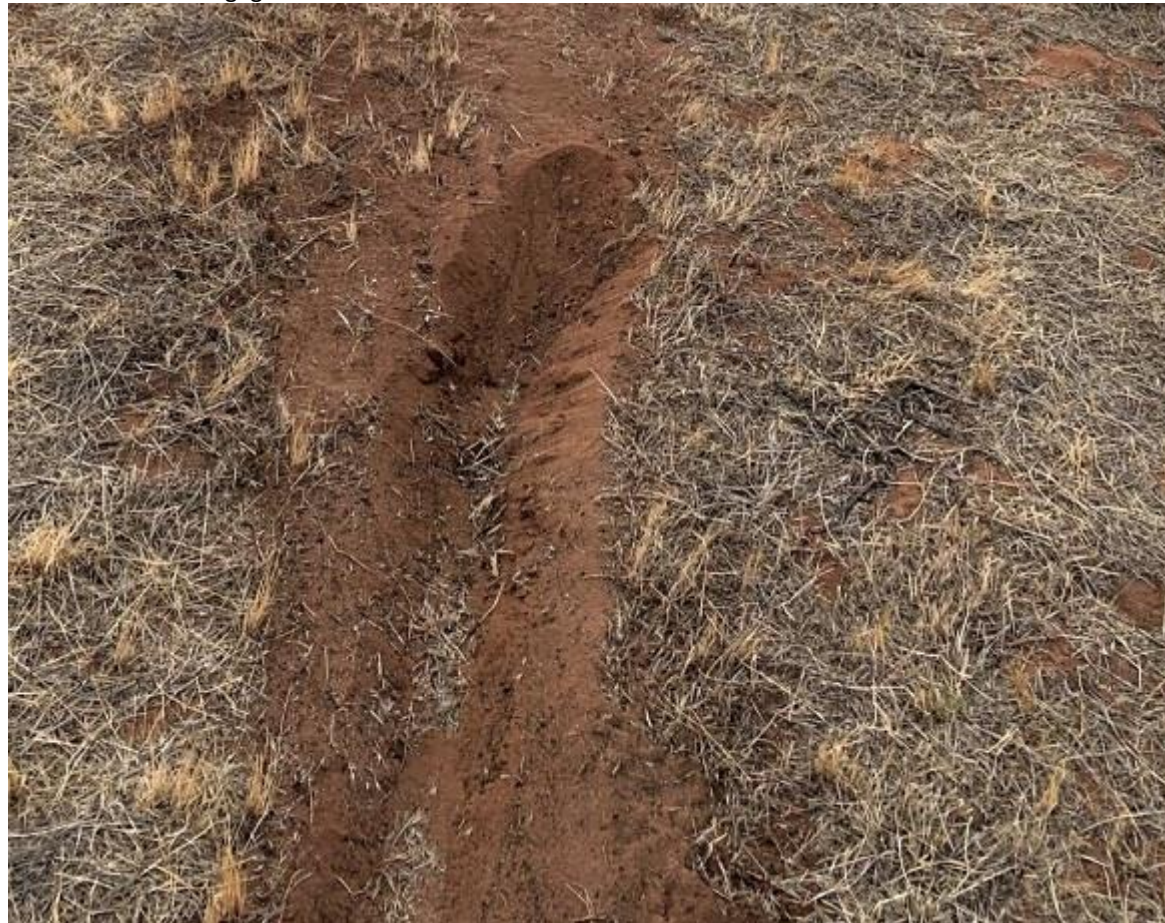
During the landing roll the glider's main wheel dropped into a depression in the grass runway. The impact caused the undercarriage over-centre to disengage, and the wheel retracted. The glider was on a training sortie and was being flown by the student pilot under the supervision of an instructor. Witnesses identified that the pilot conducted a normal approach with the wheel down. The glider touched down normally and then a loud bang was heard, which the instructor thought was the mainwheel striking a rock. It was only after the glider came to rest with the nose lower than normal that the instructor realised the undercarriage had retracted. Upon exiting the glider, the flight crew identified that the mainwheel had fallen into a depression in the grass runway just after touchdown. Subsequent inspection could find no mechanical fault with the undercarriage system but witness marks on the undercarriage frame made by the undercarriage doors suggest that the force of the impact with the runway depression may have cause the overcentre mechanism to disengage.

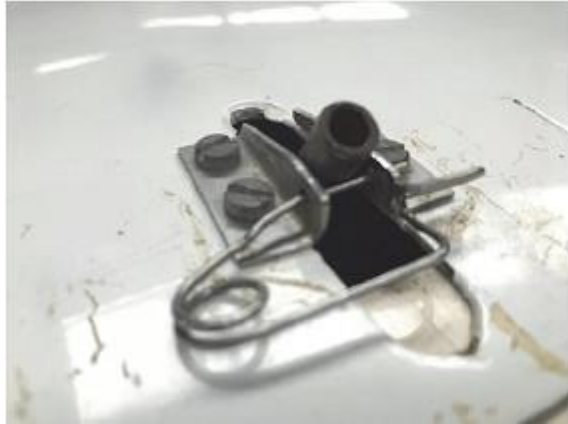
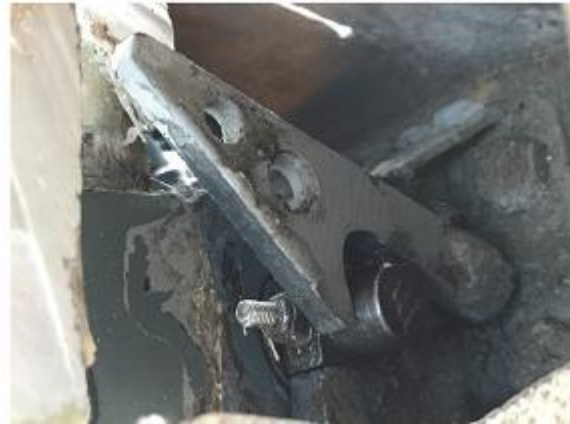
When the pilot rigged the tailplane, he did not push the locking lever sufficiently aft to lock the mechanism and inserted the safety pin behind the locking lever. This resulted in the rear mechanism being engaged but not locked, as the pin prevented the lever from travelling aft to the fully locked position (Figure 3). In this condition the locking hooks were not fully engaged on the axle but the tailplane felt secure and could not be dislodged.

Figure 3. Position of locking lever and locking hooks with lever forward of safety pin. Note: only right hook shown.

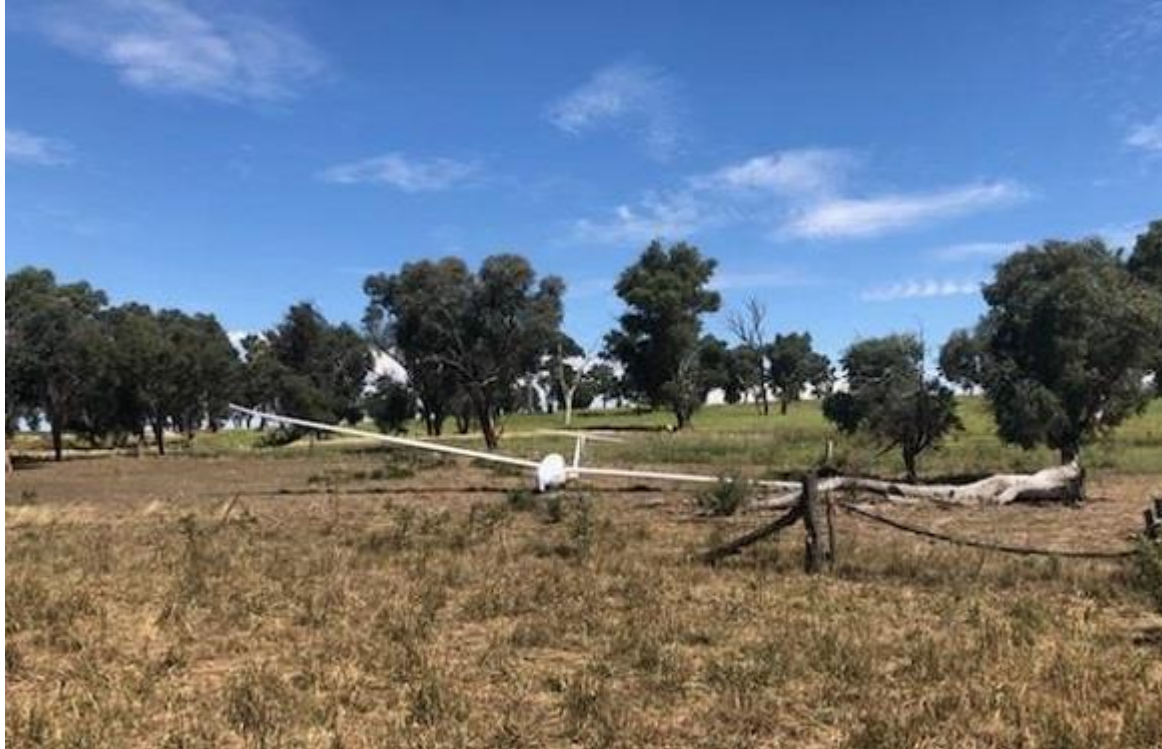
boundary fence. The glider was substantially damaged, but the flight crew were uninjured.

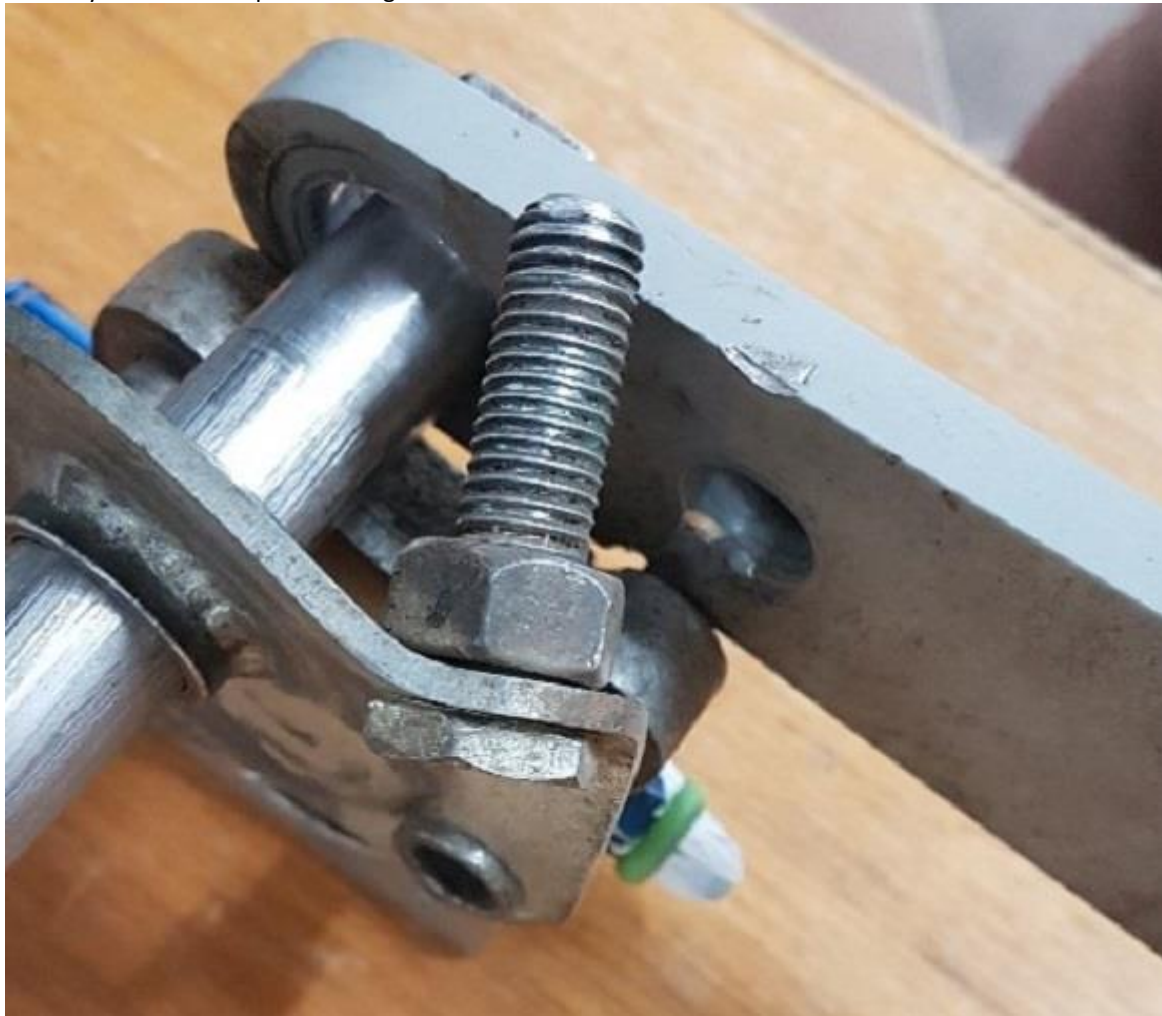
Subsequent investigation of the undercarriage identified that the brake calliper may have suffered prior damage when the glider was last loaded into the trailer. It was found that the fuselage dolly was not properly raised before it was loaded into the trailer, and this allowed the brake calliper to contact the edge of the wheel well resulting in it bearing the weight of the fuselage during transport and potentially distorting the braking mechanism. After several days of flying, the heavier than normal landing was sufficient to finally shear the calliper retaining bolt.

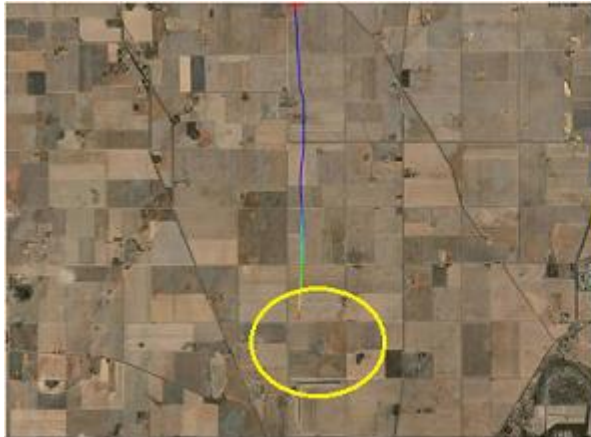
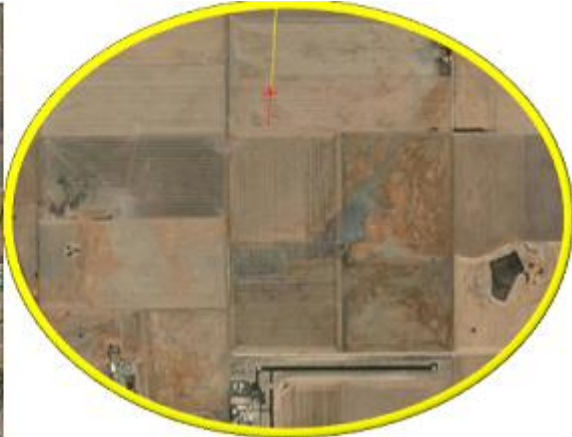
glide progressed without any periods of unusual sink or good lift, and the airfield was in clear view and looking to be sensibly within reach. However, as the glider crossed the finish line 5kms from the airfield reference point at around 500ft AGL, the pilot realised an outlanding would have to be made and began to jettison the water ballast and configure for landing. The pilot chose to perform a straight-ahead approach to land near the southern end of a large paddock that was about 2Kms north of the airfield. The glider touched down at speed and bounced several times. Towards the end of the ground roll the pilot decided to veer to the right to give himself more clearance to the fence ahead of him, at which point the undercarriage collapsed and the glider slid to a stop facing about 110 degrees to the right of the approach path. The starboard undercarriage door separated from its hinges, and a winglet fixing pin was bent.

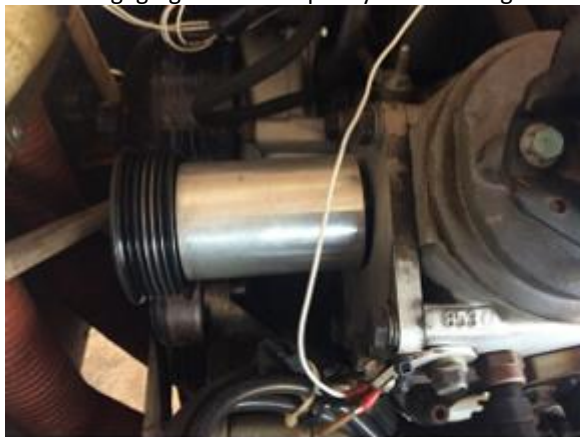
Tow plane is a modified Piper Pawnee that has been retrofitted with an automotive engine and certified under the experimental category. The Auxiliary belt drives the alternator and water pump from a crankshaft pulley. As part of the engine modification, a dummy shaft and pulley was installed to replace the power steering hydraulic pump and pulley. Investigation revealed that this dummy shaft mounting had failed and allowed the belt to be dislodged. The tow plane had completed approximately 1000hrs of service in this configuration without fault prior to this failure. The failure was attributed to the heads of two of the three retaining low-tensile screws shearing. This allowed the "dummy" shaft to become misaligned resulting in the belt disengaging and all the pulleys fell to the ground beneath the aircraft.

Picture 1 misaligned dummy shaft

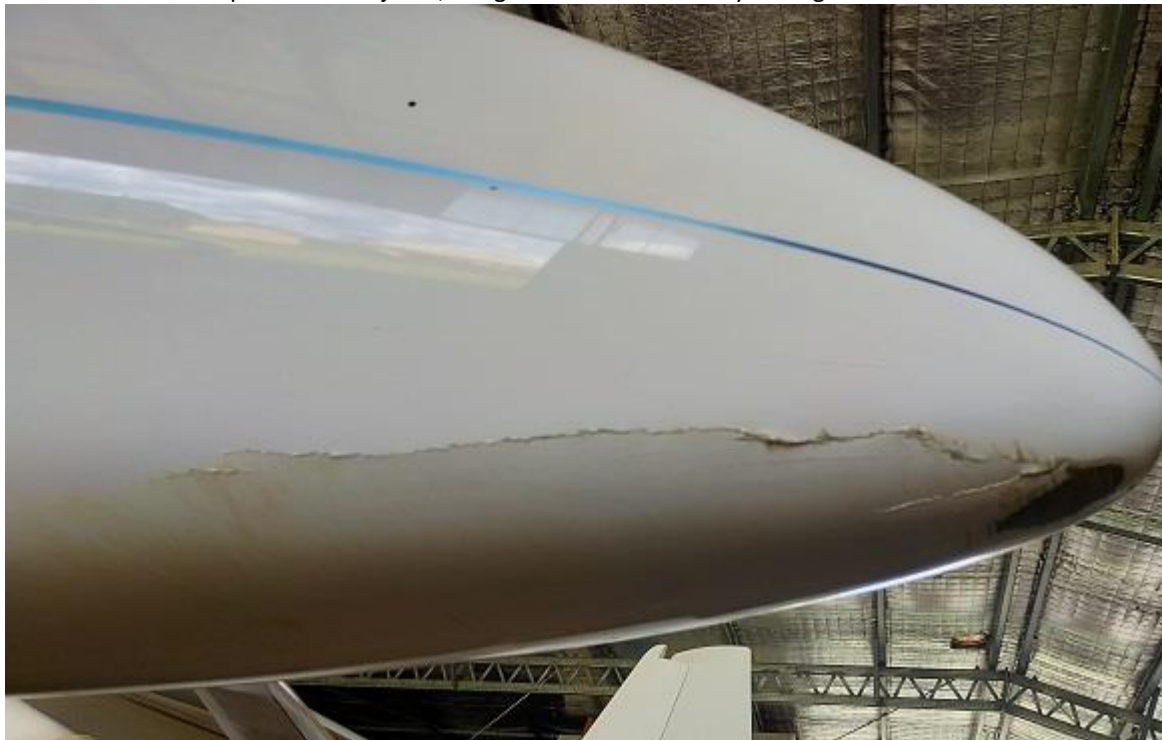
The pilot was undertaking a wing-down aerotow launch in an 8-13 knot crosswind as there was no crew at the launch point. The pilot put the into-wind (starboard) wing on the ground and deployed the airbrakes to improve aileron control at low speed. As the launch proceeded, the pilot found he could not raise the starboard wing due to the tug's prop wash and the glider began to veer to the right with the tail in the air. The pilot was about to release from tow when the starboard wing rose. Believing he could recover the situation, the pilot remained on tow. However, control inputs caused the port wing to strike the ground, and corrective action resulted in the starboard wing dropping back onto the ground. The nose of the glider dragged along the ground for a considerable distance. Unable to regain directional control, the pilot released from tow. While the pilot was uninjured, the glider was substantially damaged.

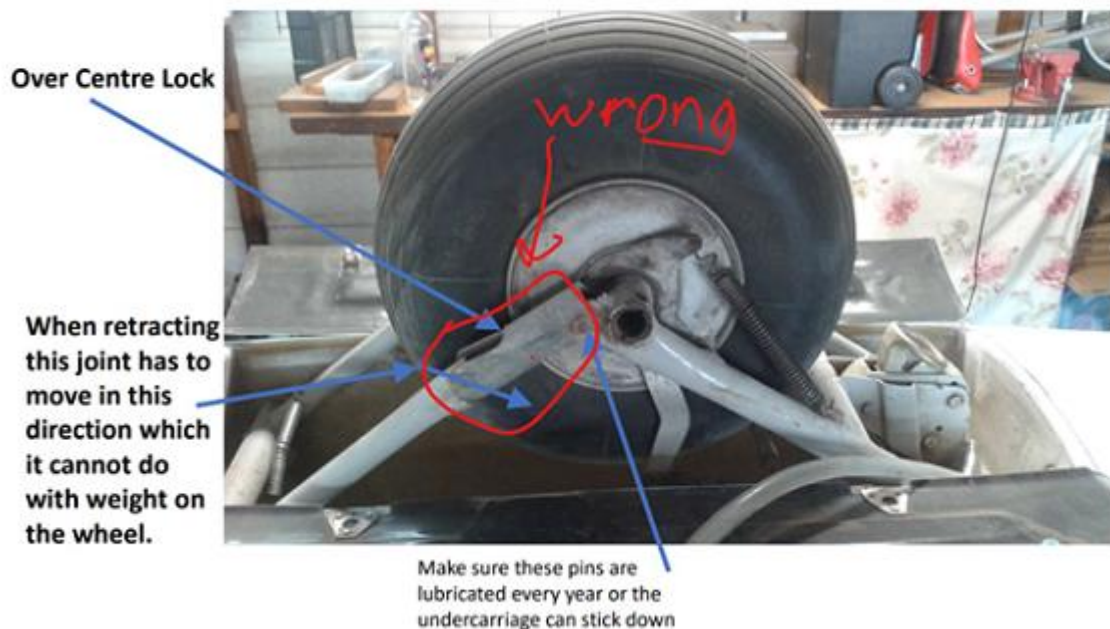
The undercarriage mechanism was subsequently examined, and it was identified that the port-side lower overlocking arm had been installed 180 degrees around. This prevented that side of the glider's undercarriage leg from locking over centre. When the glider travelled across the rough ground, the undercarriage mechanism moved resulting in the starboard leg unlocking. The port-side lower overlocking arm was reinstalled correctly, returning the mechanism back to specification.

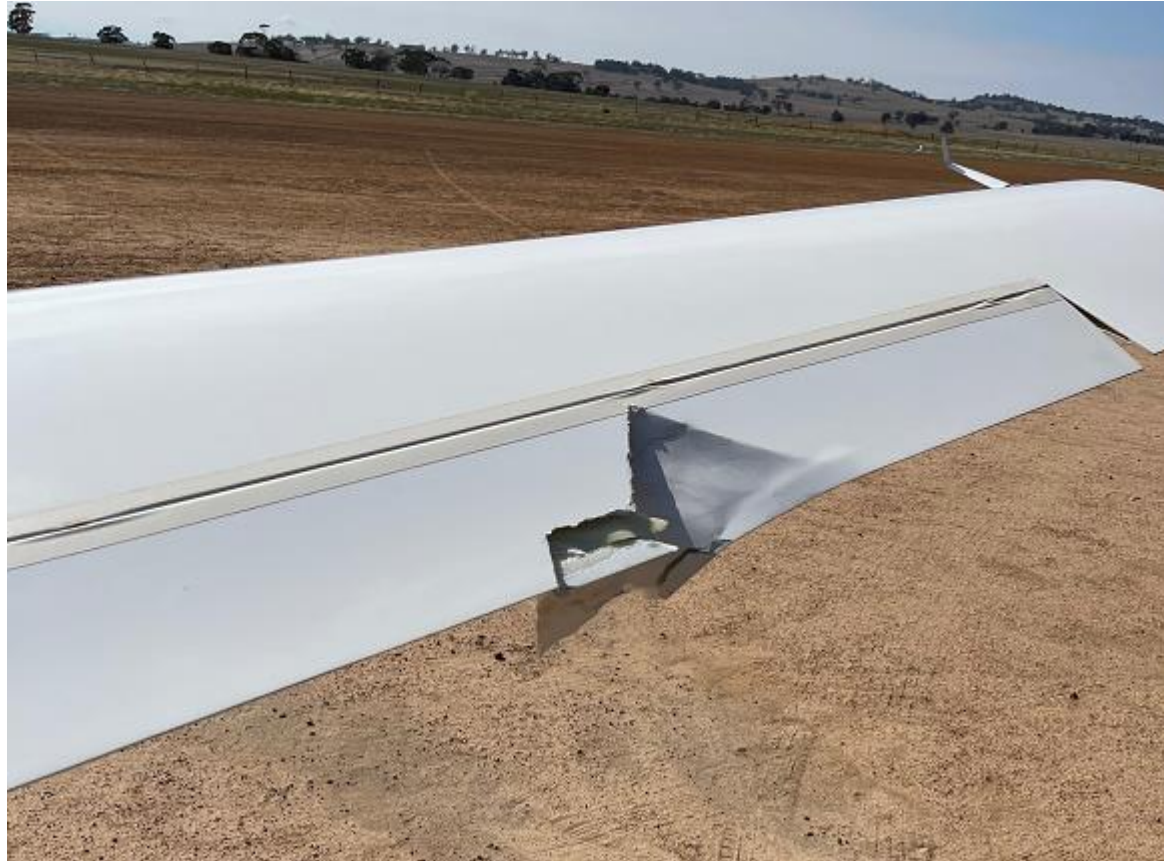
The glider had been towed to the launch point, and while manoeuvring in the tie-down area the vehicle driver misjudged the turn and the starboard wing impacted a signpost damaging the starboard aileron.

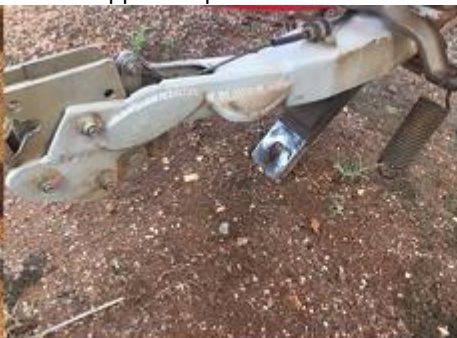
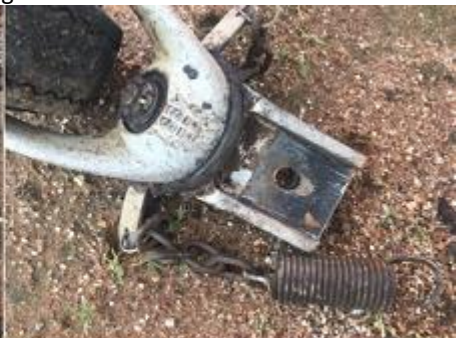
Date	12-Apr-2021	Region	WAGA		SOAR Report Nbr	S-1843	
Level 1	Operational		Level 2	Airframe		Level 3	Landing gear/Indication
A/C Model 1		PA-25			A/C Model 2		
Injury	Nil	Damage	Minor	Phase	Landing	PIC Age	
The tow plane was observed to land normally and during the landing roll the tail wheel assembly separated. Investigation identified the tail wheel spring bolt had sheared, causing the tail wheel unit to fall free from the leaf spring. The bolt was an approved part that suffered a fatigue failure.

Sheared bolt tail		Leaf Spring			Tail Wheel Unit

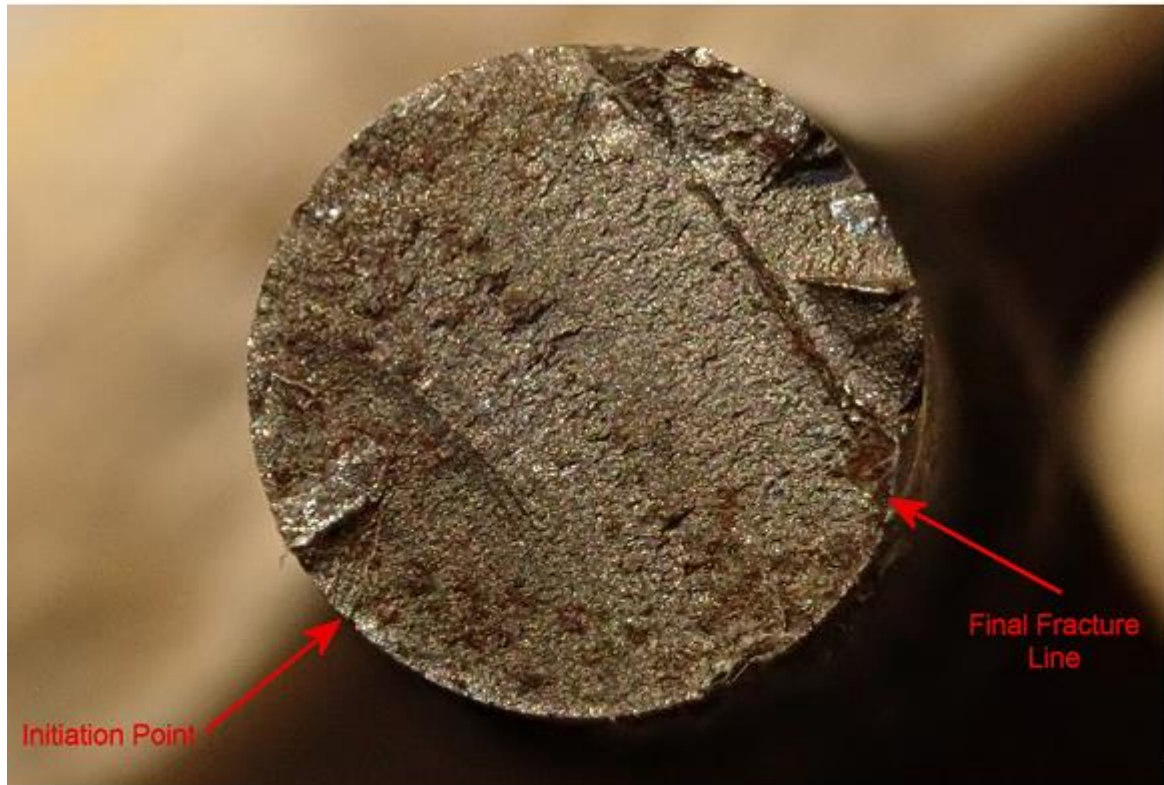
Turnbuckle thread end

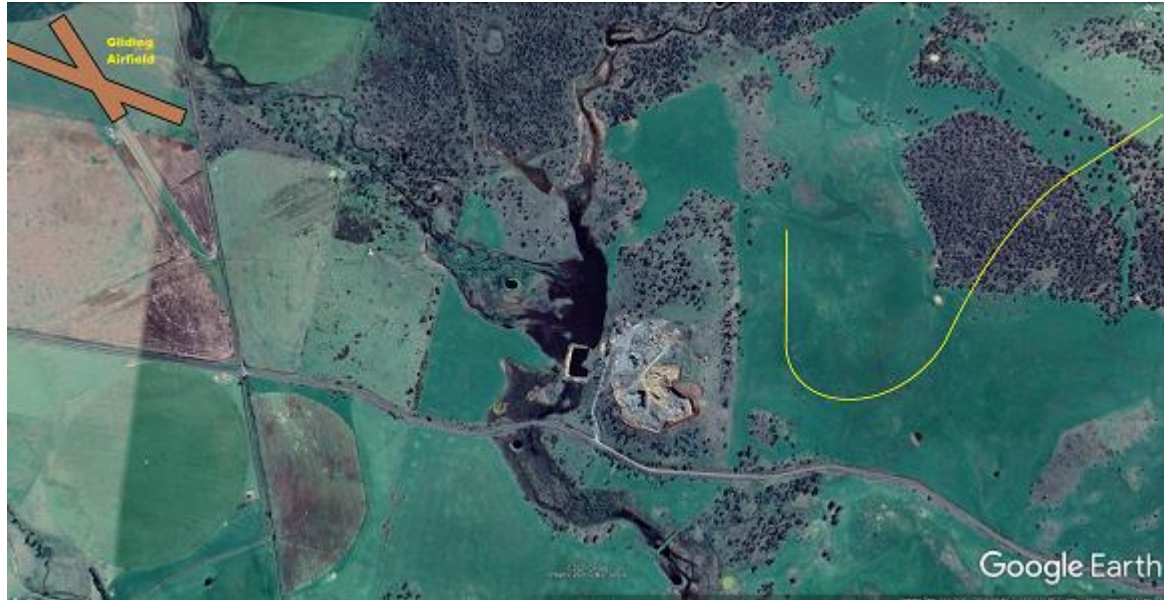
involved lowering the right wing to the ground, the fuselage suffered stress cracks aft of the cockpit, and the starboard wing was damaged when it struck rocks. The pilot was unhurt.

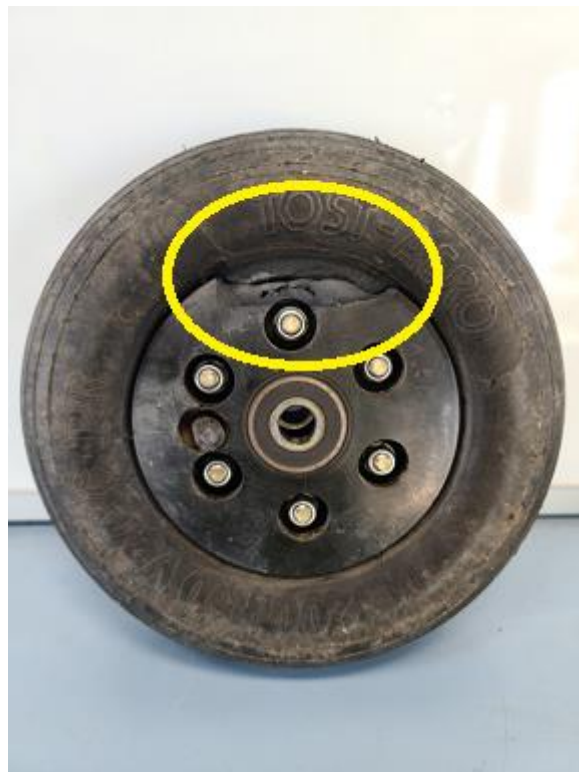
On final approach to runway 27 at about 50ft above the main runway, with the student in control, the indicated air speed started to drop below the predetermined 'safe speed near the ground' of 60 knots. As the student rounded-out, the glider landed heavily tail-first on the runway. The plastic tailwheel hub was broken.

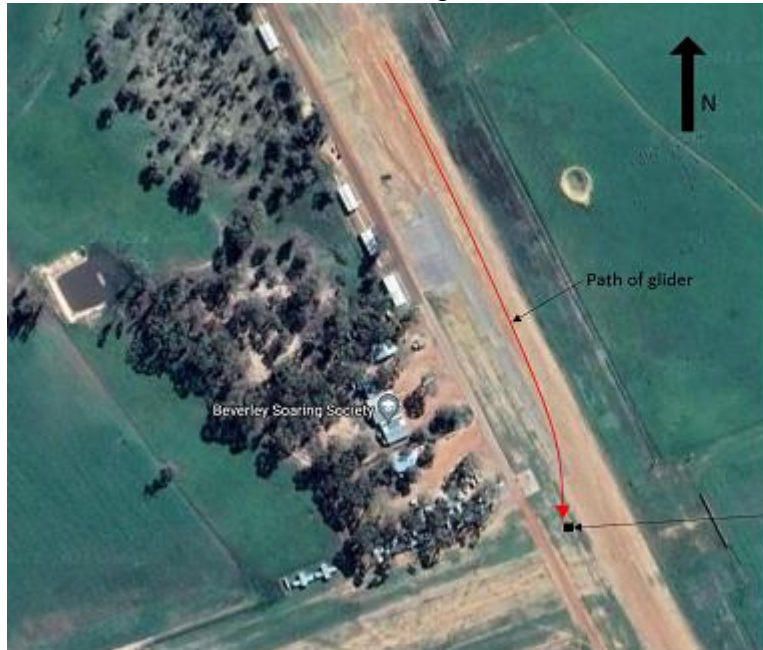
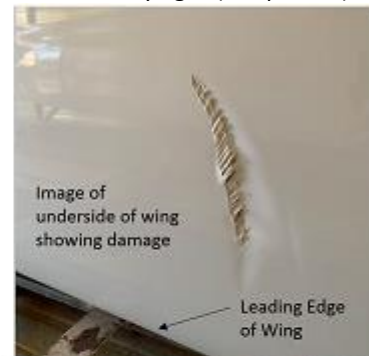
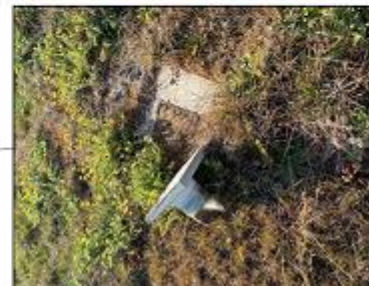
After a local flight in one of the club single gliders, the pilot landed long down the field towards the hangars as the glider was no longer required for the day. As the glider rolled past the hanger location, the pilot turned off the runway onto the grass and came to a stop. Upon exiting the glider, the pilot noticed a runway light behind the left wing had been knocked over. Inspection of the wing found a deep scratch on the bottom on the underside of the left wing where it had contacted the top of the runway light (see photos).

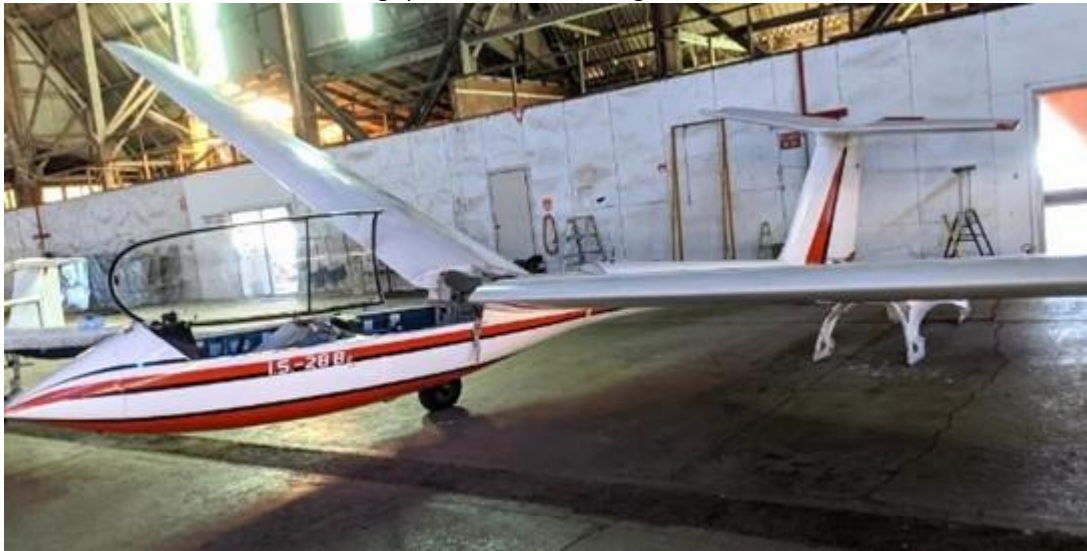
Photo 1 – VH-CQD Post Incident Showing Exaggerated Dihedral

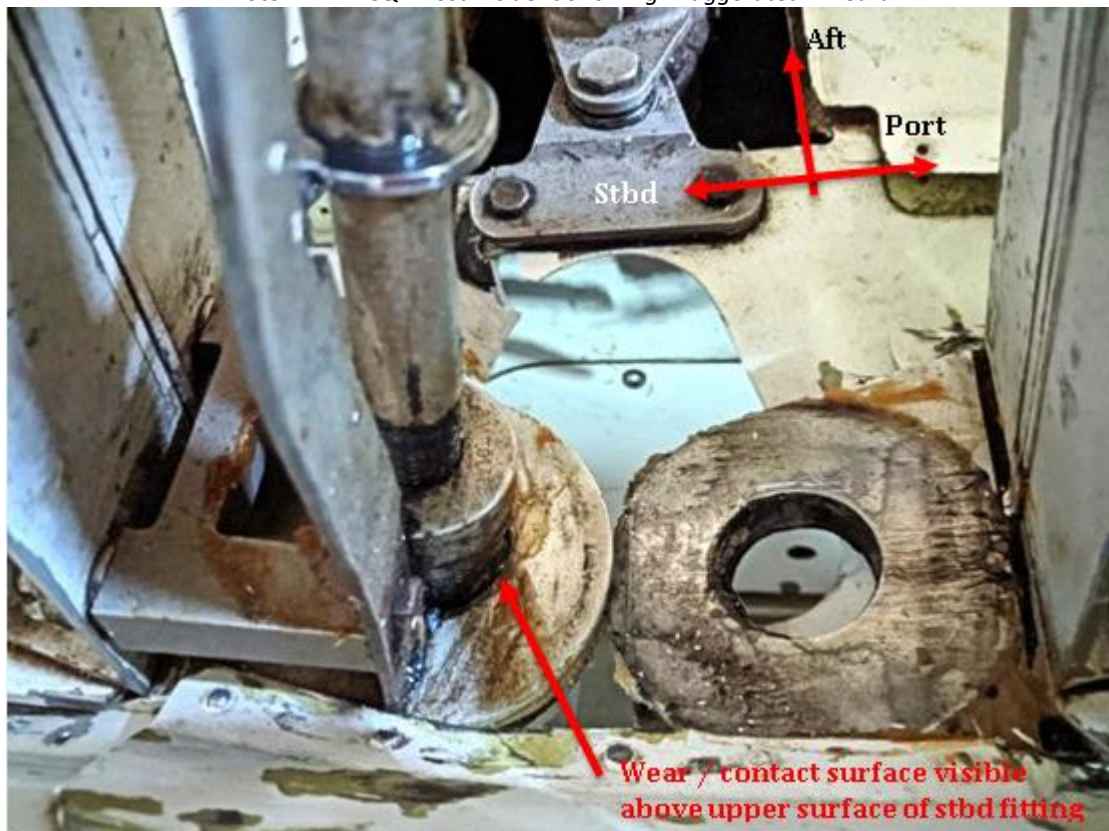
Photo 2 – Lower Spar Connection Post Incident Showing Disconnection of Fittings

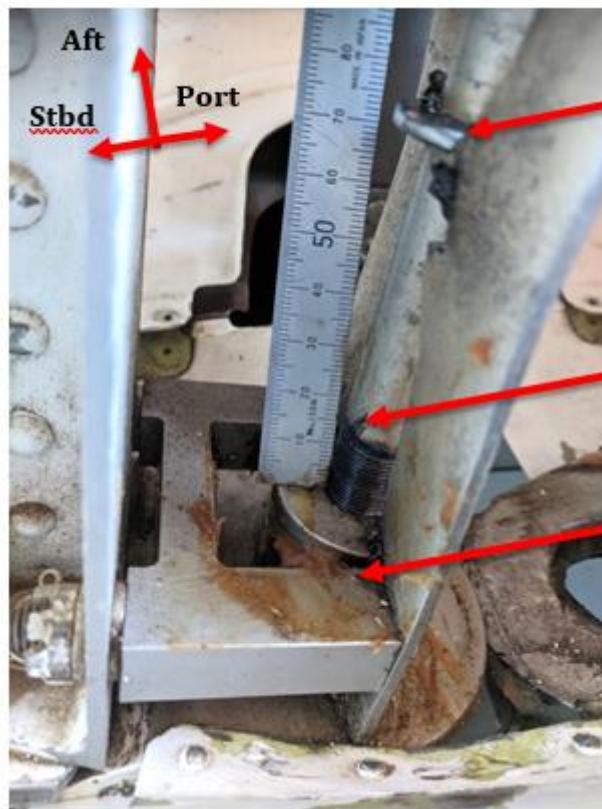
Collar above retaining slots.

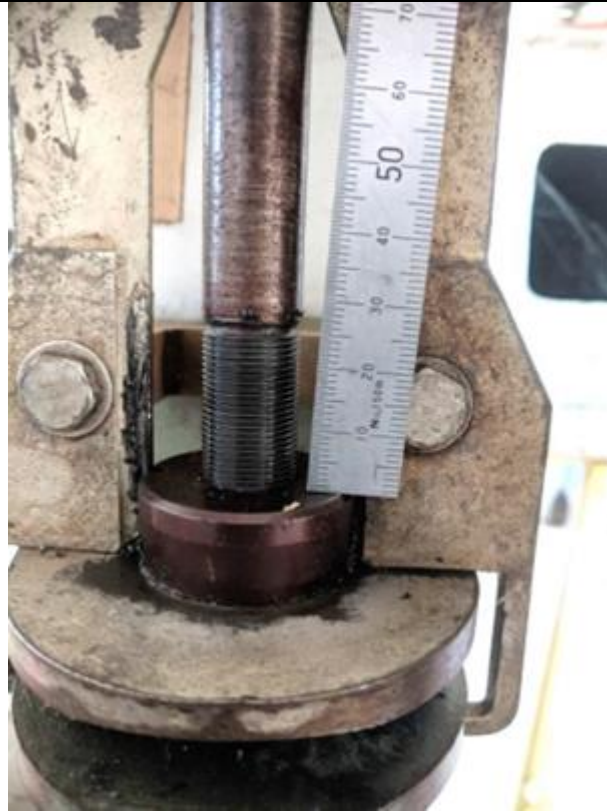
Photo 4 - Correctly engaged lower tapered bolt - 25 mm thread exposed, no wear / contact surfaces of tapered bolt exposed above upper surface of fitting, centre collar housed in retainer.

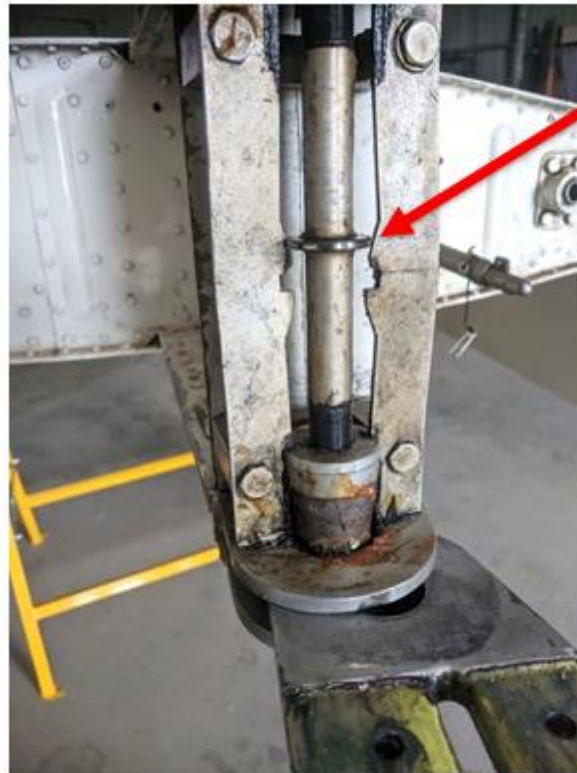
Collar has moved free of retaining slot and the retaining plates have deformed.

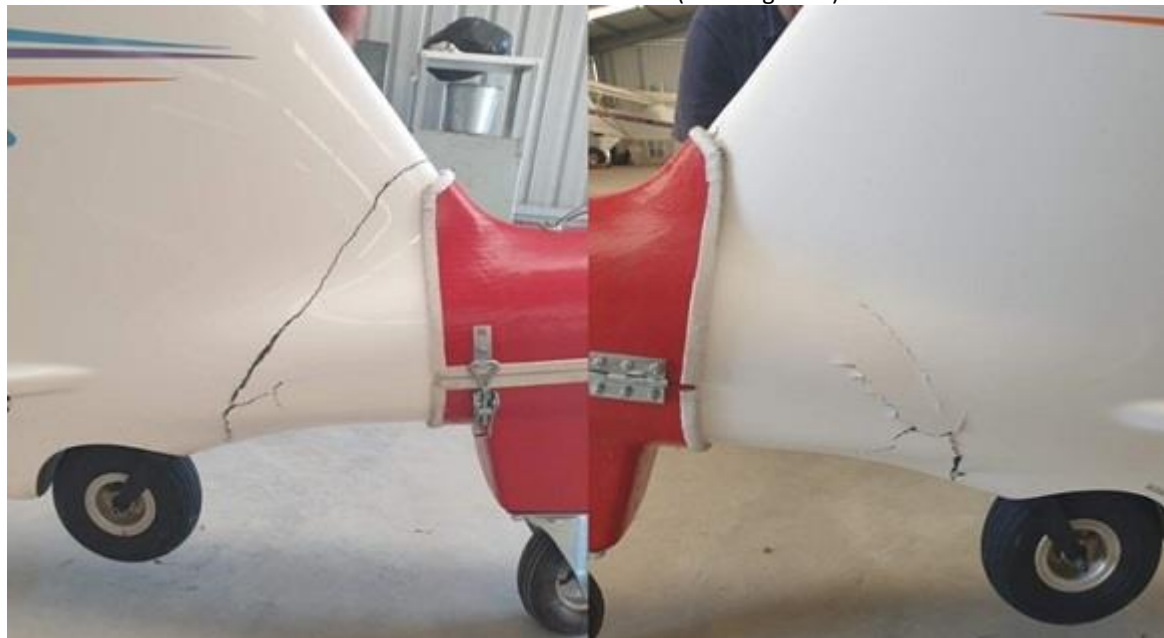
Figure 2: Damage to tail boom

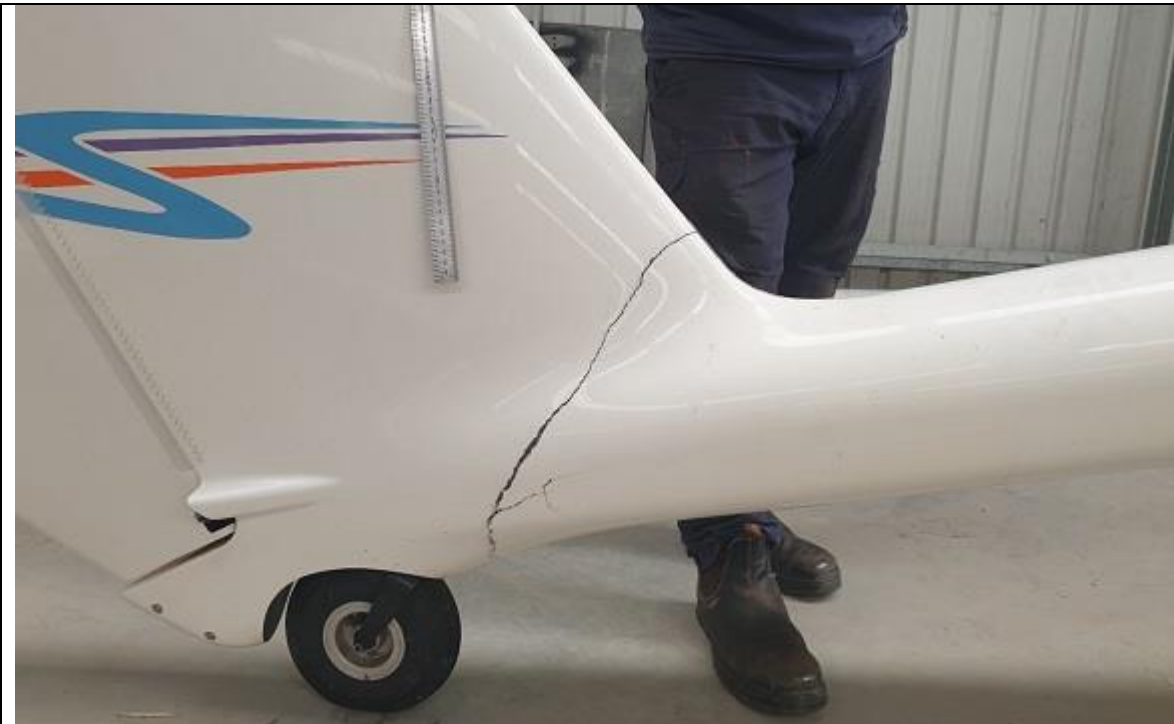
Figure 5: Full thickness fracture on the starboard side of the tail boom.

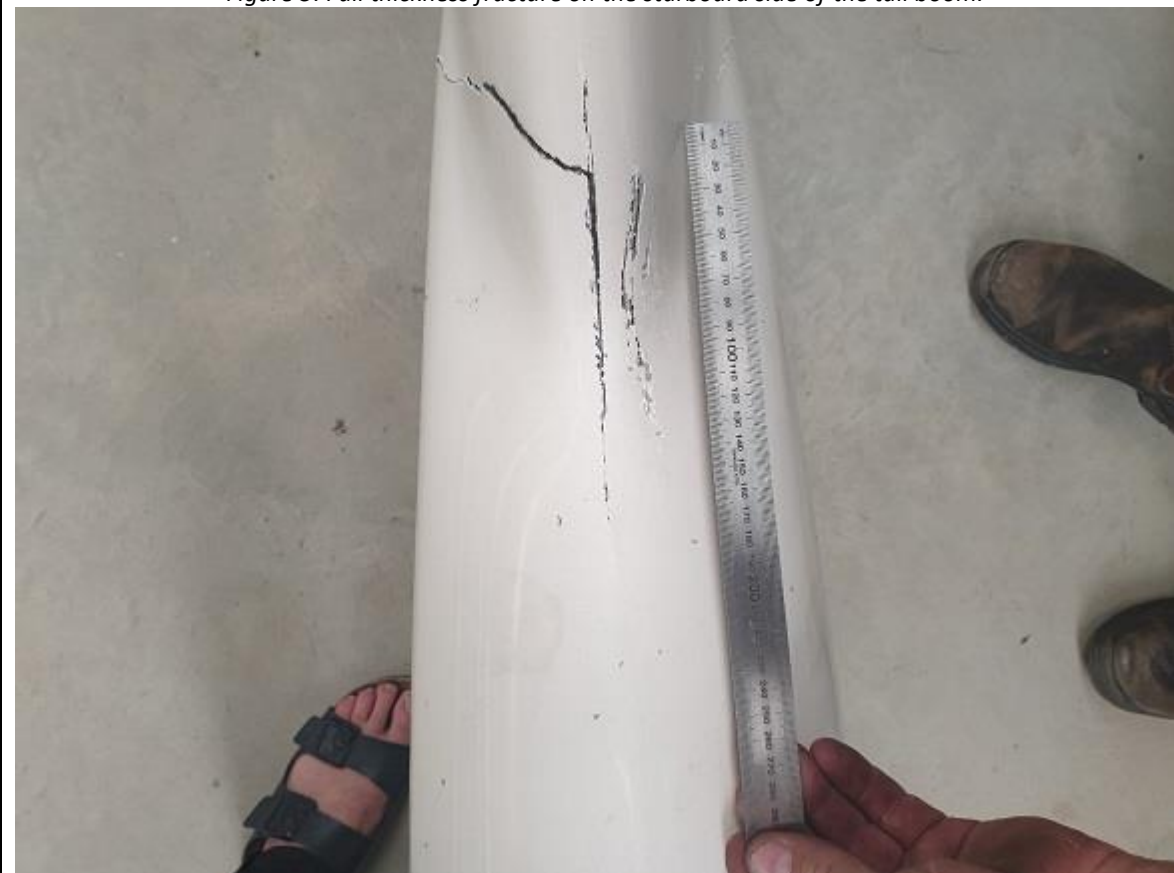
Figure 6: Full thickness fracture on the lower vertical stabiliser.

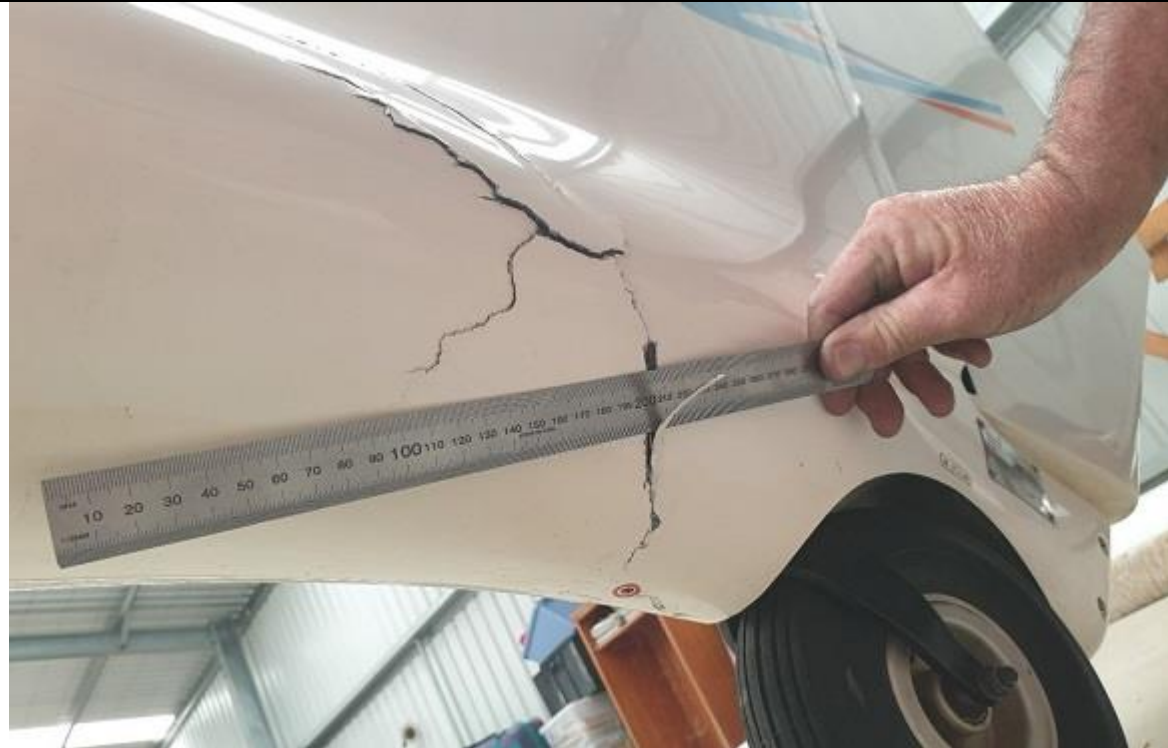
Figure 7: Full thickness fracture on the underside of the tail boom through to the port side.

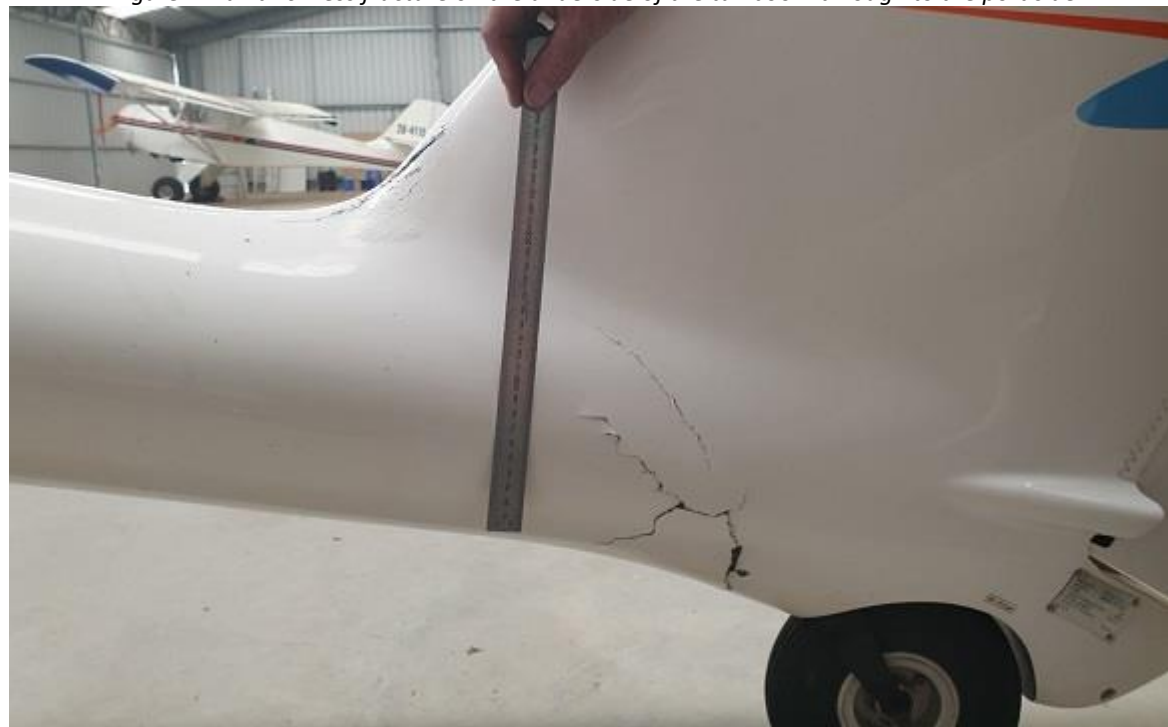
Figure 8: Full thickness fracture on the port side of the tail boom.
