Airworthiness Directive Gliders      GFA/R.Schneider/1/74

Lemke/Schneider LS-1.

74-96 Rolladen Schneider

74-70 Rolladen Schneider

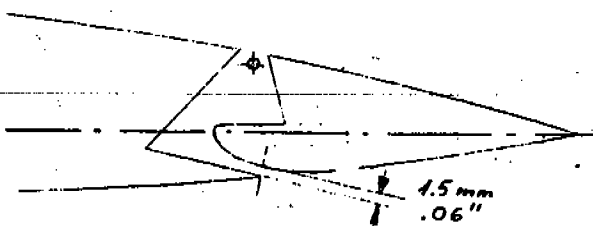
Skizze  
Sketch (A)

Owing to inaccuracy or warp the upwards deflected aileron can be blocked by the lower seal of the aileron slot if the wing is exposed to negative loads.

1. Check of aileron-gap with aileron in neutral position:  
The vertical distance between the lower seal of the aileron slot and lower aileron lip (Dimension according to sketch (A) must at no place be smaller than 1.5 mm (0.06 inch).
2. Check of aileron-gap with aileron deflected upwards 40 mm (1.6 inch):  
The horizontal distance between the lower seal of the aileron slot and aileron-leading-edge (Dimension according to sketch (B) must at no place be smaller than 1.5 mm (0.06 inch).
3. If at any place a smaller distance is found, the accurate distance as given above, are to be established by grinding or shortening of the lower seal of the aileron slot.

It is recommended to check the dimension of the gap by inserting a small plate of 1.5 mm (0.06 inch) thickness.
