# THE GLIDING FEDERATION OF AUSTRALIA

## AIRWORTHINESS ALERT

### & request for information 2004-1

### SZD-50-3 PUCHACZ

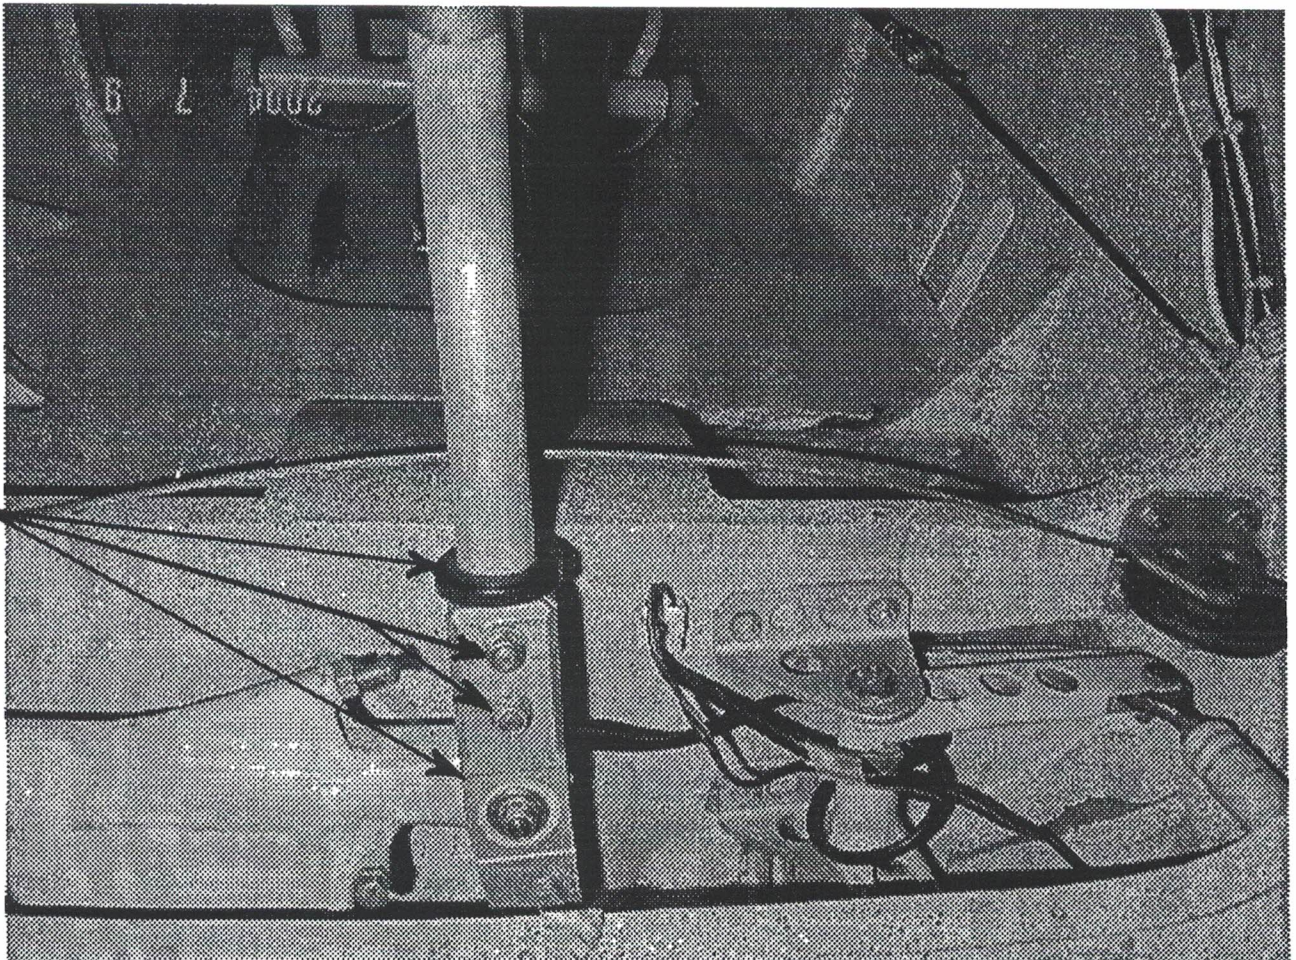
A report has been received from Poland where last week-end a Puchacz suffered a complete failure of the front control column. At this stage the precise details of the failure or the outcome of the incident are not known but it is believed to be a fatigue related failure. It is known that the aircraft had only done approx 1500 hours and the Poles have grounded their Puchacz fleet pending an inspection of the front control column. Prudence suggests we should do likewise.

POTENTIAL CRACK SITES

1. Before further flight, inspect the aircraft for cracks in the area shown on the attached drawing. Be imaginative, as we are not sure yet which part actually failed.
2. Ground the aircraft, pending rectification, if cracks are found.
3. Notify results of inspections to GFA without delay (whether cracks found or not).
4. Inspection to be performed by or under the supervision of a person holding a current GFA Airworthiness Authority endorsed for Inspection for issue of a Maintenance Release or higher.

5. Undo both nuts and tap out bolts with a soft drift.
6. Remove parts and examine control column in area around bolt holes and where it emerges from the aluminium parts just removed. Also check the front and rear halves of the fork. Use a magnifying glass of at least 3X power, preferably 5X. Dye penetrant method may also be used. (shield the bearings when spraying the fork halves!)

7. If any cracks are found the aircraft is to be withdrawn from service until replacement parts have been fitted. If no cracks are found the aircraft may be returned to service.
