COMMONWEALTH OF AUSTRALIA.DEPARTMENT OF TRANSPORTAIR TRANSPORT GROUPAIRWORTHINESS DIRECTIVE - GLIDERS

GFA/AD 53/LET 5

Glider Types affected - L-13 Blanik (all serial numbers)Subject:

Amendment to the maximum time in service between major inspections (G.F.A. Form 2 inspections) and amendment to flight manual airspeed values in annex 2 Performance Characteristics - refer Pilot's notes for the L-13 Sailplane, 2nd and 3rd edition.

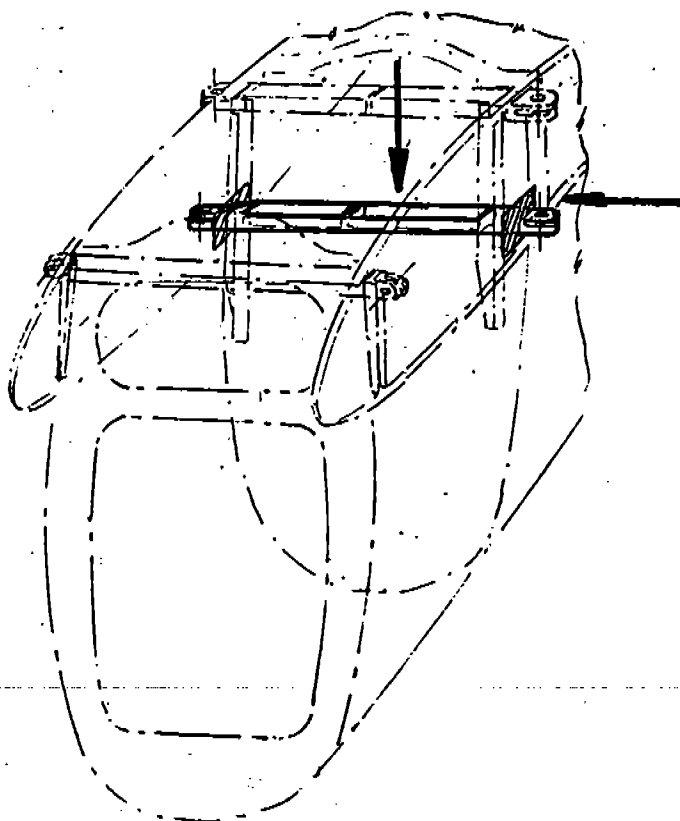
1

3. Check the bottom flangeplate of the centre-section spar for water penetration (see Fig. 1). Wipe out water, if any, and check for corrosion. Clean the affected spots using emery cloth and coat with varnish. Seal the gap between the rib and the fitting on the fuselage with fabric strip.

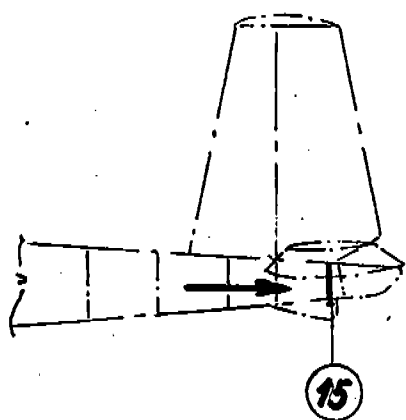
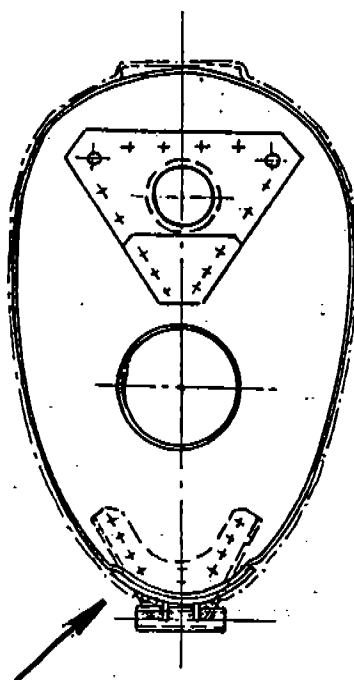
2

5. Check the bulkhead No. 15 for cracks in the area of tail-skid suspension. (See Fig. 2) Two cracks of 10 mm max. in length are permissible in the lower part of the bulkhead in the area of tail-skid suspension. In such a case, holes must be drilled into the ends of the cracks using a 2.1 mm dia. drill. If the length of cracks exceeds 10 mm or if there are more cracks found, it is necessary to replace the bulkhead.

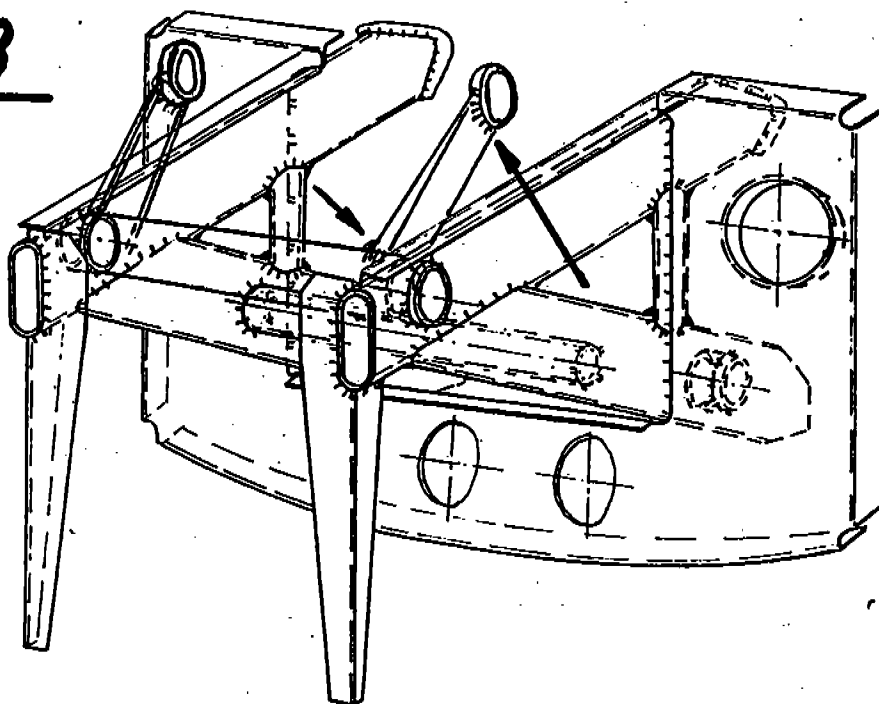
3

6. Check the tail-skid rubber shock absorber. Replace if torn up.
  7. Check the pivoted suspension of the undercarriage shock absorber and the single-arm lever (see Fig. 3) for cracks. Check all welds - replace defective parts.

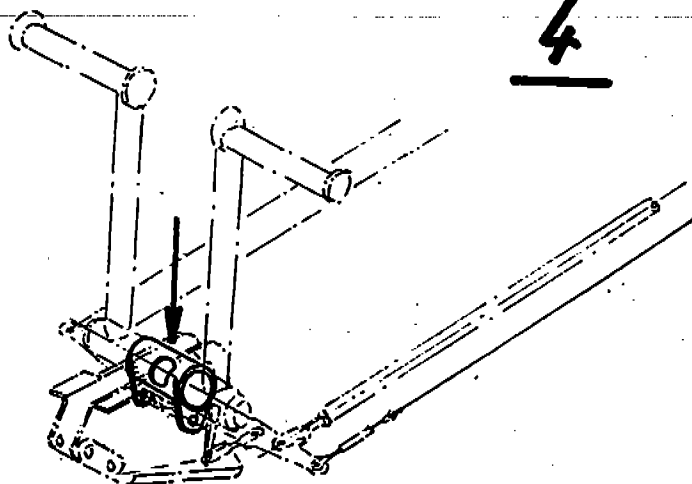
4

8. Check the rocker arm of the front pedal unit for cracks (See Fig. 4). Replace if cracks are found out. Check the clearance of the pedals. If larger than 2 mm, the pedals must only be set in the two extreme positions.

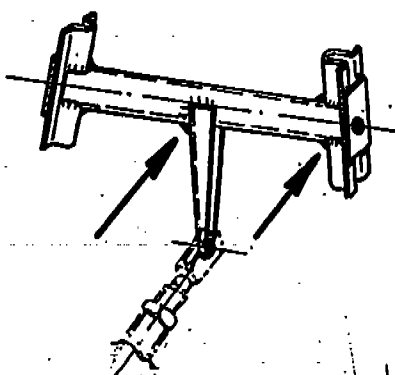
5

10. Check the elevator actuating arm for cracks (See Fig. 5). Replace if cracks are found out.
  11. Check the stiffeners for cracks in the areas marked by arrows (See Fig. 6). Replace if cracked.

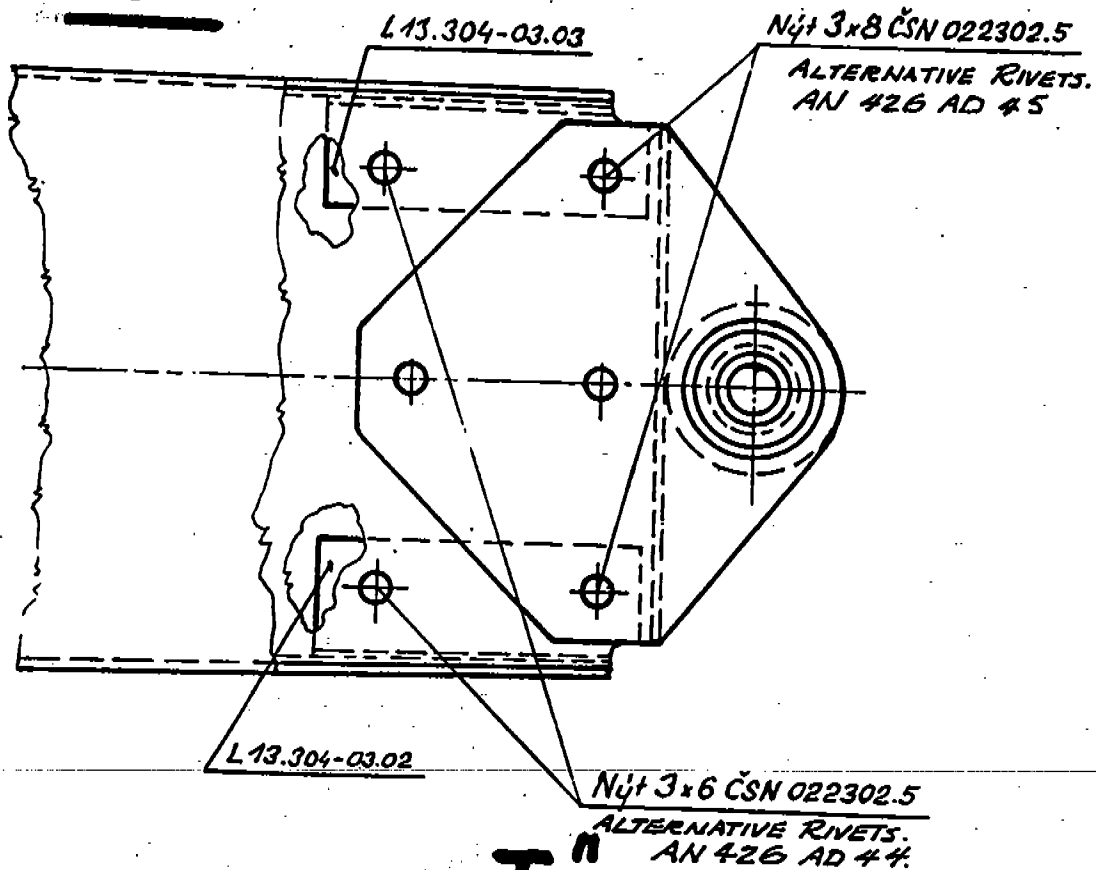
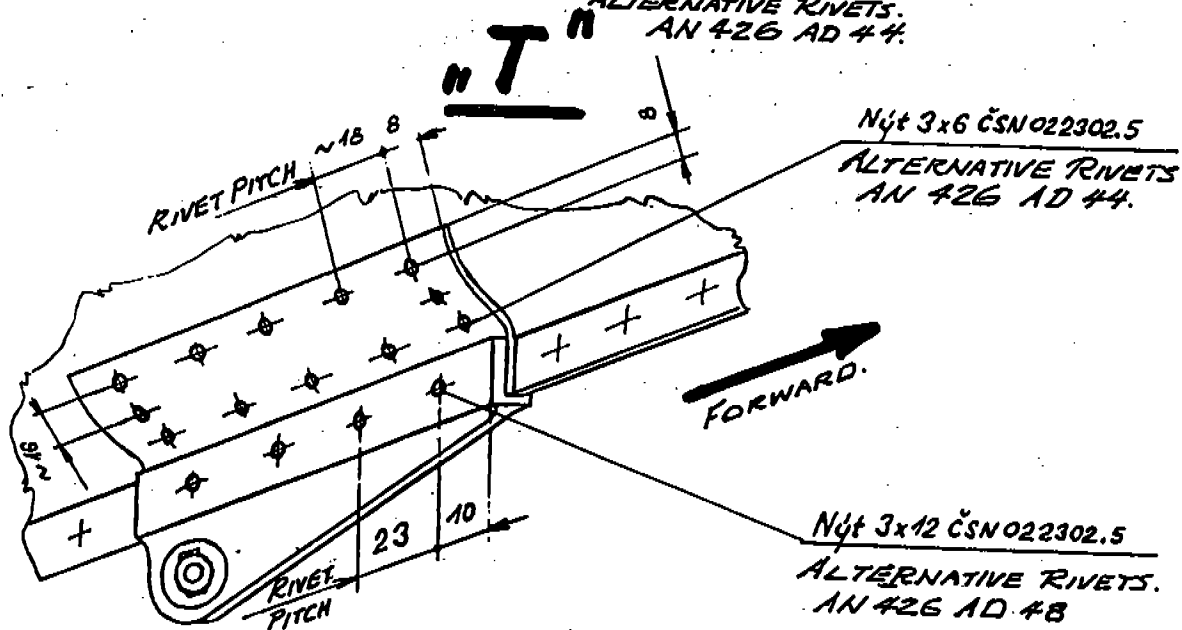
7

12. Inspect the front suspension of the tail skid, check its attachment. If damaged, replace it by a new one, SK-L 13.165, and reinforce the attachment area of both sides of the fuselage by means of a 0.8 mm thick, 60 x 100 mm size sheet, made of B16T material (See Fig. 7, detail T).

- 
13. Check the upper suspension lug of rudder and its vicinity for cracks. Reinforce the cracked areas, if any, by means of angle irons L 13.304 -03.02. (See Fig. 7, View S).
