AIRWORTHINESS DIRECTIVE - GLIDERS

GFA/AD 61/GLASFLUGEL 5

Glider Types Affected: Glasflugel H301 & H301B Libelle (from Serial No. 2, however No. 2 to 85 only if the elevator bracket has welded assembly guides instead of screwed guides);
Standard Libelle 201 & 201B (all serial numbers);
Club Libelle 205 (up to serial number 107)
Hornet (up to serial No. 3)

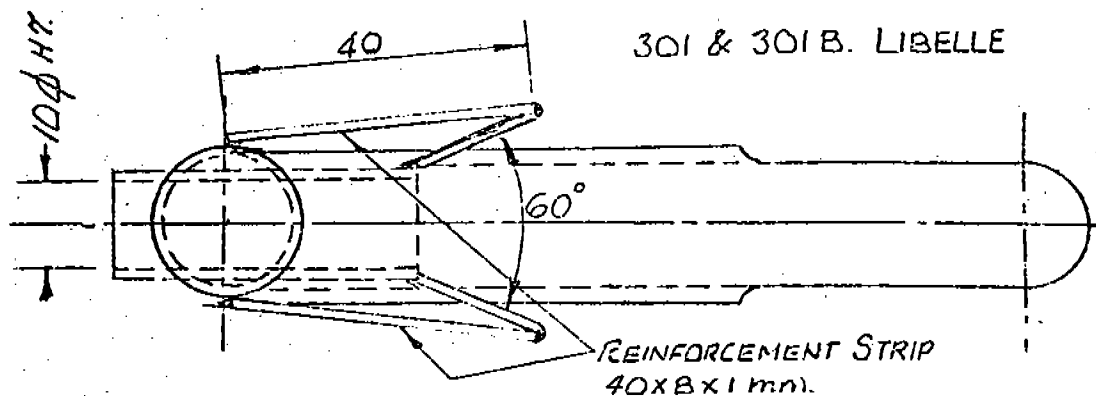
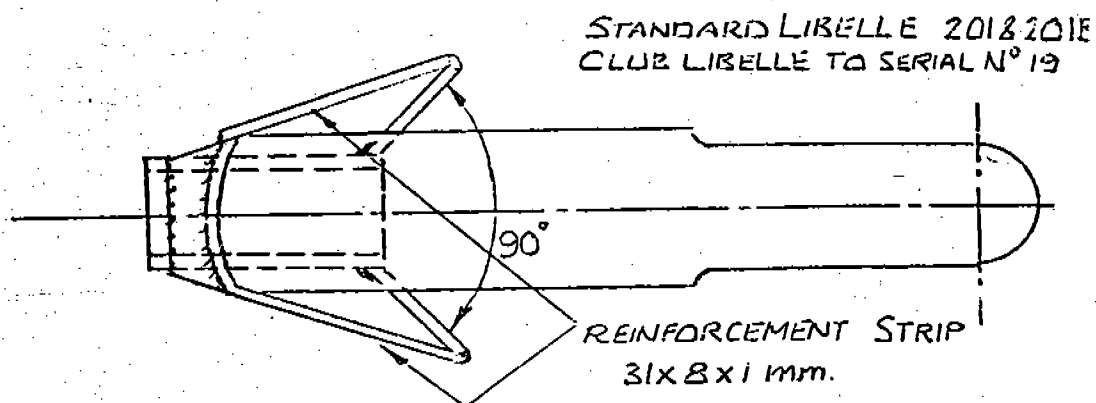
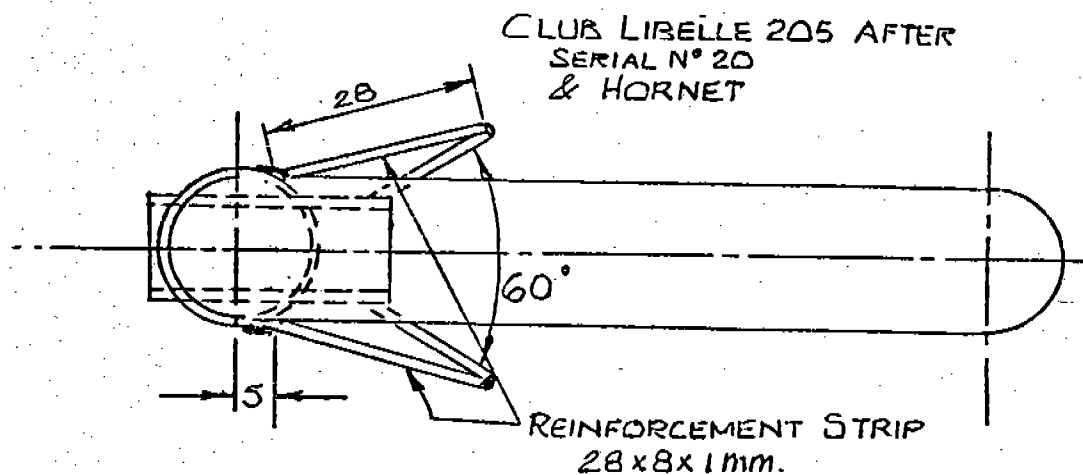
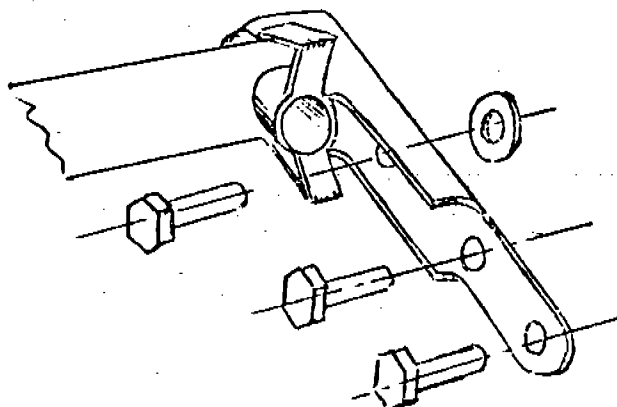
Due to careless assembly of the tailplane, damage to the assembly guides can occur which could lead to possible incorrect assembly of the tailplane and loss of elevator control.

1. With a magnifying glass of at least 5x magnification, visually inspect the tailplane assembly guides for distortion, bending and/or cracks in the welded seams.
2. If any damage is detected, the bracket is to be removed and reinforced according to detail shown in attached drawing or replaced with a new reinforced bracket before further flight.
3. If no damage is found, the glider may continue in service but the bracket is to be reinforced or replaced with a reinforced bracket before date set out in "Compliance".
4. The bracket is to be reinforced by welding two metal strips to dimensions shown on drawing. Steel to be 4130 chrome molybdenum sheet 1mm thick; welding is to be carried out by a Department of Transport Approved aircraft weld using the Tungsten Inert Gas (T.I.G.) process.

After removing the bracket, insert a 10 mm pin into the tube for the actuator pin to prevent distortion during welding. The pin should be a sliding fit; remove the pin when the filling has cooled after welding.

Clean up and repaint fitting to protect from corrosion.

Reassemble bracket to tailplane paying attention to fit the two washers between the bracket and the ball bearings.
