Schemp-Hirth Standard Cirrus.

BACKGROUND:

Technical Note No. 278-18

Reinforcement of the seat

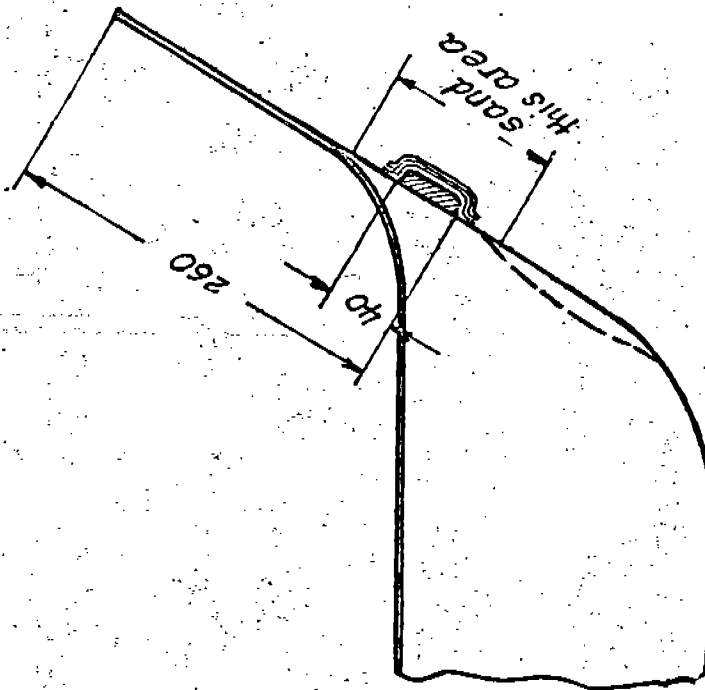
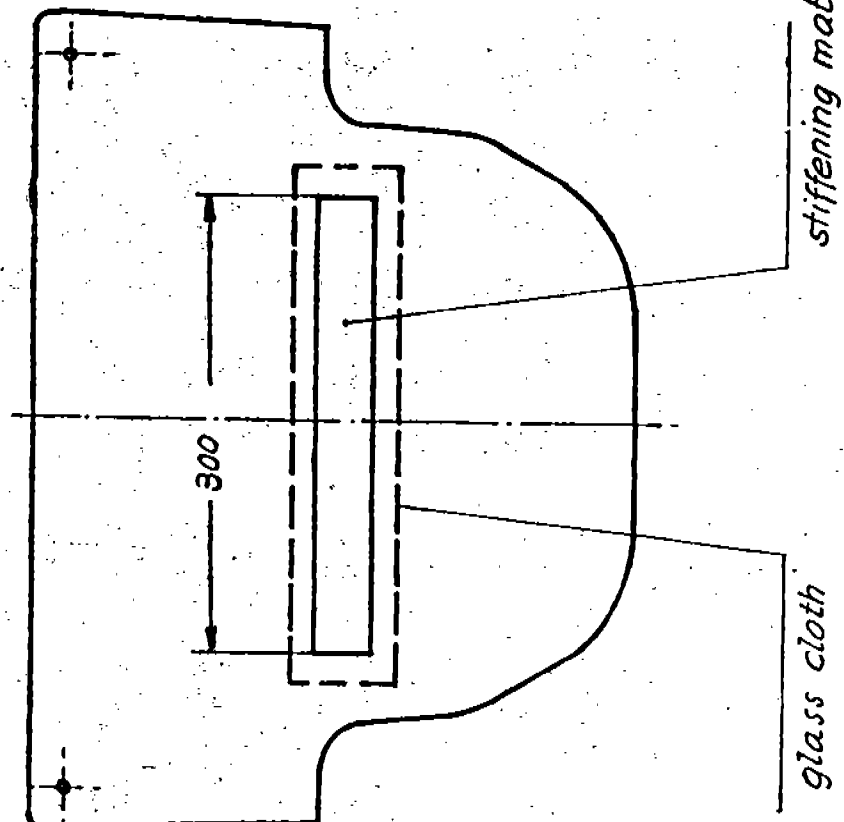
It has been found that with a heavy pilot or if the upper attachment bolt holes are elongated it is possible for the pilot's seat to deflect sufficiently to obstruct operation of the release hook. Additionally it has been found that if the left aileron push-rod is not connected the intermediate rod may cause jamming of the aileron control.

- 1 a. Check if the seat is already reinforced as shown in sketch No. 1; if not, proceed as follows -
- 1 b. (i) Sand the area to be reinforced with sharp sandpaper.
- (ii) Adhere the stiffener core material which may be foam styropor, or conticell, plywood or solid wood 300 x 40 x 10 mm using epoxy. Epecote 162 and Laromin C260 hardener or similar thickened with microballoons or chopped cotton wool. Lay up over the stiffener with three layers of Intaglas 92125 glass cloth or equivalent each about 350 x 100 mm.
- 1 c. After curing of the resin reinstall the seat and check that the release hook can be operated without obstruction.
