INCIDENT REPORT

VH- [REDACTED] PROPELLOR FAILURE

Issue 2

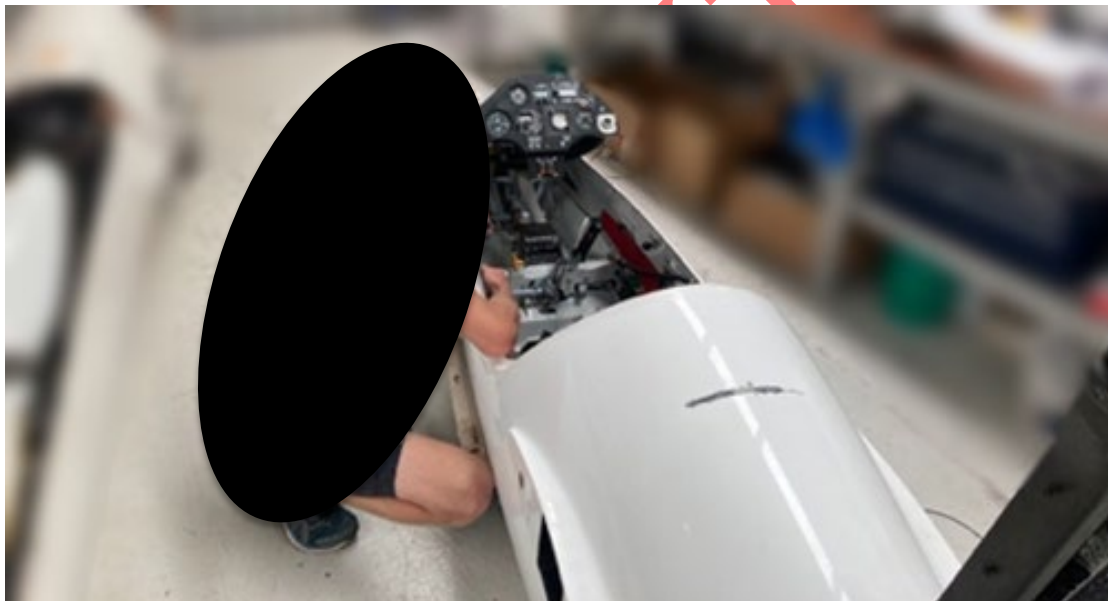
The propellor struck the upper fuselage between the pylon and the rear edge of the cockpit. The propellor then travelled forward and to the left and struck the senior engineer on the left hand rear of their head. The propellor continued for a further 30 meters, passing close to the safety observer before impacting two sailplane trailers.

Photo 1 – Recreation of Senior Engineer Position With VH- [REDACTED] Post Incident. Sailplane Has Been Moved into a Workshop. Propellor Strike on Upper Fuselage. Propellor Pylon Visible at Bottom Right

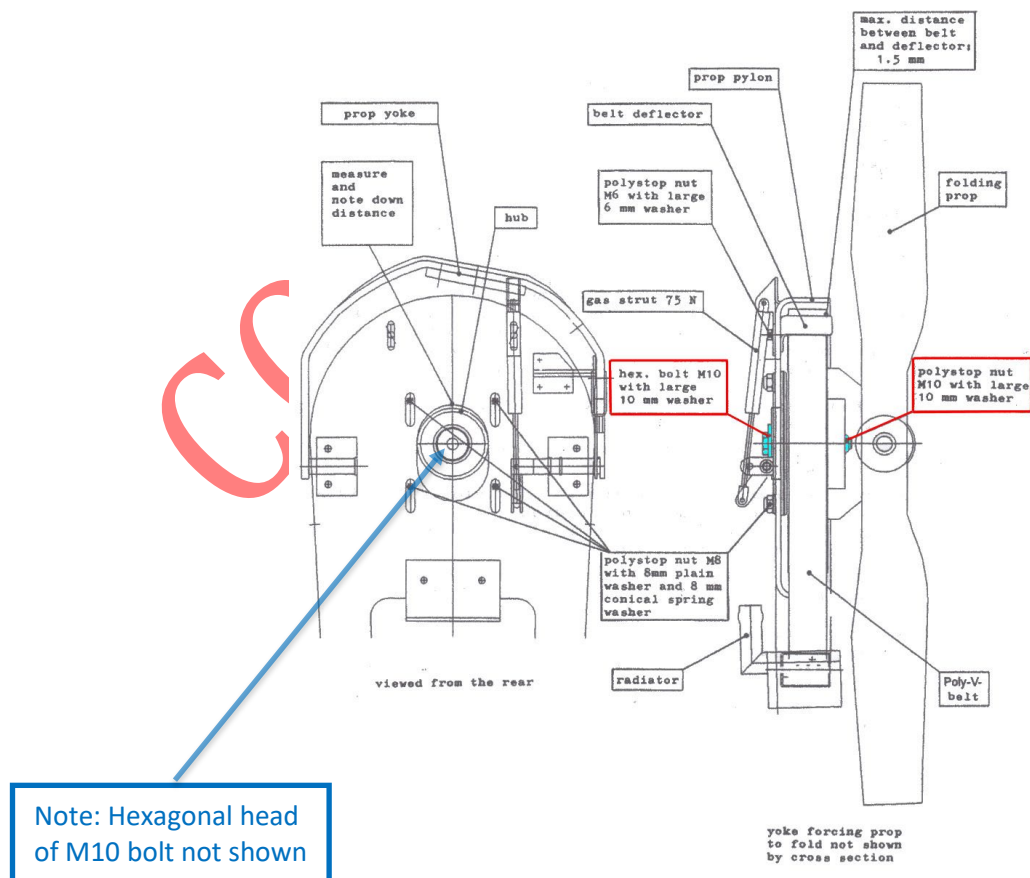
Photo 2 –Propellor and Pylon Assembly Diagram from Maintenance Manual. Missing Bolt is Highlighted.

The senior and junior engineers stated they referred to the schematic of the propeller and pylon assemblies. Other pylon systems have the pylon arresting wire attached to a bolt in the center of the spigot attaching the propeller to the pylon. This model sailplane has two arresting wires, one to each side of the pylon. It would be expected that the hub center would be hollow and not necessarily have a center mounting bolt. The independent safety check on the refitting of the propeller failed to identify the M10 securing bolt was missing. The maintenance manual does not list critical checks to be carried out after each installation procedure. It was noted the forward view on the left hand side of the installation drawing (Photo 2) in the maintenance manual does not show a hexagonal bolt head. The bolt is only shown on the side view on the right hand side.

6. GFA Airworthiness Department to inform sailplane manufacturer and recommend changing use of the word hub and inclusion of a list of critical checks to be performed at the end of each installation procedure in the maintenance manual.

7. GFA Airworthiness Department to recommend the sailplane manufacturer correct the omission of the bolt head in the rear view of the drawing.

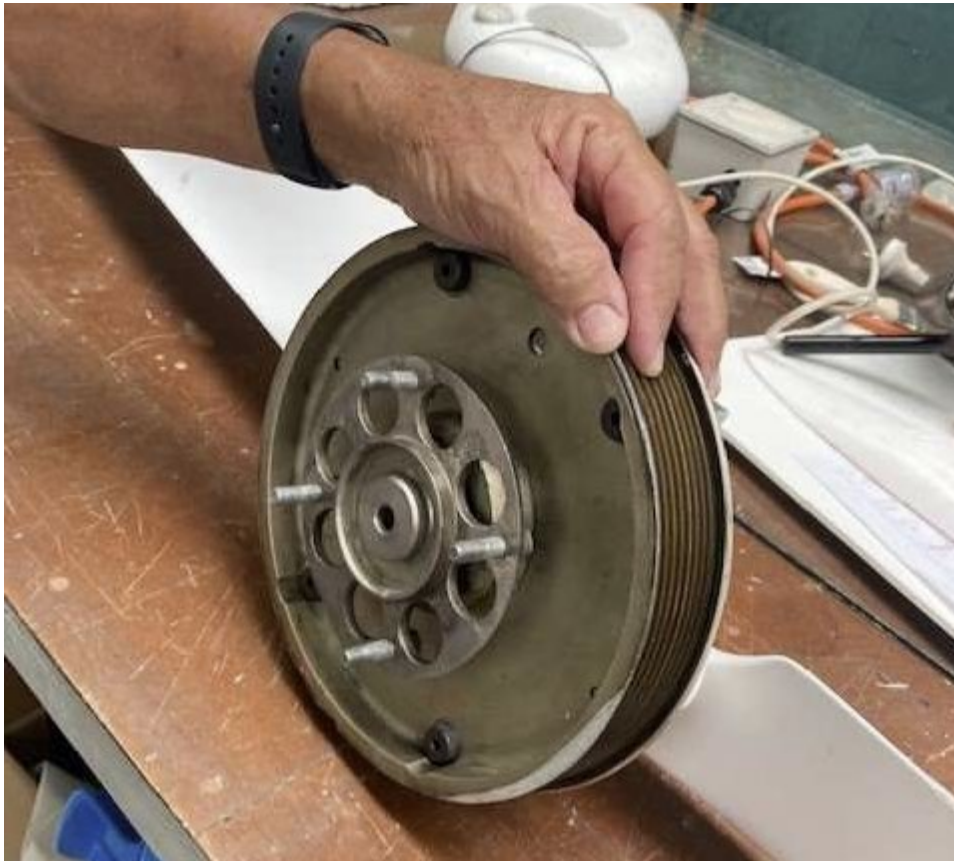
Visual inspection of the sailplane fuselage showed the propellor and pulley assembly had separated from the spigot post (referred to as the hub in the sailplane maintenance manual). The propellor and pulley assembly contains bearings which are press fitted onto the spigot post and secured in place with a M10 bolt and large washers. The M10 bolt was missing.

Photo 3 – Recreation of Prop and Pulley Assembly Fitted to Spigot Post (Hub). Missing Bolt is Fitted from Left to Right in Centre Hole.

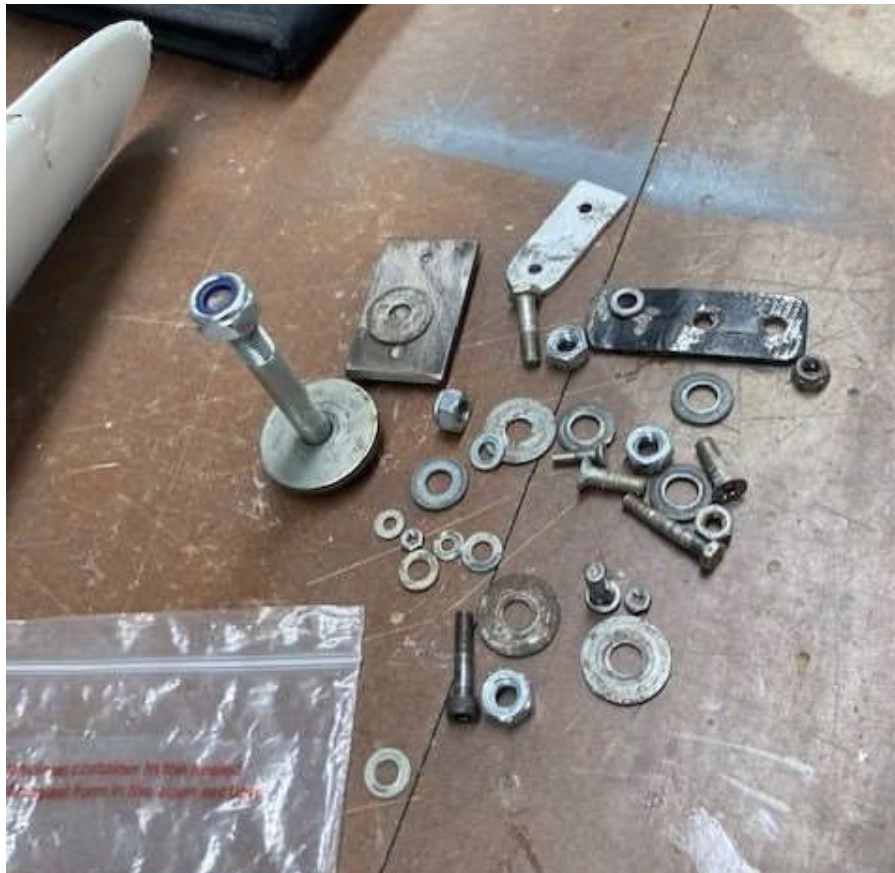
The M10 mounting bolt was placed in a zip lock bag and then in a large plastic lunch box with an assortment of other components in similar zip lock bags. The sailplane owner claims that the components were labelled (as per e-mail dated 27 Aug 2021).

The maintenance venue received the plastic lunch box of assorted components but claim the components were unlabelled when they were delivered with the sailplane paperwork making it not immediately obvious where the M10 bolt in the zip lock bag belonged.

Photo 4 – M10 Mounting Bolt (centre left) and Assorted Fasteners After The Incident at The Maintenance Venue in Zip Lock Bags (bottom left).

For a critical component, it would be considered best practice to replace the M10 mounting bolt into the hub assembly. The alternative would be to place the M10 mounting bolt in a separate zip lock bag and secure the bag to the hub assembly.

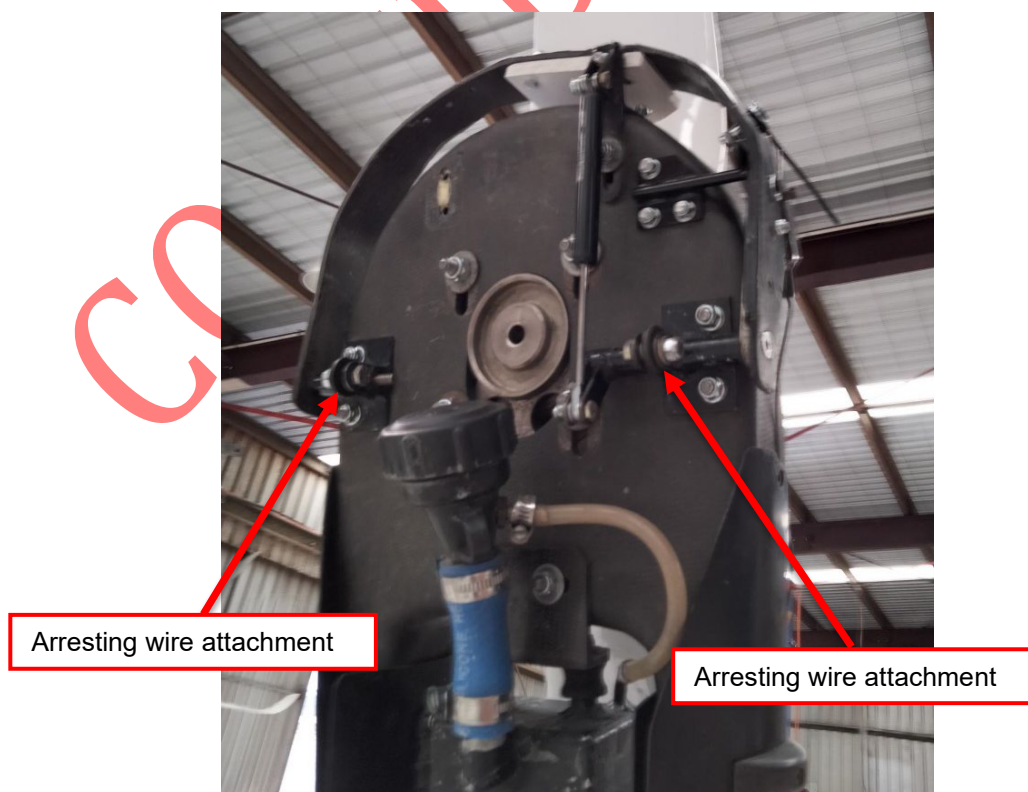
on the sailplane previously and had experience on other similar propellor and pylon systems. By observation, it appeared that the propellor and pulley assembly and hub was simply installed using the four M8 studs on the back of the hub mounting plate. The missing M10 mounting bolt was not immediately apparent.

Photo 5 – Rear of [REDACTED] Pylon Prior to Engine Run Showing Open Centre Bolt Hole with M10 Bolt Missing. The Position of the Two Arresting Wires are Indicated.

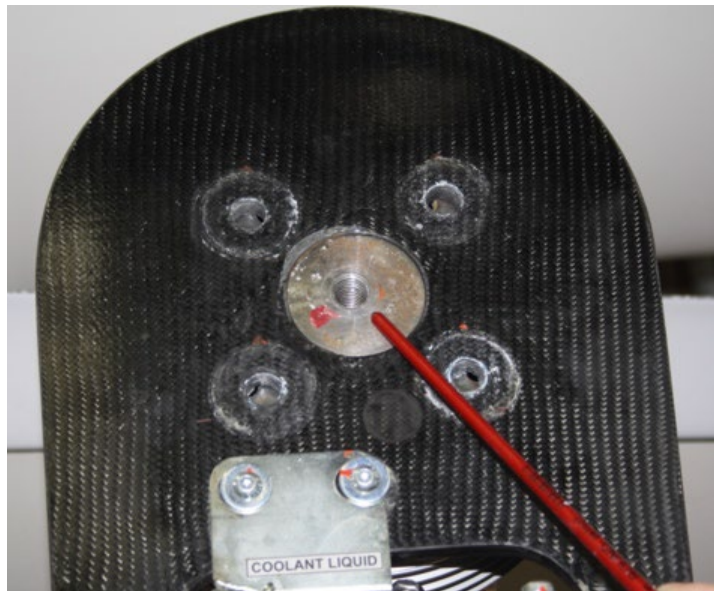
Photo 6 – Rear of [REDACTED] Pylon Showing Centre Bolt Hole in Hub Where Pylon Arresting Wire Attaches.
