## AIRWORTHINESS ADVICE NOTICE

TYPE AFFECTED: IS-28B2

SUBJECT: Miscellaneous airworthiness information.

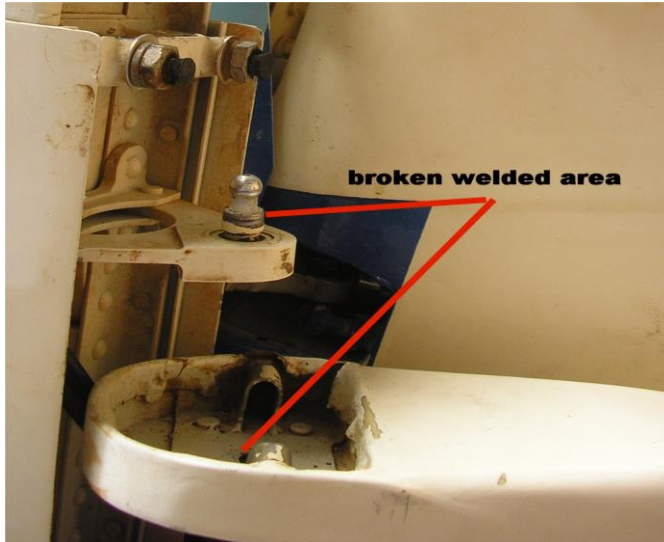
DEFECTS: 1. A left elevator hinge pin was found broken in 2008. AWA 2008-1 was raised at that time but is now cancelled. Further inspection showed the right hinge pin on the right elevator was also cracked. The hinge pins in question are the inner ones and also serve as a locating pin for the elevator connecting yolk which couples the left and right elevator root ribs together during rigging and transmits the drive from the elevator push rod. It is not possible to detect the failure unless the tailplanes are in the folded position and the connecting yolk is separated from the elevator root ribs. At annual inspection it is recommended that hinge pin and flange area is thoroughly cleaned and visually inspected for cracks. Use X10 magnifying glass. A high-resolution digital camera with magnification may also assist in the inspection. Refer photos 1 to 3 on page 2 of this notice.

Photo 1. Left elevator hinge and root area showing hinge pin completely detached from bracket on root rib.

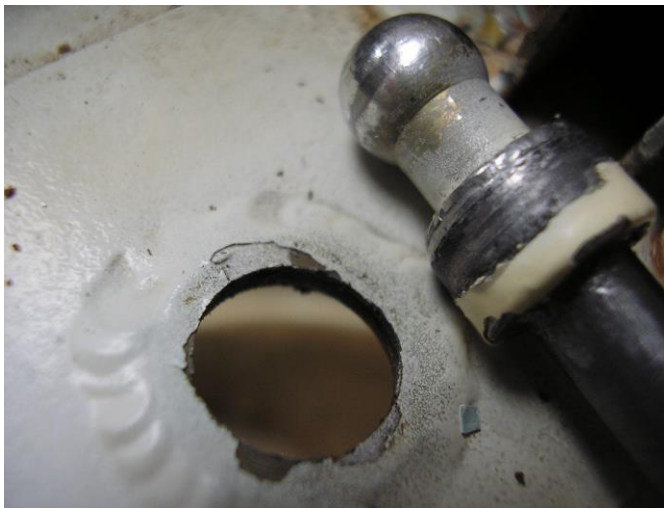
Photo 2. Left hinge pin failure area.

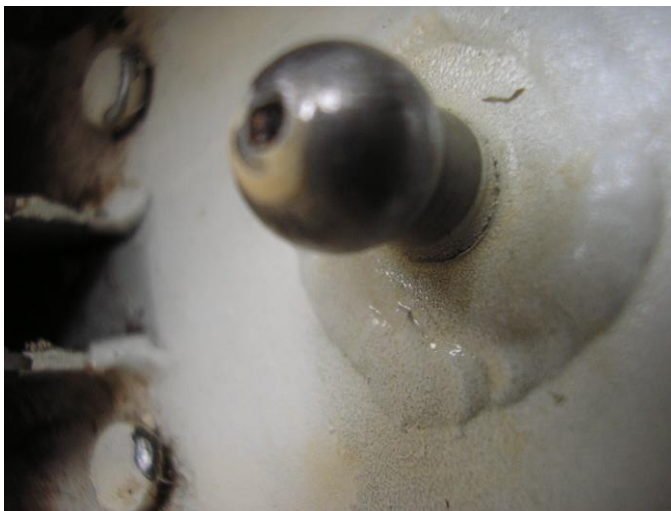
Photo 3. Right elevator hinge pin showing cracking around 40% of the circumference.
