# The Gliding Federation of Australia Inc

## Occurrence Summaries

01/01/2023 to 31/12/2023

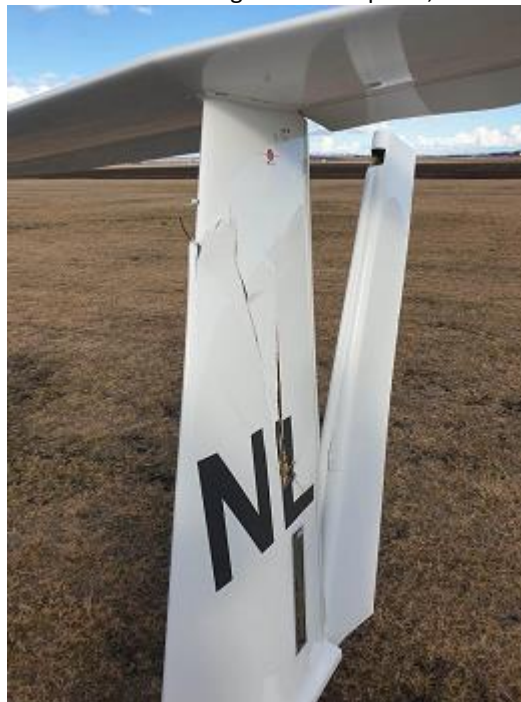
During the landing approach to RWY 06 at Clifton ALA Qld the tow rope of the Pawnee tug struck the tail of a DG-1000S that was lined up immediately behind the threshold of runway 06. The glider was substantially damaged.

The gliding club was utilising this regional aerodrome for the purpose of conducting outlanding training and cross country aerotow training including straight and level and descending on tow. Two tow planes were in service. Runway 06 was being used as the wind was 10 knots from the northeast. The DG 1000S was parked behind the 800-metre runway threshold near the runway markers and was occupied by a flight crew awaiting the other tug to provide a launch. The wingtip runner was also standing nearby, and the pilot of the other tug was waiting for the Pawnee on approach to land before entering the runway. Witnesses reported seeing the tow plane rather low on approach. The pilot in the other tow plane could see the incident unfolding and made a radio call to the Pawnee pilot to drop the rope, but by then it was too late. The witnesses heard power being applied just before the tow plane reached the aerodrome boundary and the tow plane passed directly over the glider at a height of about 50 feet. The tow rope, which was approximately 60 metres long with metal rings on the free end for attachment to the glider's tow assembly, caught on and wrapped around the port side of the glider's tailplane. The glider's tail was lifted, and the glider yawed 90 degrees to starboard. With the tailplane now parallel to the direction of the tug's flight, the rope slid free. The glider suffered substantial damage to the tailplane, elevator, fin and rudder (see photo).

A 55-metre tow rope hangs about 40 feet below a tow plane at approach speeds, so tow pilots must ensure they manage the risk caused by the trailing rope and rings by allowing plenty of clearance over obstacles. They should also avoid landing over the top of parked gliders, and in this case the pilot could have approached on the clear side of the runway and then manoeuvred to align with the runway centreline after passing the gliding operation. If the pilot suspects they are coming in too low and are unsure about obstacle clearance, whether it be buildings, vehicles, parked or taxiing aircraft or people (especially people), they should drop the rope. When the rope is dropped, it loses forward momentum very quickly and ends up dropping almost vertically to the ground. When clubs are conducting remote operations, it is sound practice to conduct a risk assessment and ensure procedures are implemented to mitigate identified risks.
