AIRWORTHINESS DIRECTIVE - POWER SAILPLANE

GFA/AD/87 SPORTAVIA 1

Type Affected: Scheibe SF 25C

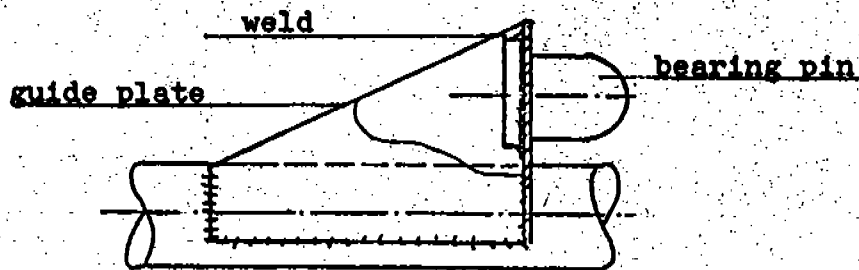
Aft elevator support - fuselage

Affected Area: Elevator support has been reported as possibly defective (Sportavia TM S-02-77)

Reason: Loosening of the aft bearing pin which is secured in the support fitting by means of tack welding.

1. Prior to next flight after disassembly of the elevator, check tight fit of the bearing pin in the fitting by tapping the bearing pin end slightly with a plastic hammer. Slight resilience will show that the weld is not in sound condition.
2. If the weld is not satisfactory, cut the chamfered guide plate so as to gain access to the pin head which is to be welded to the pin holder (using the W I G procedure welding wire 1.7734.2).
