AIRWORTHINESS ALERT 2023-1

Horizontal Tail Elevator U-Bracket - Inspection

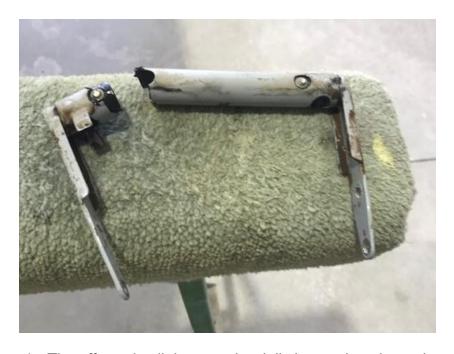
A defect report has been received detailing a failed horizontal tail elevator U-Bracket on an Arcus M powered sailplane. The powered sailplane had logged 946 hours and 287 landings. The maintenance release had an entry to perform EASA AD 2022-0242_E at 1,000 hrs as per the AD requirement.

Figure 1: The affected sailplane on the daily inspection showed excessive lateral play. With the failed component installed, the crack looked like only the surface finish was cracked. The crack is therefore very insidious and requires a thorough inspection. Any surface finish defects around the holes in the torque tube should be treated with suspicion and investigated further.

This AWA is issued to raise awareness of the potential early failure of the Horizontal Tail Elevator U-Bracket on all affected types before 1,000 hrs. The Airworthiness Panel <u>recommends</u> that sailplanes with less than 1,000 hrs should have the U-Bracket inspected prior to next flight using the "Working Instructions for Technical Note No. 396-22, 380-3, 868-24, 890-18, A532-10" as guidance. The tailplane should be removed to carry out the inspection.

Technical Note No. 396-22, 380-3, 868-24, 890-18, A532-10 amends the Flight Manual with additional information for the daily inspection and after hard landings. Technical Note No. 396-22, 380-3, 868-24, 890-18, A532-10 also amends the Maintenance Manual with improved information on annual inspections. This improved guidance should be carried out each daily and annual inspection and after hard landings accordingly.
