GLIDING FEDERATION OF AUSTRALIA

AIRWORTHINESS DIRECTIVE GLIDERS:

GFA/AD/156 GLASFLUGEL/6

SUBJECT: Canopy emergency jettisoning system

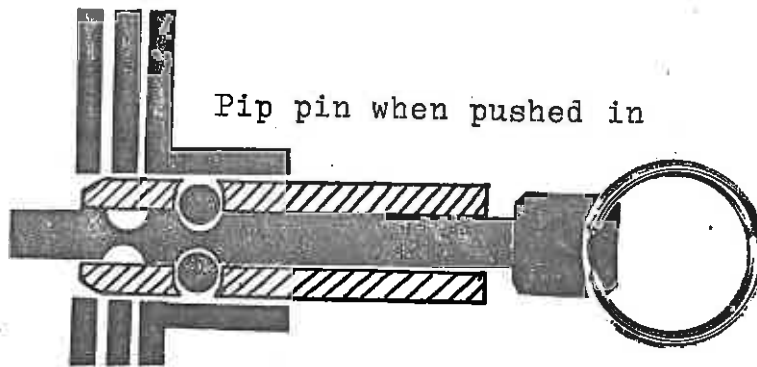
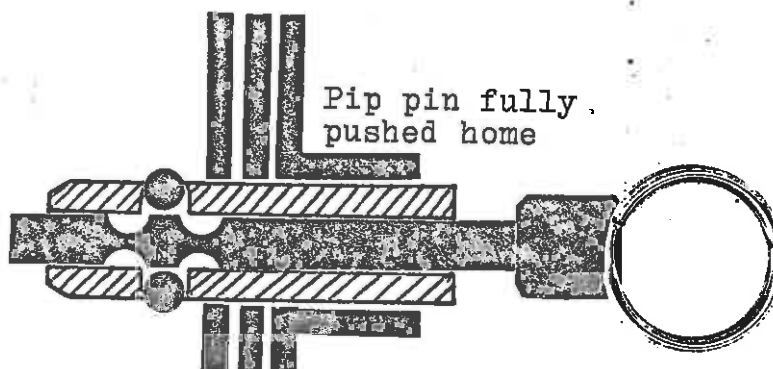
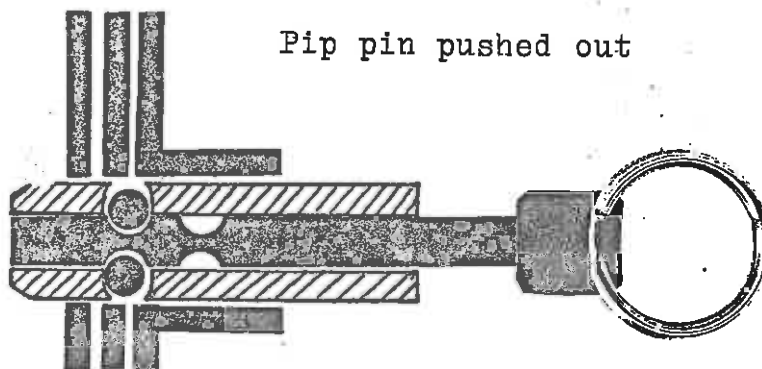
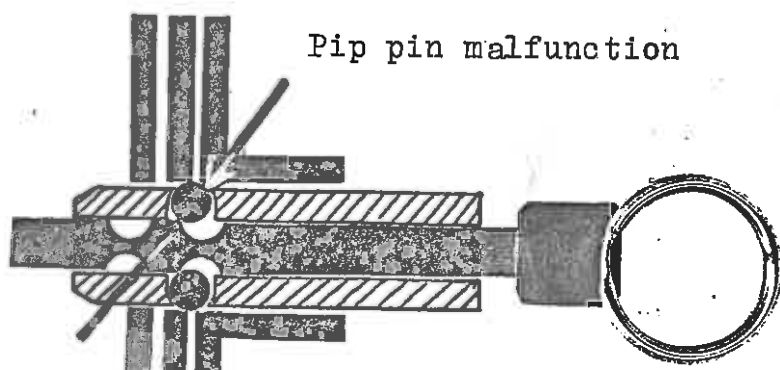
REASON: During a routine check it was discovered that either of the "Pip Pins" of the canopy jettisoning system, which disengage when the red knob is pulled, could become jammed if they had not previously been pushed fully home. (See sheet 2 for illustration of malfunction).

ACTION: On page 19/3.3 of the Flight Manual the following amendment must be inserted -  
"Whenever the canopy emergency jettison knob is pulled and prior to each flight, if no locking thread is used, it should be ensured, that the Pip pins are fully pushed home, so that the locking balls are clear of and behind their fittings".  
(The text is repeated at the foot of this A.D. for owners to cut off and affix to the manual).

"Whenever the canopy emergency jettison knob is pulled and prior to each flight, if no locking thread is used, it should be ensured that the Pip pins are fully pushed home, so that the locking balls are clear of and behind their fittings".
