AIRWORTHINESS DIRECTIVE GLIDERS:

REF: No. GFA/AD 159 Glasflugel 8

Glasflugel. H201 Libelle, H301 Open Libelle, H401 Kestrel,
H205 Club Libelle, H206 Hornet, Mosquito and Slingsby Kestrel.

Mandatory precautionary Inspection.

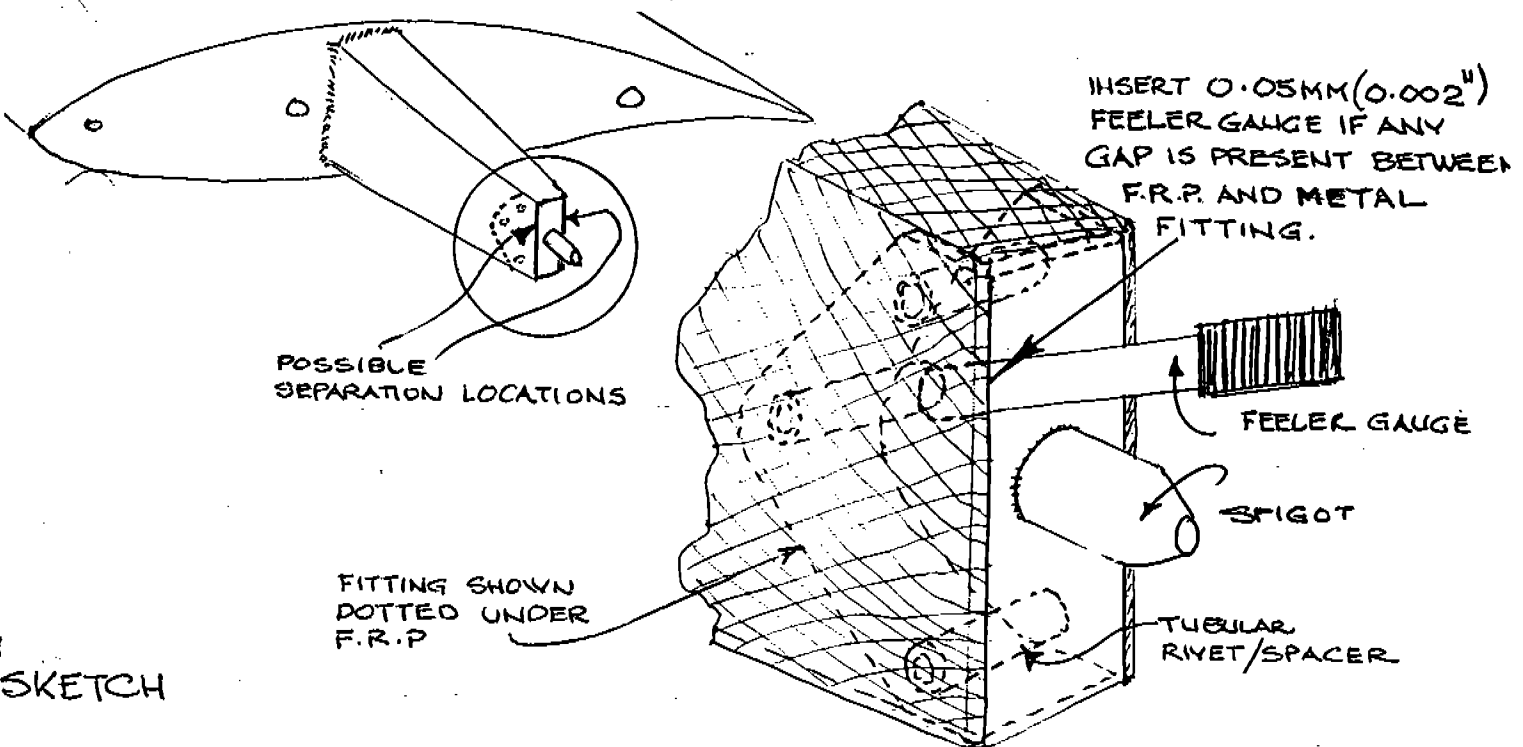
During inspections corrosion in the wing root stub end fittings of a number of Glasflugel H206 Hornets has been detected and in at least one case the corrosion was considerable. The precautionary inspection is extended to the other listed types because of the similarity of the fitting detail.

1. Derig wings from glider and inspect wing root stub ends of each wing for any signs of separation between the fibreglass wrapping of the spar stub/s and the metal fitting at the end of the spar stub. (See sketch). There are six places to inspect.

2. If any separation between the fibreglass wrapping and the stub end metal fitting is detected insert a 0.05 mm or 0.002 inch feeler gauge into the gap between the fibreglass and the metal fitting to check the depth of separation but do not force the feeler gauge into the gap.

3. If there is no evidence of corrosion and the separation, if present, does not extend more than 6 mm at any of the spar stub ends, no further action is necessary except that the inspection should be repeated during each G.F.A. form 2 inspection.

4. If separation extends beyond 6 mm deep or corrosion is evident in the separation zone, the glass wrapping over the metal fitting must be removed for further inspection. The removal of the fibreglass wrapping and removal of the fittings for inspection and further action to remedy the corrosion may only be carried out by persons with approval for carrying out F.R.P. major repairs.

5. Care must be taken in removing the tubular rivets to ensure the holes in the fitting are not affected. If the fitting is not heavily corroded and no significant pitting is present, the fitting may be cleaned by sand blasting but be sure that the spigot pin is protected against abrasion.

6. If corrosion pitting is present or if the spigot pin is worn the fitting is to be replaced.
7. Before refitting the stub end fitting it must be primed with an epoxy primer. The fibreglass wrapping is to be ground back to a splice angle and after restoring the fitting with new tubular rivets the stub end and the fitting is to be rewrapped to the original configuration.
