GLIDING FEDERATION OF AUSTRALIA

AIRWORTHINESS DIRECTIVE GLIDERS:

GFA/AD 172 ROLLADEN SCHNEIDER 15

GLIDER TYPES AFFECTED: Rolladen Schneider LS 1f, LS 3 and LS 3a

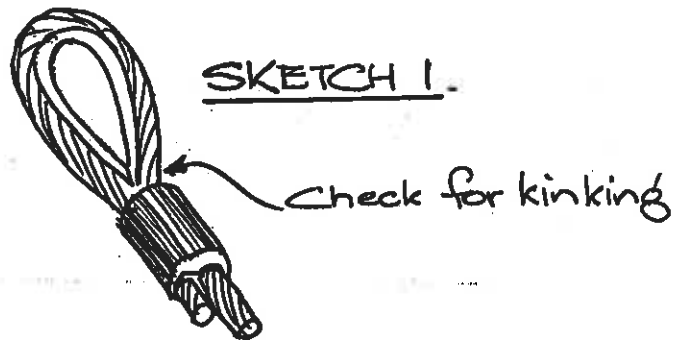
BACKGROUND: During a recent inspection, the owners of an LS 1f glider detected damage to a rudder cable due to insufficient clearance in the rudder horn.

Before further flight check the cable eyes at their attachment to the rudder horn where indicated in sketch No. 1. If any kinking of the cable is evident the rudder horn is to be relieved where indicated on sketch No. 2. If any wires on the cable are fractured, the cables are to be replaced.
