GLIDING FEDERATION OF AUSTRALIA.

AIRWORTHINESS DIRECTIVE GLIDERS:

REF. No. GFA/AD 203 SCHLEICHER 10

GLIDER TYPE AFFECTED: Schleicher ASW 19 and ASW 20 All Serial numbers.

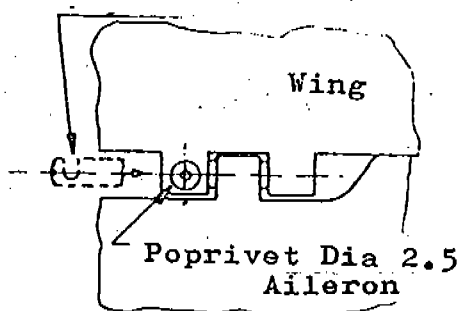
Ground notch

L.B.A. Airworthiness Directive 81-74/2 Schleicher has been received advising that there is a possibility in some aircraft that the aileron hinge shaft may not be correctly secured.

Unless already accomplished, check all the aileron hinges before further flight after receipt of this directive to ensure that the pop rivet securing the aileron hinge shaft is in place. (See illustration).

The rivet head should be able to be felt under the adhesive gap sealing tape but if necessary remove the tape to facilitate checking.

The inspection and if necessary the fitting of securing pop rivet is to be carried out by the holder of a Glider Inspectors Certificate DOT 1109 endorsed for standard repairs, replacement of Components or Certificate of Airworthiness Inspections.
