THE GLIDING FEDERATION OF AUSTRALIA

GFA/AD 217

AIRWORTHINESS DIRECTIVE GLIDERS/POWERED SAILPLANES

SUBJECT: Incorporation of inspection hole in the vertical fin.

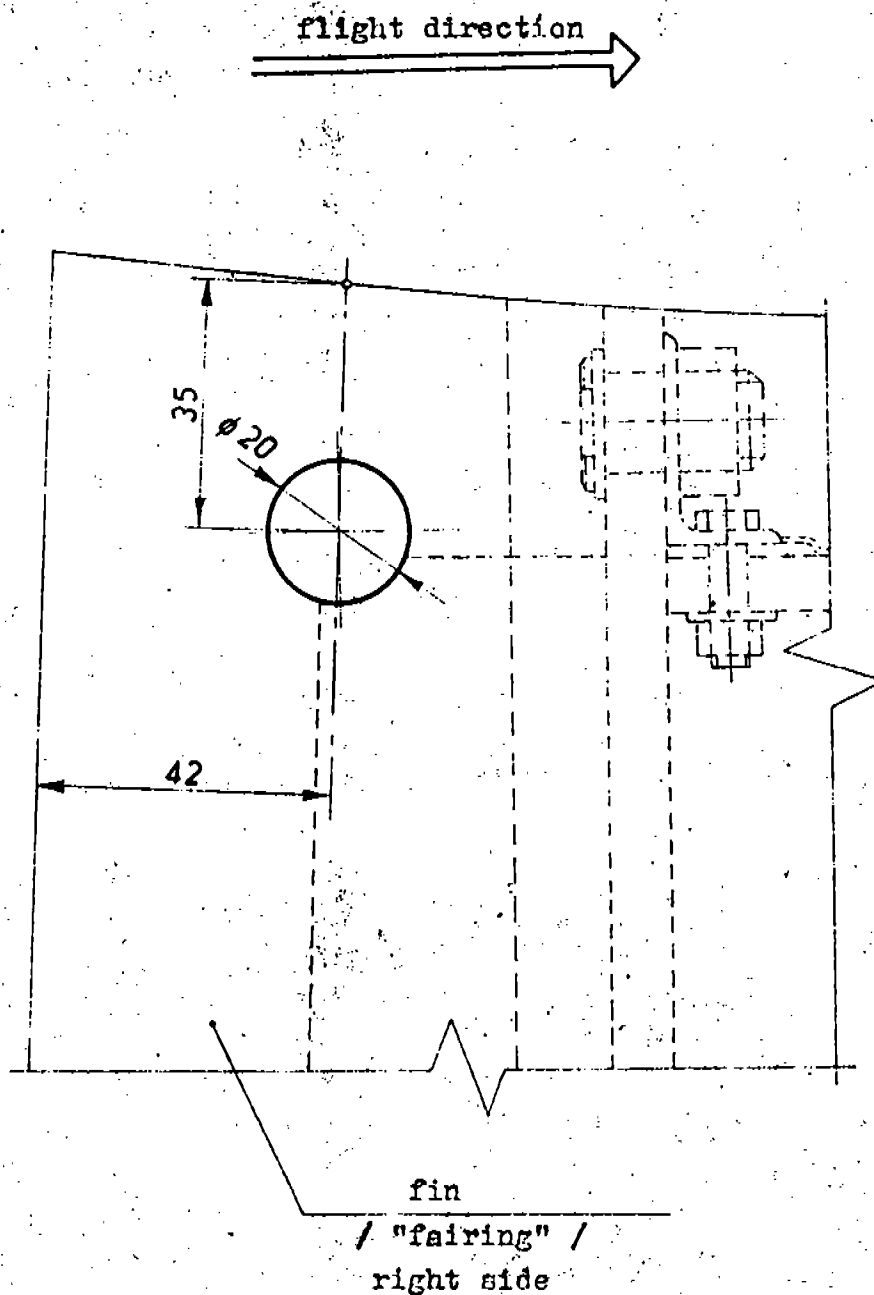
Fig. 1.

BACKGROUND: This inspection hole allows the visual inspection of the elevator lever connection to the elevator control push rod.

- (1) Mark hole location on the righthand side of the fin, using the dimension shown on Fig 1.
- (2) Using a hole saw cut a 20 mm dia. hole.
- (3) Seal the hole edges and repair any local damage with polyurathane lacquer.
