# THE GLIDING FEDERATION OF AUSTRALIA

## AIRWORTHINESS DIRECTIVE GLIDERS/POWERED SAILPLANES

GFA/AD 221

SUBJECT: Longitudinal cracking of the leading edges of the wings and horizontal tailplane.

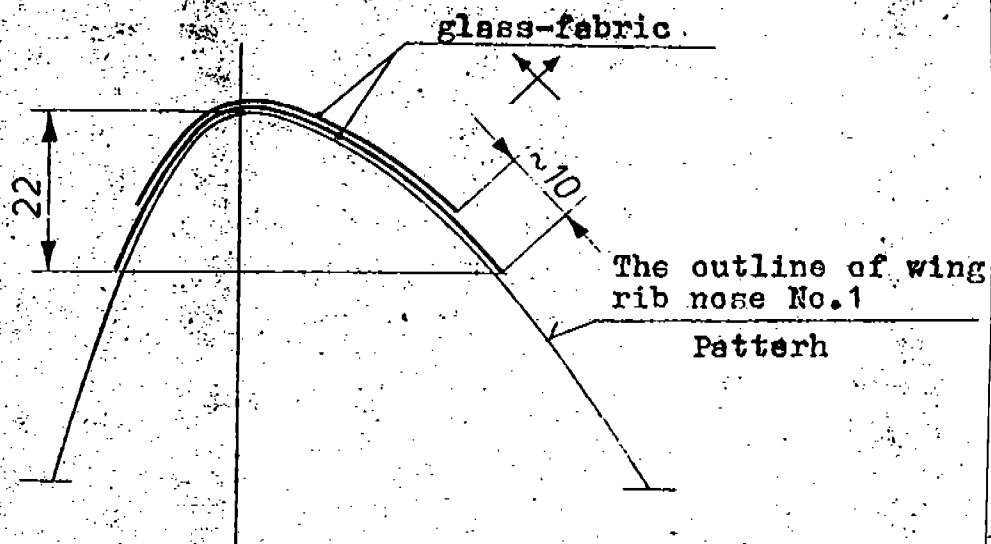
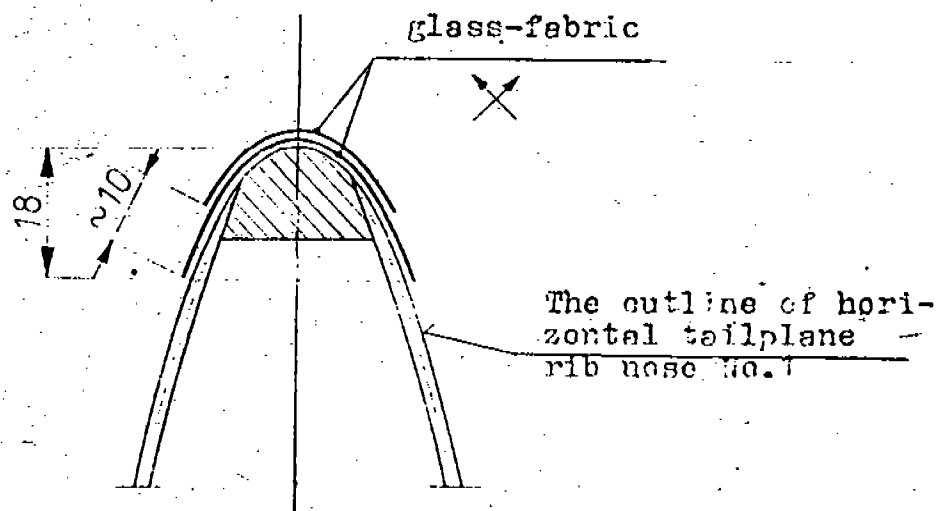
Fig. 1.

(b) If more severe cracking is evident, over 2mm deep, which will indicate splitting of the leading edge block, then the following repair method (Drawn on Sheet 2) should be carried out as soon as possible.

(a) Remove surface paint from the area, then remove the glass fabric back to the wood, (Ref. to Fig 1.) scarfeing the edges to achieve proper bond of the new overlapping glass.

(d) After profiling the filled areas, apply 2 layers of Interglass 92110 fabric or equivalent, over the area to Fig 1, using epoxy resin.
