# THE GLIDING FEDERATION OF AUSTRALIA

## AIRWORTHINESS DIRECTIVE. GLIDER/POWERED SAILPLANE

GFA/AD 223

Control column free play.

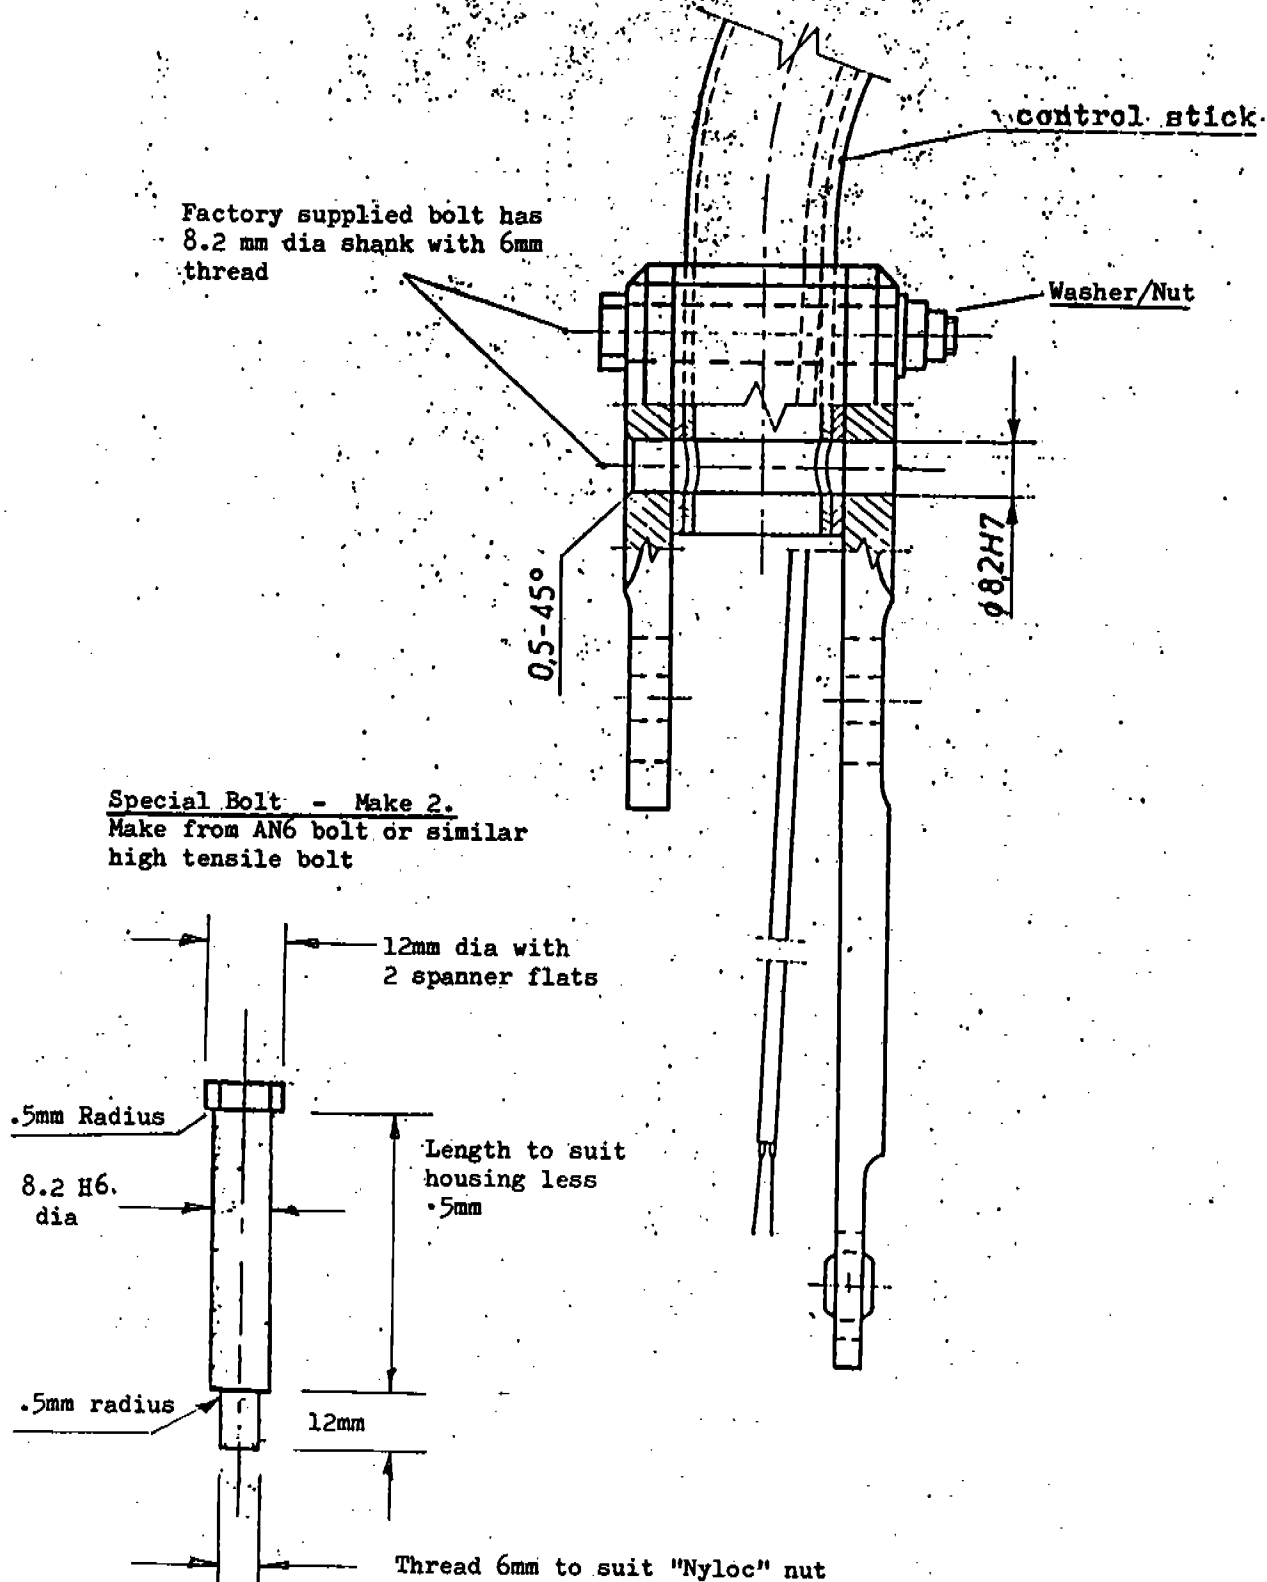
PZL Bulletin BR-09/80 requests the modification of control columns to remove excessive free play caused by loosening tubular rivets.

(1) Inspection Before next flight inspect the control column for free play in its attachment to its bottom housing. If no free play is present this modification can be deferred until the next Form 2 inspection.

If free play is found, at the inspectors discretion, the rivets must be replaced immediately or within a short flight time.

- (1) Remove the control column including the bottom housing from the aircraft.
- (2) Factory supplied bolts (M6) washers and nuts should be available through the Australian distributor.
- (3) Remove one rivet and sleeve and replace with a high tolerance bolt, reaming to 8.2 H7 fit, countersinking to remove sharp edge under the bolt head (Ref. Fig. 1.)
- (4) Repeat the process for the second bolt to Fig. 1.
- (5) If factory supplied bolts are not available manufacture 2 bolts to details on Sheet 2, reaming holes selectively, fit nyloc nuts and washers.
- (6) Modification details to be entered into the glider's log book.
