AIRWORTHINESS DIRECTIVE GLIDER/POWERED SAILPLANE

GFA/AD 228

SLINGSBY 21

SUBJECT: Inspection of attachment of wing centre section to Frame 6.

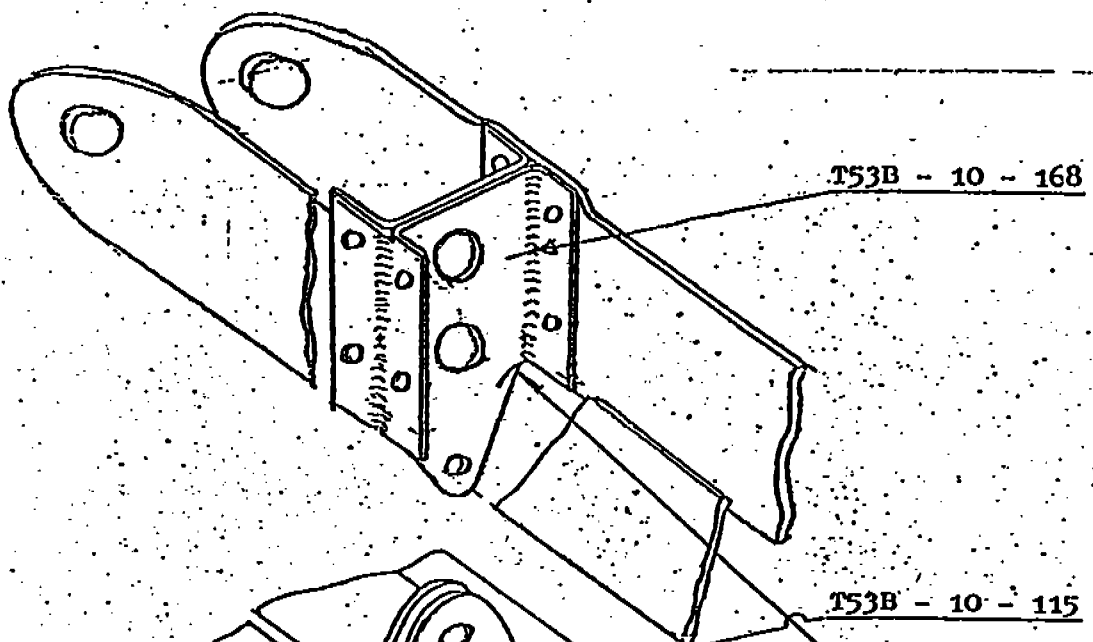
Figure 1

BACKGROUND: This is a re-issue of GFA/AD 169 (Slingsby T.I. 90) which this Airworthiness Directive cancels and replaces. A failure in fatigue of the brackets which hold the rear span member of the centre section to fuselage Frame 6 has been reported, resulting in the issue of T.I. 100/T53 issued by Slingsby Engineering Ltd.

Remove glass fibre fairing No. T53B-10-1093 and wings if fitted. Using a Dye penetrant crack detection system, inspect for cracks at the corner of the fittings where the attachment flanges begin (a) the welded brackets Pt No. T53B-10-168 issue 1-4 see figure 1 page 2 which holds the rear spar member of the c/s to the fuselage frame 5 and (b) the alternative riveted bracket Pt No. T53B-10-168 issue 5. Also in a similar manner inspect the metal lugs T53B-10-115 and channel section T53-10-118 on frame 6. See Figure 2. Checking for cracks in way of rivets.

If any cracks are found the aircraft is to be grounded. All findings to be reported to CTO/A G.F.A. New components can be obtained from S.E.L. if required as listed above. If there are no cracks the aircraft is cleared for flight.

The above inspection procedure is to be repeated at each Form 2 inspection.
