# THE GLIDING FEDERATION OF AUSTRALIA

## AIRWORTHINESS DIRECTIVE GLIDER/POWERED SAILPLANE

GFA/AD 229

SUBJECT: Kestrel Rudder Actuator Inspection

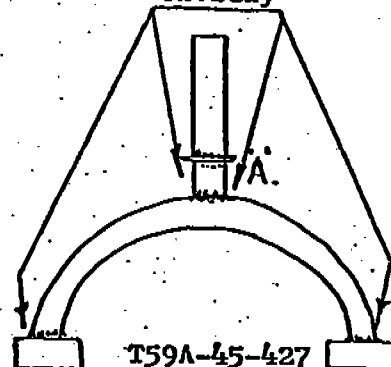
BACKGROUND: Slingsby T.I. 101/59 Issue 1 requests inspection of rudder actuators following reports of fitting cracks.

Inspect these areas closely

Remove the rudder in accordance with Addendum A.2.2 of the Pilots Notes. Visually examine (using a x5 magnification) the actuator for cracks especially in the area of the central weld 'A' see diagram. Should any sign of cracking be found then the existing part must be discarded and scrapped. Replace Rudder. Anotate aircraft log book showing compliance of this T.I. All findings to be reported to the undersigned.
