AIRWORTHINESS DIRECTIVE

ISSUE 2

ALL ASW 15 and ASW 15B GLIDERS

Immediate/periodic inspection of the elevator actuator bellcrank and amendment to the Operations Manual.

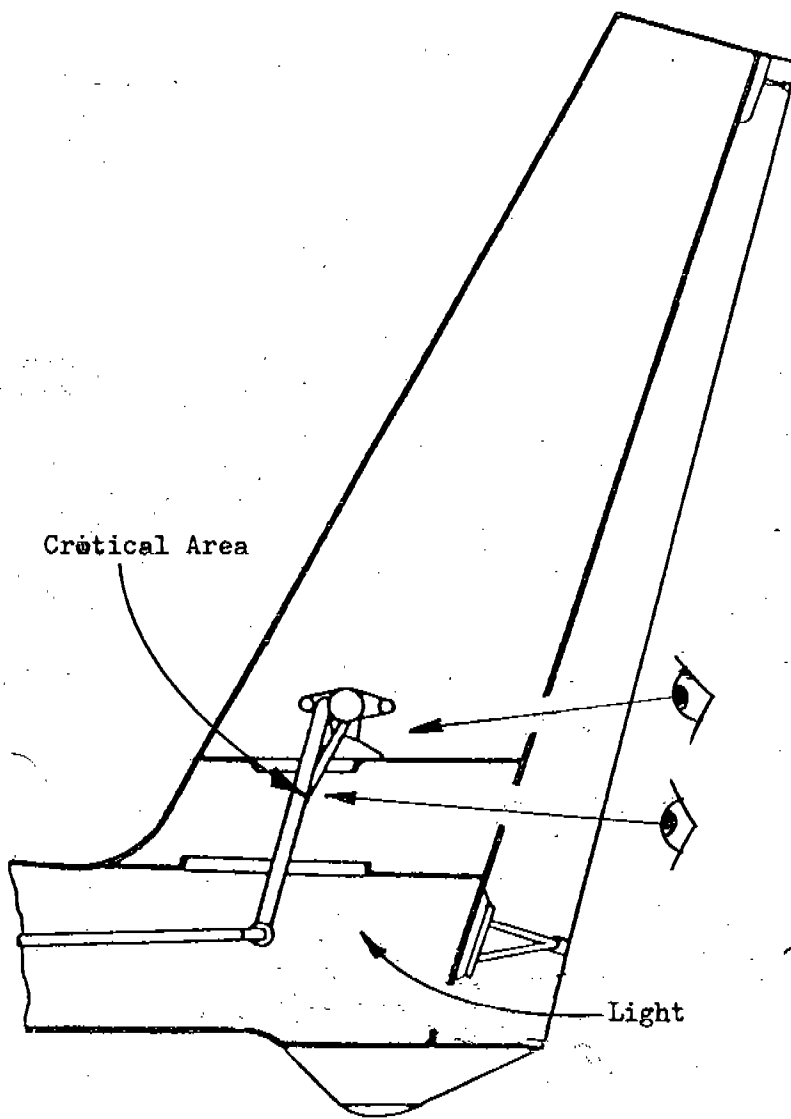
Sheet 3 of 4

With an ASW 15 the bellcrank actuating the elevator failed in flight. (see attached sketch). Luckily the pilot could save himself by parachute. An inspection of the bellcrank showed that an older crack most likely caused by a hard landing some years ago resulted in fatigue failure of the bellcrank. Alexander Schleicher Technical Note 21 refers.

1. The elevator actuator bellcrank must be inspected for cracks. To do so the rudder has to be disconnected from the fin, as inspection is possible through holes in the fin spar located and cut in accordance with sketch sheet 3.

Through these access holes both visual and dye penetrant inspection of the crack sensitive area can be carried out.

- (1) Cut 2 -35mm dia holes through fin spar web on centres shown.
(Check dimensions first to ensure the area is clear of other structure).
- (2) Visual and dye penetrant inspection can then be carried out.
- (3) If necessary, the holes can be increased in dia to a max of 60mm without reinforcing the cut-out.
- (4) Cover the holes with Contact or similar.
- (5) Critical area is the lowest point of the weld, with cracks in the weld or in the long arm starting at the weld.
