# THE GLIDING FEDERATION OF AUSTRALIA

## AIRWORTHINESS DIRECTIVE GLIDERS/POWERED SAILPLANES

GFA/AD 235

SUBJECT: Tailplane, front fitting.

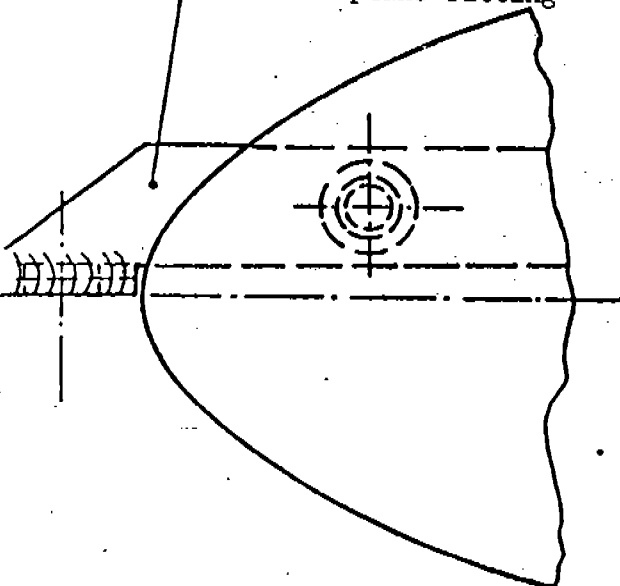
Front tailplane fitting

BACKGROUND: Possible manufacturing defects in the welded seams.

- (a) Dismount the tailplane from the fuselage.
- (b) Remove the paint from the front tailplane fitting (see sketch).
- (c) Inspect the fitting in the area of the welding seams for cracks by using a magnifying glass of at least 5 x power.
- (d) If cracks are found, then a new fitting must be mounted prior to the next flight. The defective fitting must be sent to the manufacturer (giving the total number of flight hours), with the request for a new fitting.
- (e) If no cracks are found, the fitting is to be protected against corrosion with prime and then painted.
