## AIRWORTHINESS DIRECTIVE GLIDERS/POWERED SAILPLANES

GFA/AD 239

TYPES AFFECTED: Grob Twin Astir  
G103-11 Serial Nos. 3501 to 3689

SUBJECT: Inspection and replacement of the front pilot's rudder pedal slide unit. Part No. 103-4208-10.

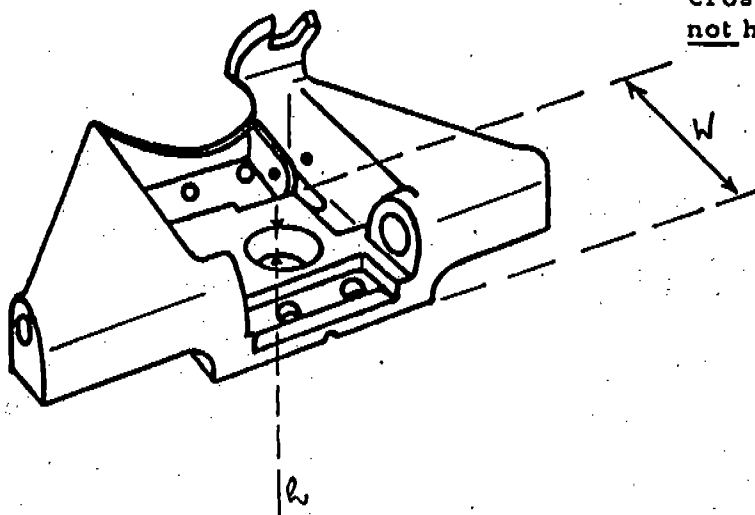
Picture 1 :

Slide no. 103B - 4208.10

This slide with wide, high cross-web is safe and does not have to be exchanged.

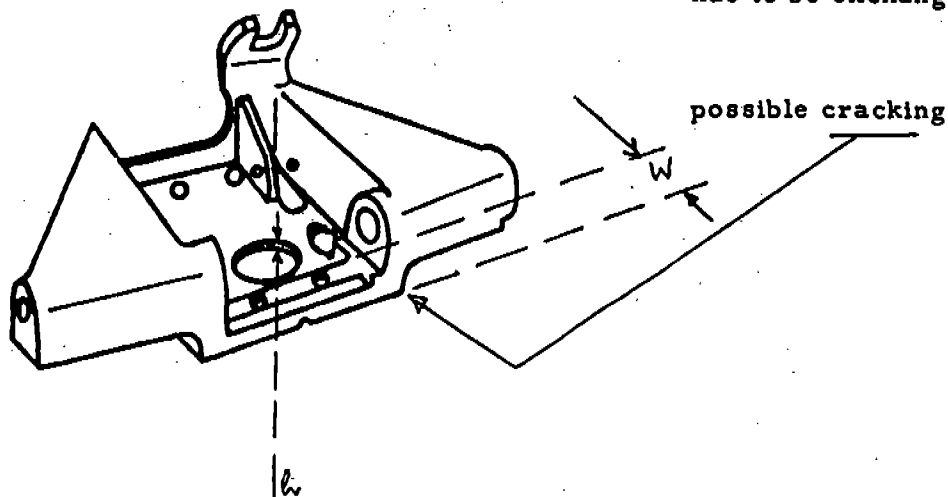
Picture 2 :

1. Before next flight Inspection of the slide at the front pedal unit before next start. If the slide no. 103B-4208.10 (picture 1) with the wide, high cross-web is installed, there is no reason for modification. Instructions 1 and 2 are not applicable.  
If the slide No. 103-4208.10 (picture 2) with the small low cross-web is installed, actions 2 and 3 have to be carried out.
2. Each Daily Inspection  
Until completion of action 3, the slide at the right pedal suspension has to be inspected for cracks and deformations before each flight and the function of the pedal adjustment and the rudder control has to be checked. If there is any damage, instruction 3 has to be carried out before the next flight. Until exchanged, when adjusting the pedals, the locking bar has to be relieved with the least possible power of the heel to the lower tube of the pedals.

Slide no. 103 - 4208.10

This slide with small, low cross-web is rejected and has to be exchanged.

The slide No. 103-4208.10 (picture 2) has to be exchanged against slide No. 103B-4208.10 (picture 1) not later than October 31, 1982. The necessary material for this purpose (see below) has to be ordered from the manufacturer or Australian distributor.
