THE GLIDING FEDERATION OF AUSTRALIA

GFA/AD 242
SZD 29
Issue 1
Date of issue 5.10.1982
Sheet 1 of 2

AIRWORTHINESS DIRECTIVE GLIDER/POWERED SAILPLANE.

Securing instrument panel cover.

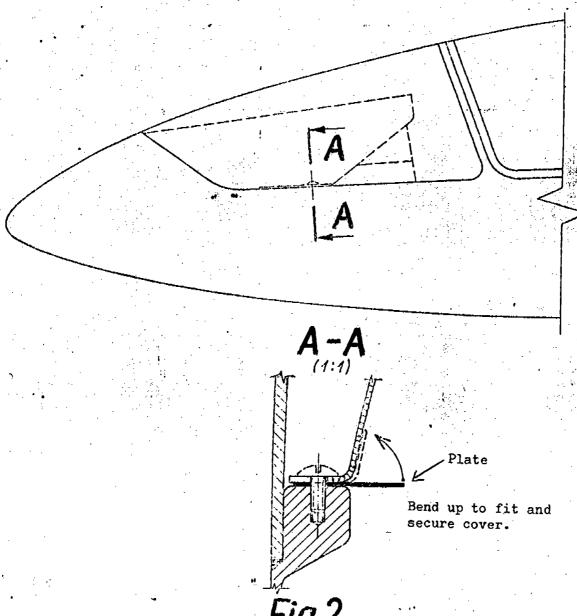
Fig.1.

Experience shows that if the two screws which locate the instrument panel cover become loose, the cover can be dislodged in flight. Bulletin BK-015/81 "Jantar", was issued by the manufacturer detailing this modification.

- (1) Make two plates to Fig. 1.
- (2) Fit plates as shown in Fig 2 bending up the legs to secure the cover under the head of the locating screw.

Make 2 plates from .5mm aluminium
