AIRWORTHINESS DIRECTIVE

Grob Twin Astir (Not G103)
All Serial Nos.

GFA AD 256	Issue 1
3/8/1983	Sheet 2 of 2

IMPROVED ATTACHMENT OF FRONT COCKPIT
SEAT SUPPORTS TO FUSELAGE SKIN.

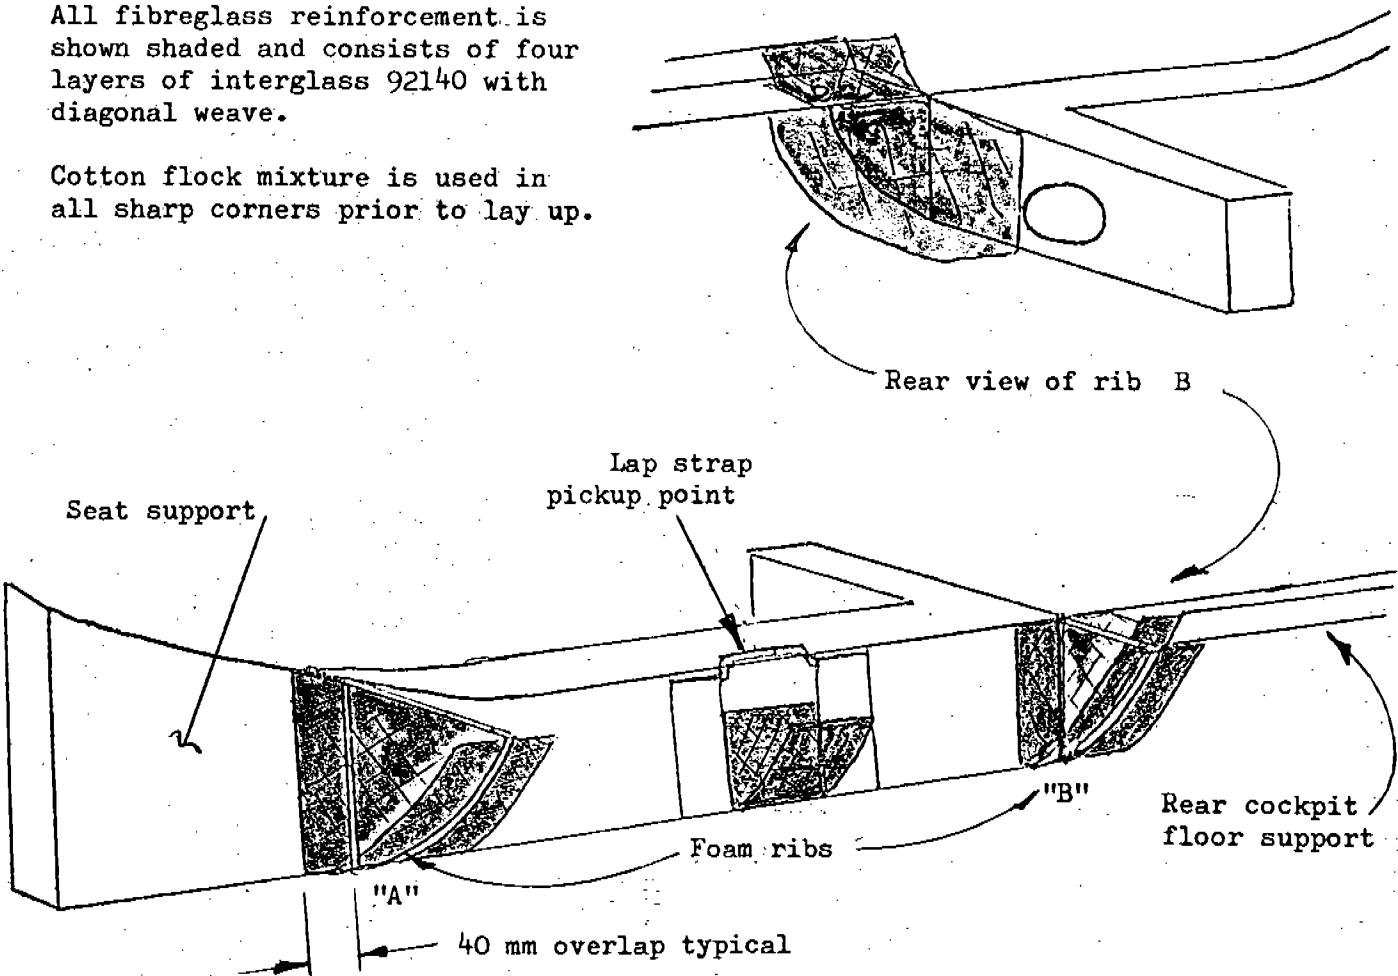
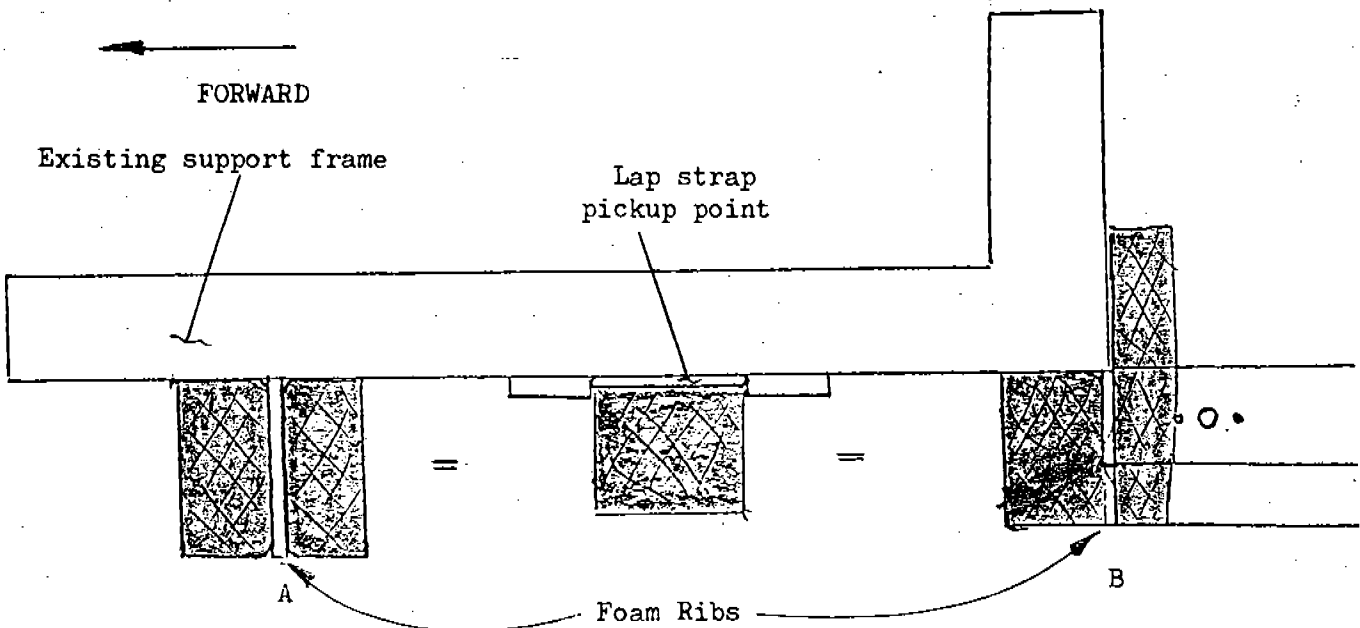
The service record of the Twin Astir so far shows a tendency for ground impact to fracture joints between the inside fuselage shell and components glued to it. The "Gluing" consisting of gap filling resin/flock paste which tends to fracture and "peel". This failure has been most evident in two accidents involving extensive destruction of the forward cockpit area with the 2 lap strap supporting frames probably coming free of the outer shell prematurely, due to the joints peeling apart.

Sheet 2 outlines reinforcement of the attachment of the two underseat frames and the fuselage shell to improve load carrying ability under dynamic conditions.

Foam ribs "A" and "B" are cut from 8mm thick Conticell foam.

All fibreglass reinforcement is shown shaded and consists of four layers of interglass 92140 with diagonal weave.

Cotton flock mixture is used in all sharp corners prior to lay up.
