## AIRWORTHINESS DIRECTIVE

**TYPE AFFECTED:** Club Astir III, Club Astir IIIb and Standard Astir III.

**SUBJECT:** Inspection and replacement of the rudder pedal slide unit.

| | Technical Information<br>TM 306-22 | GROB G 102<br>CLUB ASTIR III and IIb<br>STANDARD ASTIR III | |

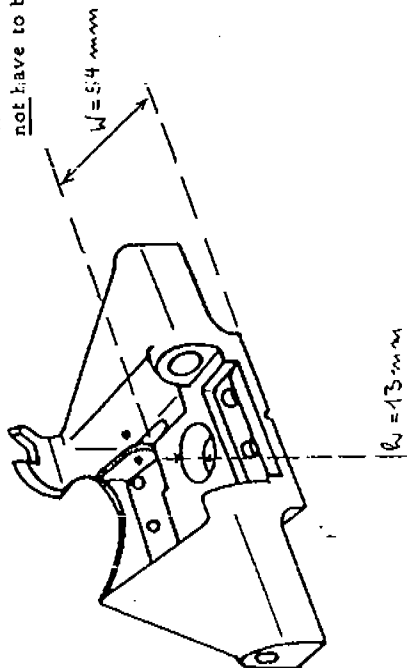
Picture 1 :

Slide no. 103B - 4208.10

This slide with wide, high cross-web is safe and does not have to be exchanged.

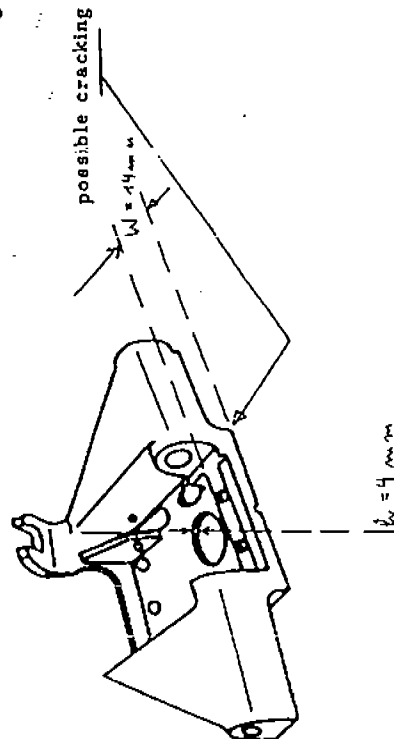
Picture 2 :

| Reason: | At the pedal unit of the mentioned serial numbers, slides were partially mounted which might break when overloaded. | | |

Slide no. 103 - 4208.10

This slide with small, low cross-web is rejected and has to be exchanged.

The repair instructions belong to instruction 3 of the technical information and include the exchange of slide no. 103-4208.10 in the pedal unit against slide no. 103B-4208.10.
