## AIRWORTHINESS DIRECTIVE

SZD-9 BOCIAN 1E SAILPLANES

Replacement of elevator horn alloy rivets with steel rivets.

BULLETIN No BK-023/82 "BOCIAN-1E"

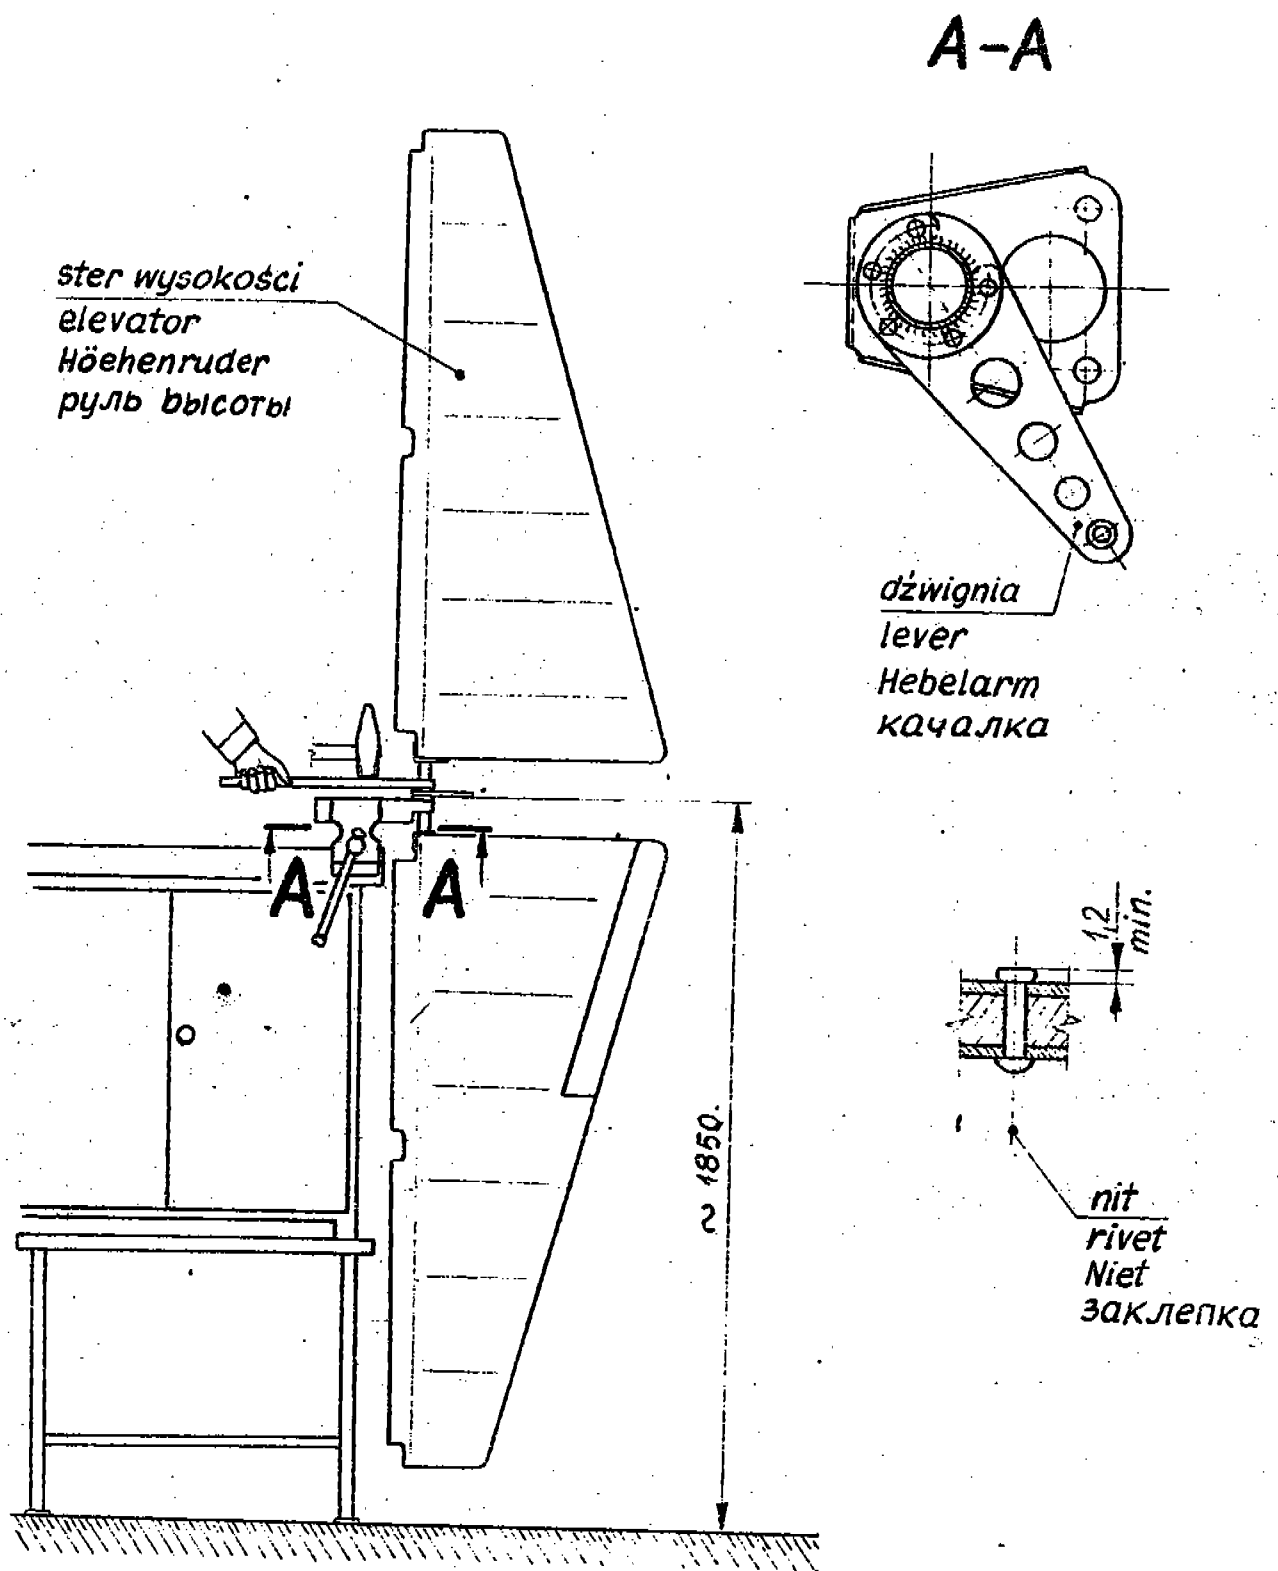
**Fig.1.**

This Bulletin is introduced in connection to the found, but individual, case of the rivets connecting the elevator actuating lever with the shells of torque tube being sheared off. This fault occurred in aerobatic manoeuvres performed. The change is aimed to protect the gliders of "Bocian 1E" type against such an accident.

To this Bulletin the sketch Fig. 1 describing the above mentioned lever and the way of riveting it is enclosed.

The change defined in this Bulletin depends on the replacement of duraluminium rivets by the steel ones of the same dimension in the connection mentioned above.

- 5.1. Disassemble the horizontal tailplane out of the glider
- 5.2. Disassemble the elevator out of the stabilizer.
- 5.3. Cut off by means of chipper the heads of 3 rivets /each second in the rivet-row/ connecting the lever with torque tube shells /pay attention to avoid the damage of torque tube!/.  
Remove the rivets and replace the new steel ones /steel 45/.- 5.4. Fasten the rivets on crossed sequence /beat the rivets by intermediation of metal strip/.  
Minimum height of formed rivet head should range 1,2 mm, Pay attention that the rivet correctly plugs the hole diameter. For this reason a hammer of about 1 kg mass and the support of about 2 kg mass are necessary.
- 5.5. With the rest of rivets proceed similary to instructions of items 5.3. and 5.4.
- 5.6. Formed rivet heads should be protected with the pad for metal.
- 5.7. Assemble the elevator, check the operation.
