# AIRWORTHINESS DIRECTIVE

SZD-9 BOCIAN 1E SAILPLANES

Crack inspection of elevator actuating rod fork end.

BULLETIN NR BE-025/82 "BOCIAN 1E"

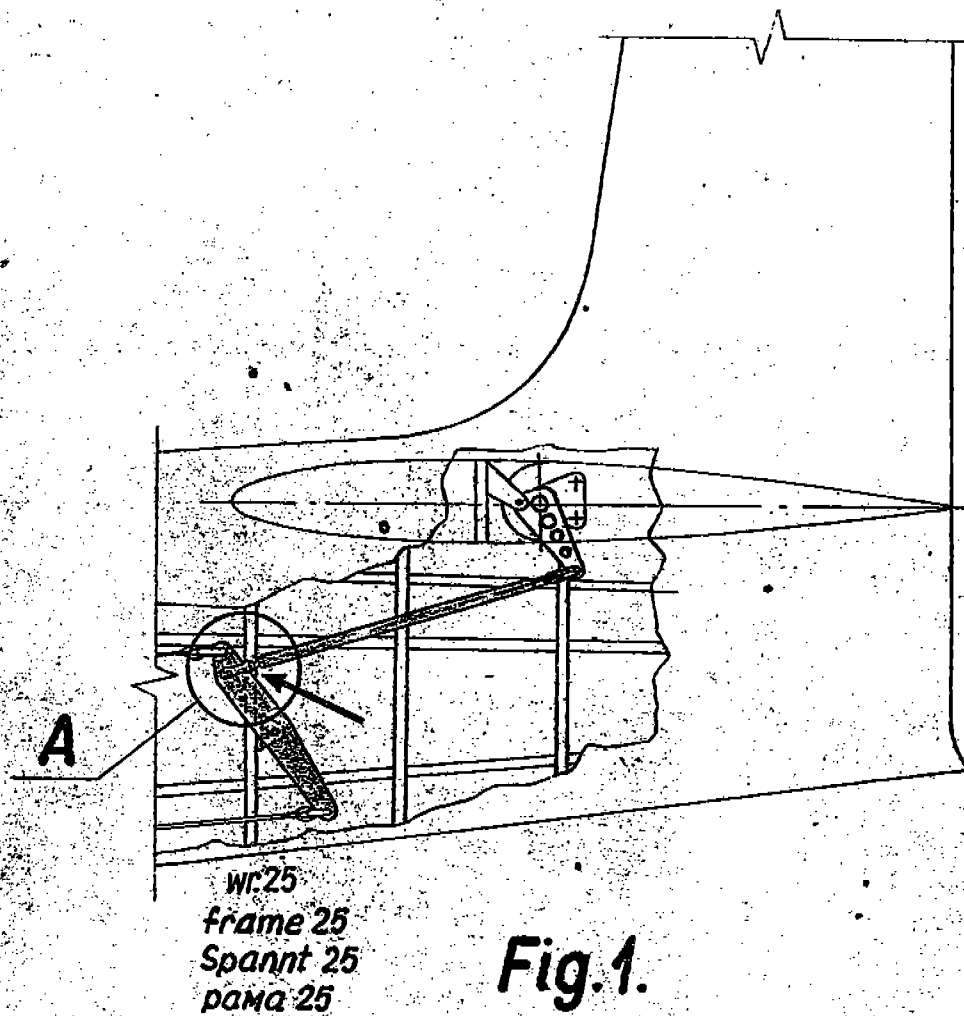
Fig.1.

This Bulletin is introduced due to the crack of threaded part of steel fork with groove end of elevator control circuit push-rod which was found during a periodic inspection. This Bulletin requires the inspection of above mentioned push-rod and orders the service directives aimed to eliminate the possibility of damage of the push-rod end.

- 4.4. Degrease the end in gasoline and inspect /using the 5 times magnifying glass/ the threaded part of the end particularly on the groove side and pay attention for cracks at the thread root. In case the cracks were found the new end shall be installed.
- 4.5. Reassemble the push-rod and check the correct elevator deflections.

location of appearing of cracks  
Stelle der Rissbildung  
место возникновения трещин

Remove and inspect the fork end for cracking as outlined in the Service Bulletin.

**Note:** If cracks are found, or the threaded section is bent, a new fork must be fitted before further operation.

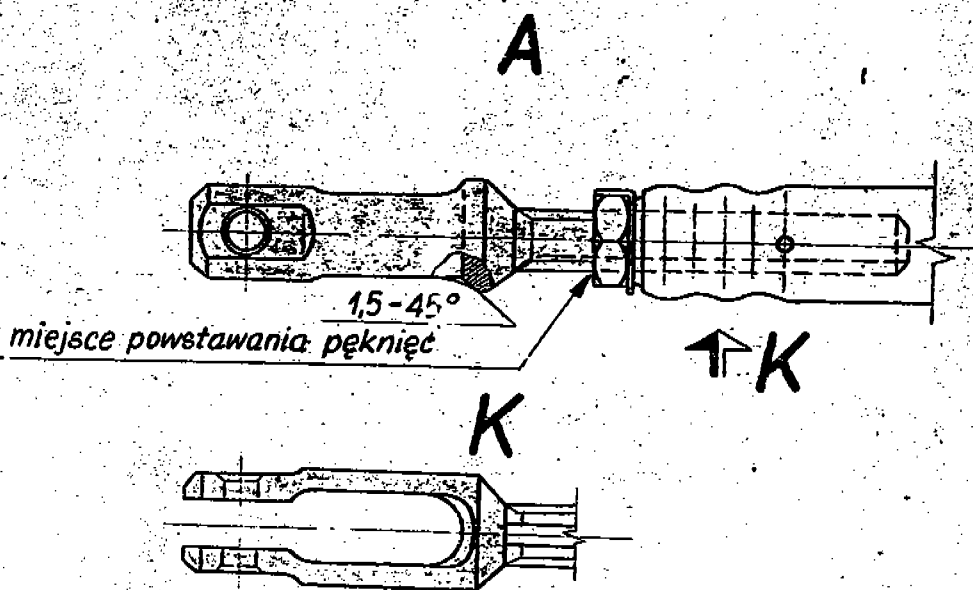
Fig.2.

- 5.1. The incorrectly adjusted length of the rudder control cables results the contact of the steel fork end of push-rod with the lever on frame No 25, when the elevator is deflected down. Inspect the lever for lack of traces of end to lever contact. This trace informs that the end is additionally bent what is restricted..

- 4.1. Disassemble the push-rod out of the elevator lever.
  - 4.2. Disassemble the connection of push-rod fork end with the lever on the frame No 25. Take out the push-rod. If the push-rod end engages the above mentioned lever during the normal elevator deflection /traces on lever/ the end may be filed as shown on sketch Fig. 2.
  - 4.3. Dissecure and screw out the fork end /remember to mark its original alignment in respect to control circuit adjustment/.
- Pay attention that the end is not bent in. The bent end is not allowed to be aligned but the new one shall be installed.

- In such a case the adjustment of cables for the correct elevator deflections should be checked.
- The collision of end and lever shall be avoided.
- The small fileing of lever edge at  $45^\circ$  is allowed but it must be protected with pen for metal /see fig. 2/.
