AIRWORTHINESS DIRECTIVE

JANTAR SERIESTYPES AFFECTED:

Replacement of the aileron pivot pins and their securing M3 screws.

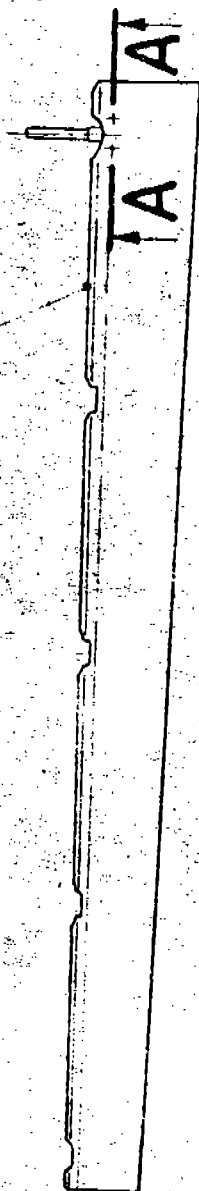
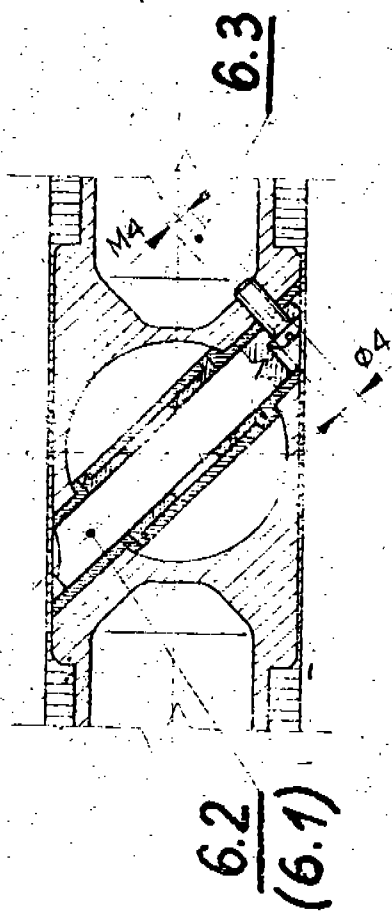
Fig.1.

Lotka lewa SZD-48-1 (SZD-48) - jako przykład.
Left aileron SZD-48-1 (SZD-48) - for example.
Linkes Querruder SZD-48-1 (SZD-48) - zum Beispiel.
Левый элерон SZD-48-1 (SZD-48) - на пример.
